VEHICLE INSPECTION REPORT

YJ65UGL

Daf CF 400

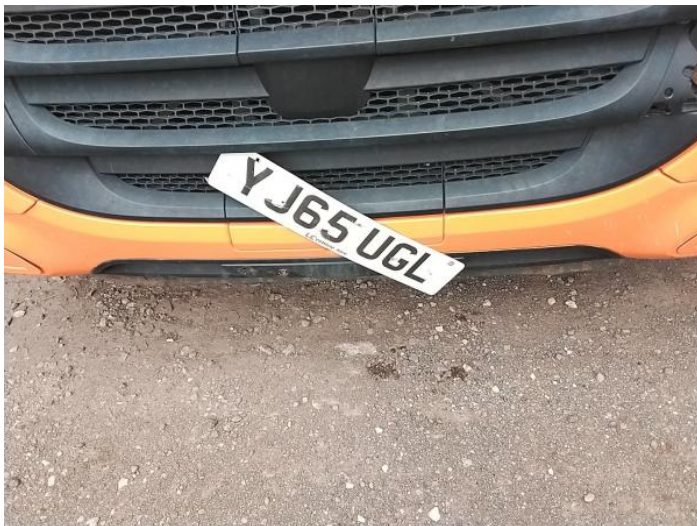
1: Number Plate Front
Broken
Replace

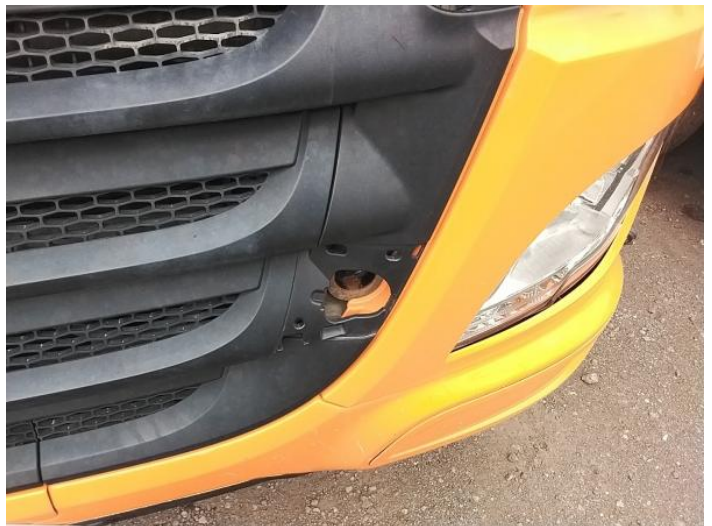
2: Bumper Front Moulding
Missing
Replace

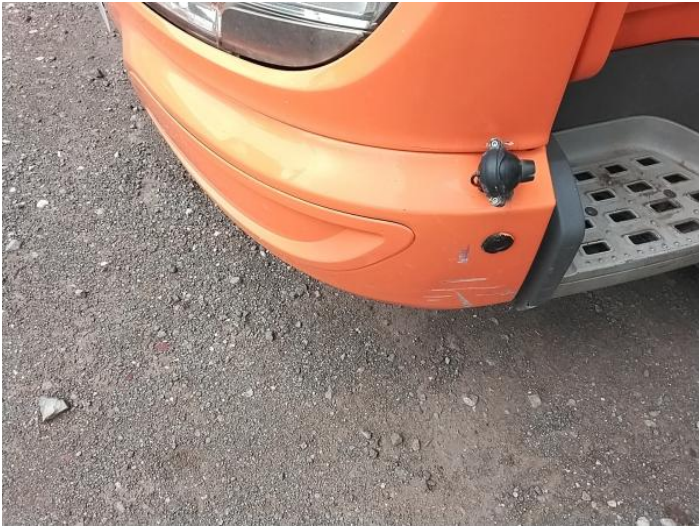
3: Bumper Front
Dented
With Paint Damage

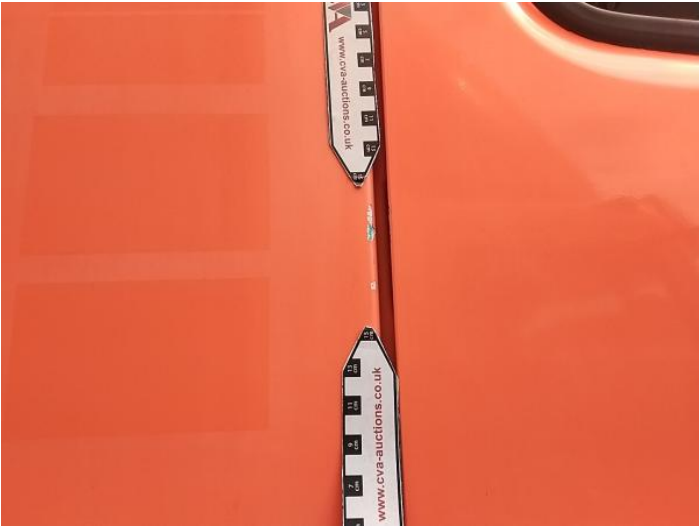
4: Qtr Panel osr
Scratched
Over 25mm Thru Paint

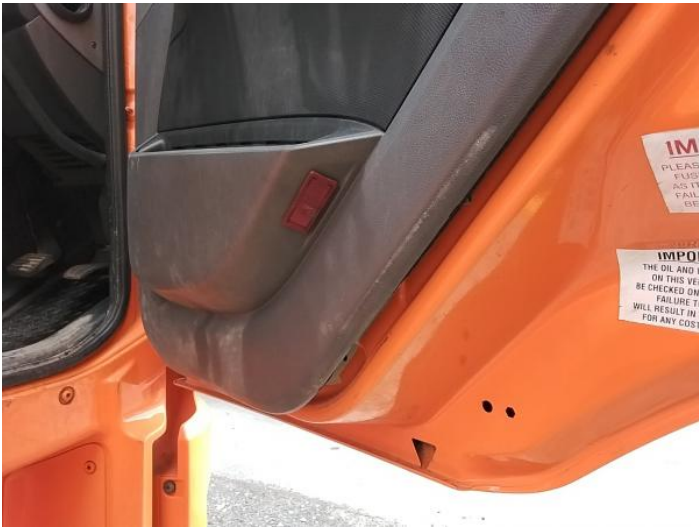
5: Door Pad osf
Broken
Replace
