VEHICLE INSPECTION REPORT

NL69ETD

Scania G 450

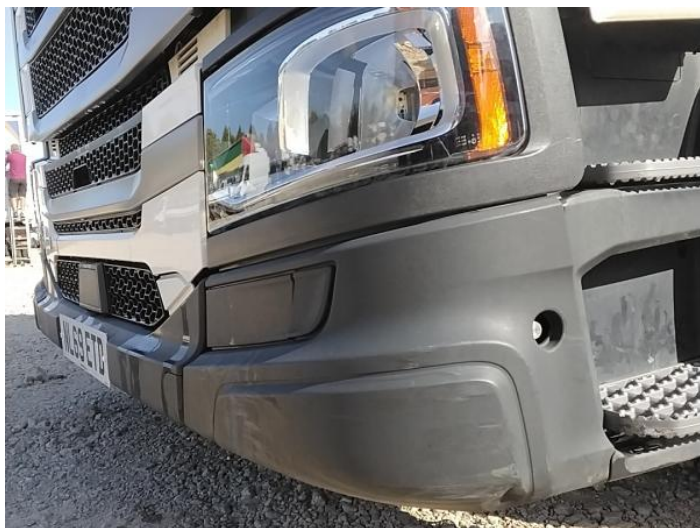
1: Bumper Front Moulding
Scuffed (Unpainted)
Up To 100mm

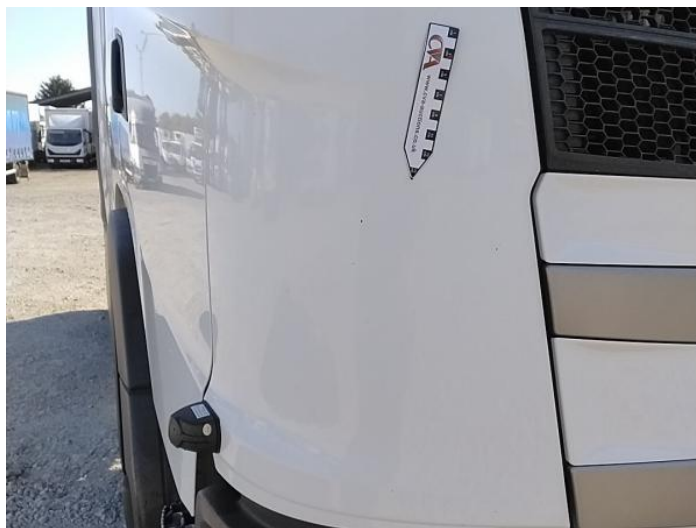
2: Wing osf
Chipped
1 To 5

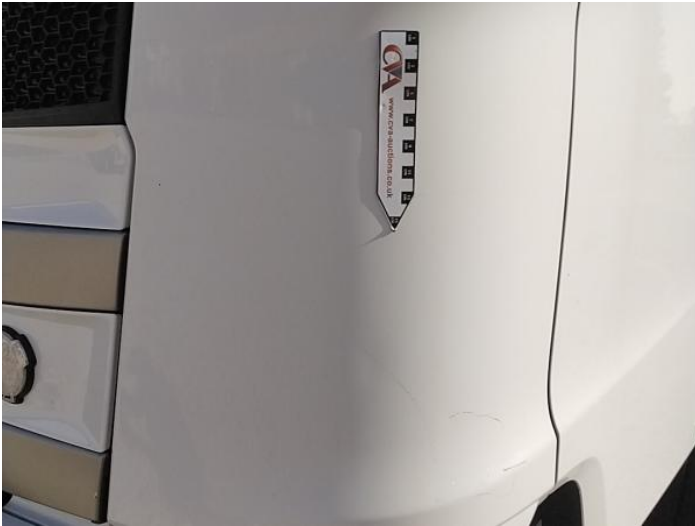
3: Wing nsf
 Scratched
 UpTo 25mm Not Thru Paint

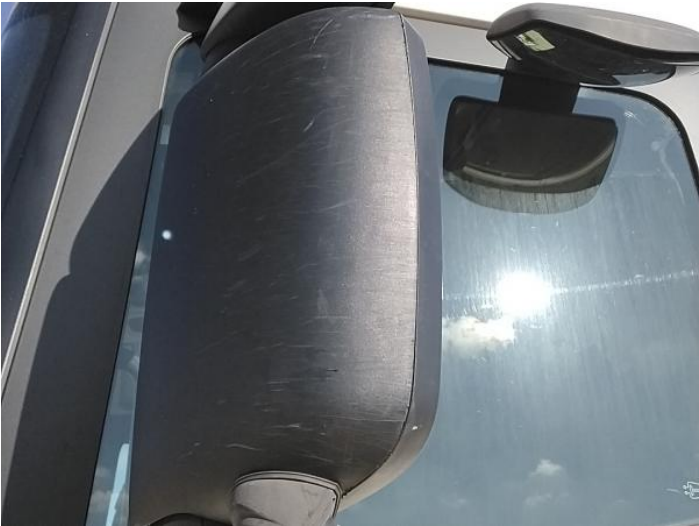
4: Door Mirror Assy nsf
 Scuffed (Unpainted)
 UpTo 100mm

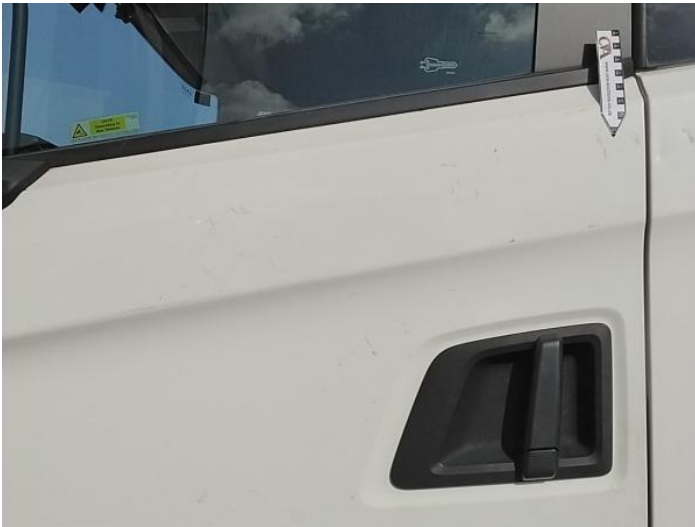
5: Door nsf
 Scratched
 Over 25mm Thru Paint

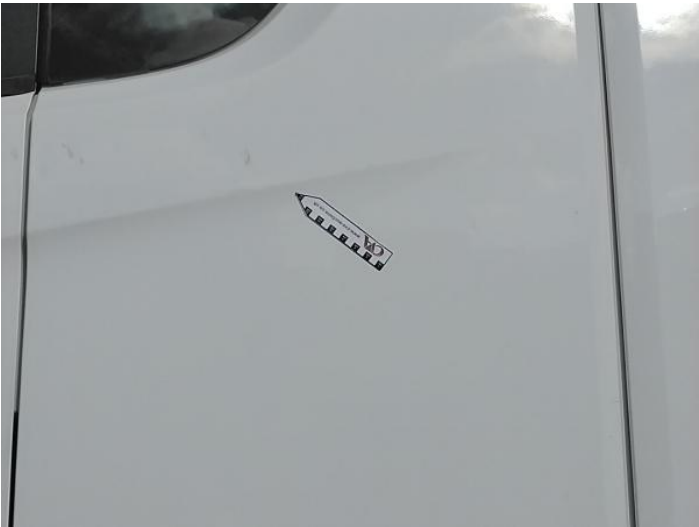
6: Qtr Panel nsr
 Scratched
 UpTo 25mm Thru Paint

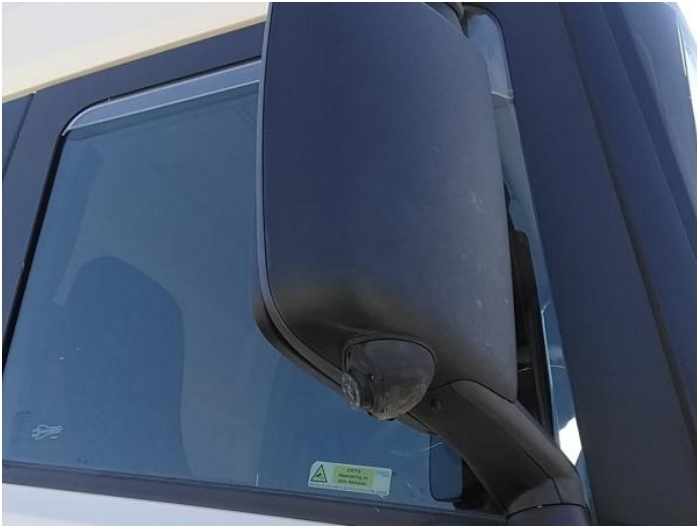
9: Door Mirror Assy osf
Scuffed (Unpainted)
UpTo 100mm

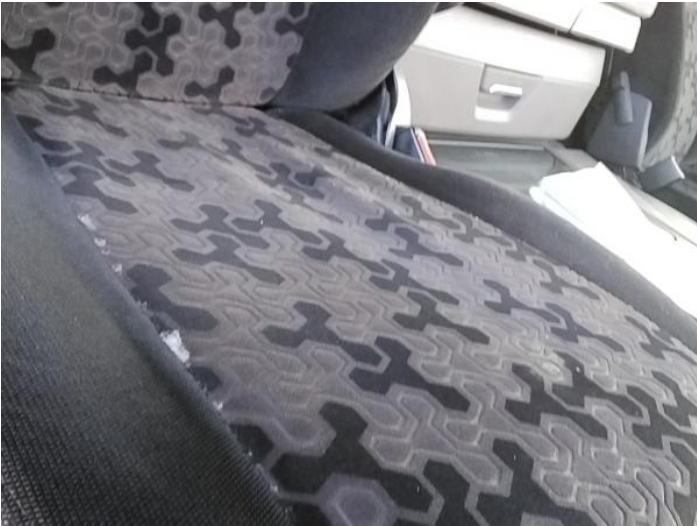
10: Seat Base Cover osf
Holed
Over 3mm
