VEHICLE INSPECTION REPORT

RE69TMX

Ford Transit 350 2.0 ECOBLUE 130PS

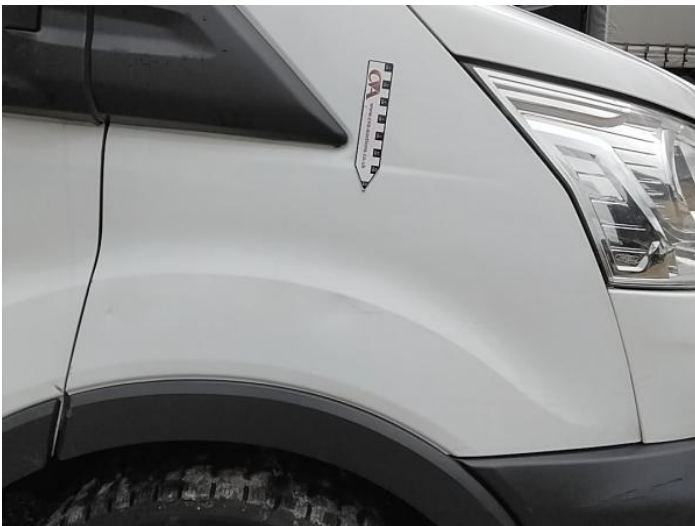
1: Wing of
Dented
Between 10mm + 30mm

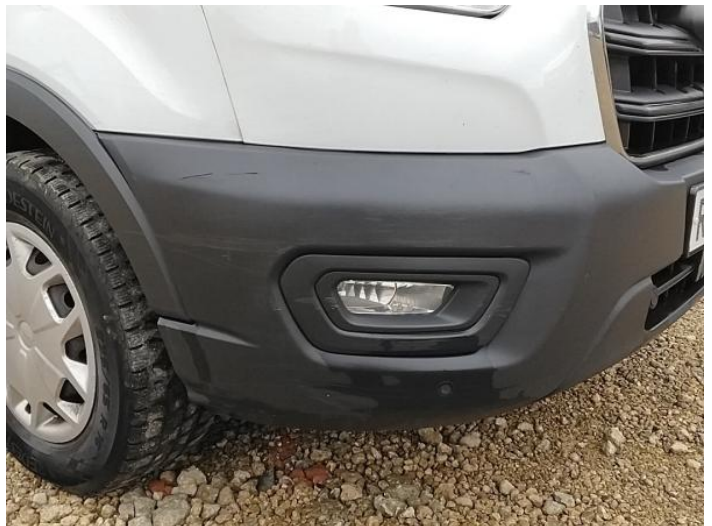
2: Bumper Front Moulding
Scuffed (Unpainted)
Over 100mm

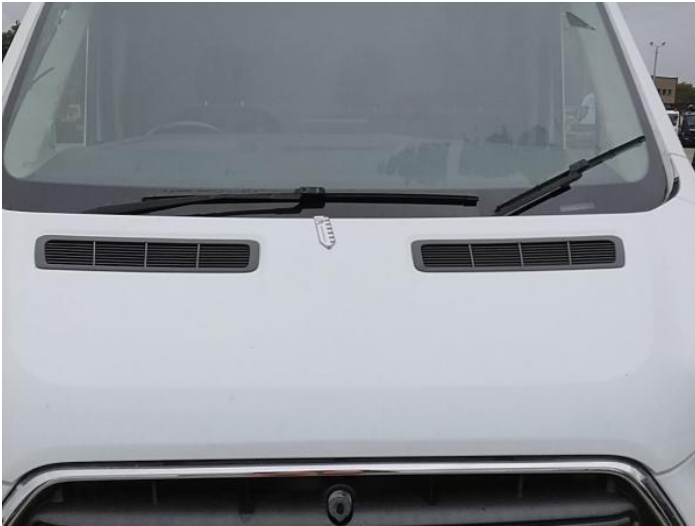
3: Bonnet
Chipped
Multiple Chips

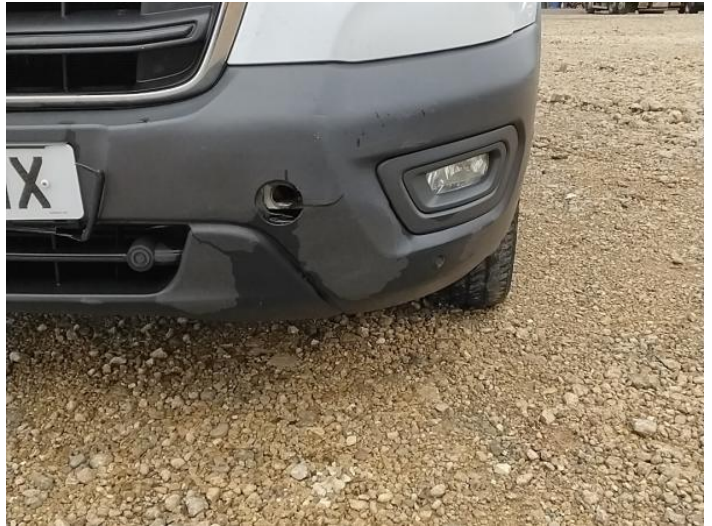
4: Front TowEye Cvr
Missing
Replace

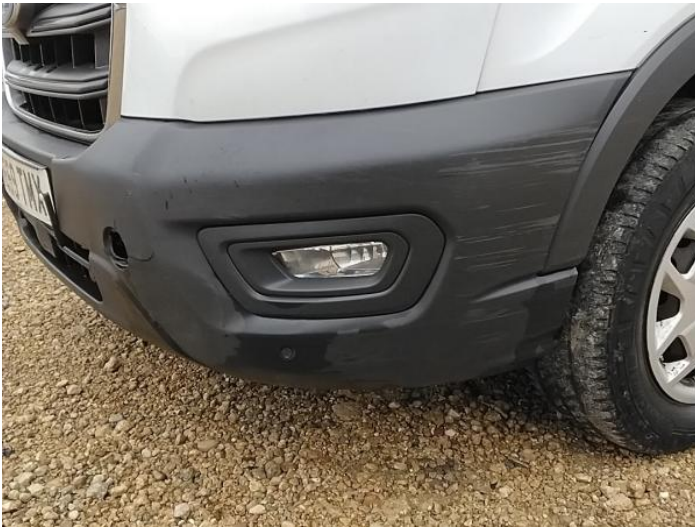
5: Bumper Front Moulding
Scuffed (Unpainted)
Over 100mm

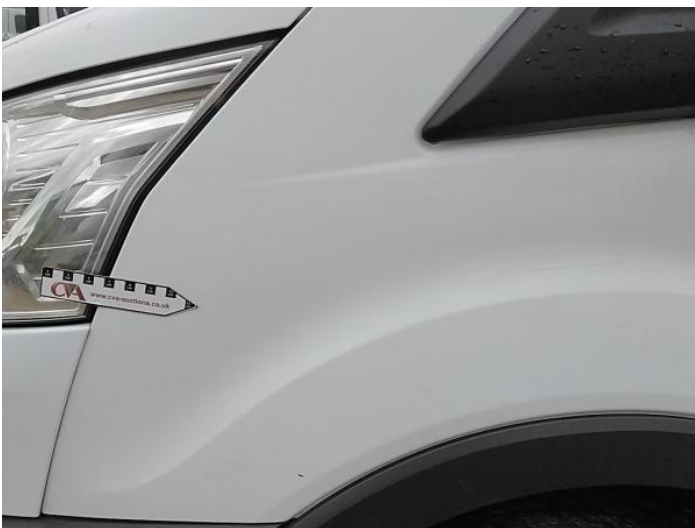
7: Wing nsf
Scratched
Over 25mm Not Thru Paint

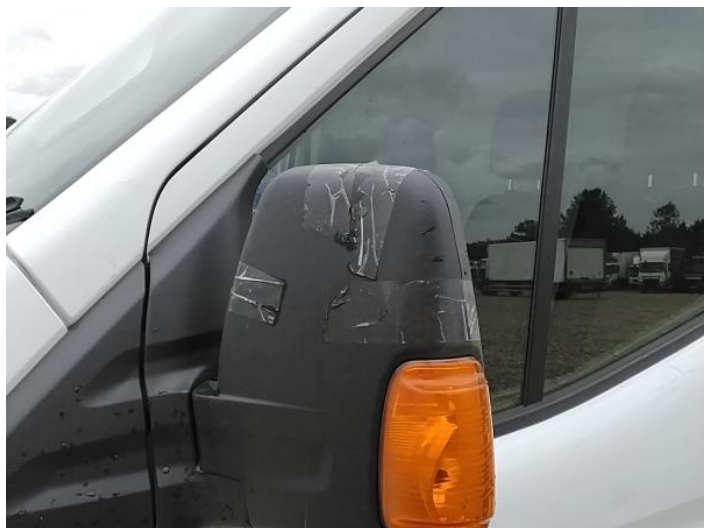
8: Door Mirror Assy nsf
Broken
Replace

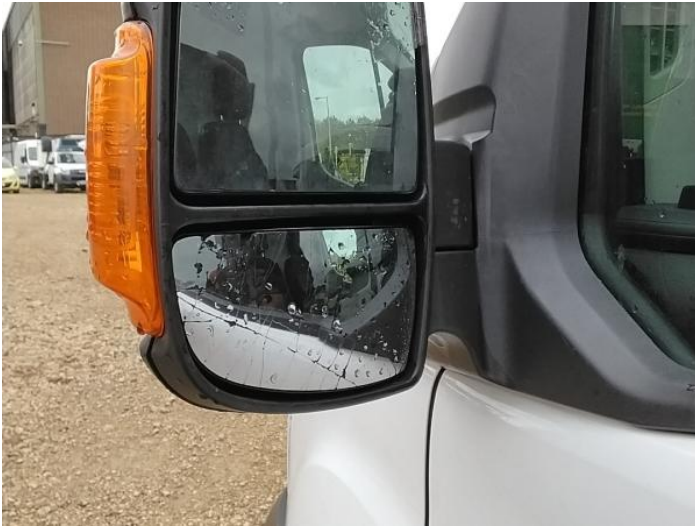
9: Door Mirror Glass ns
Broken
Replace

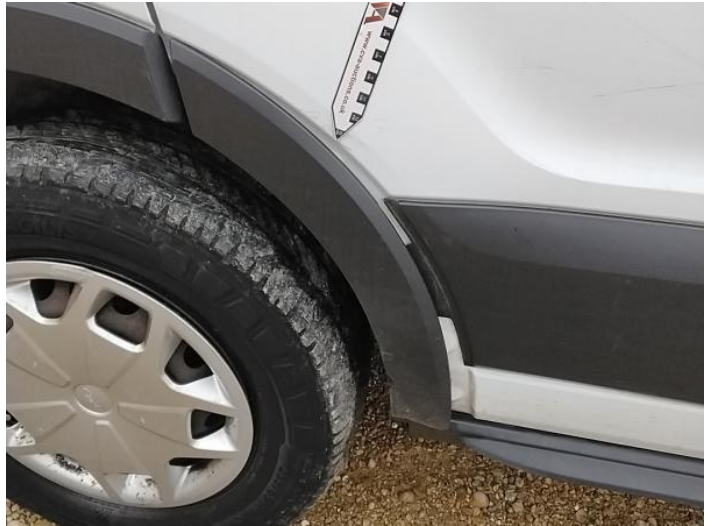
10: Moulding nsf Wing
Broken
Replace

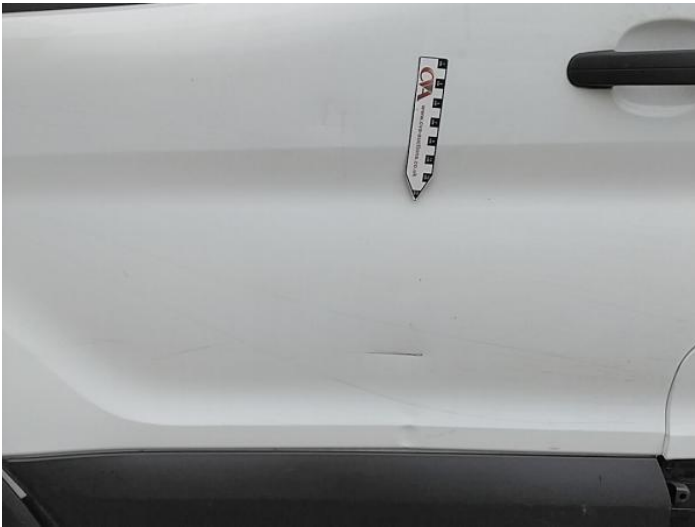
11: Door nsf
Dented
Between 10mm + 30mm

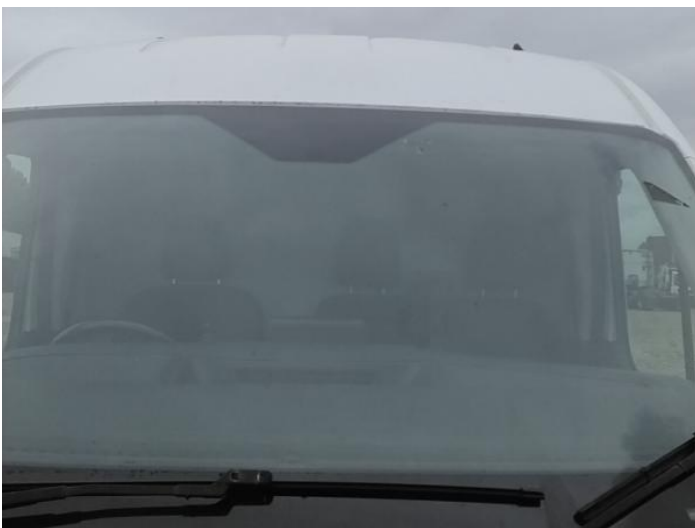
13: Screen Front
Cracked
Replace

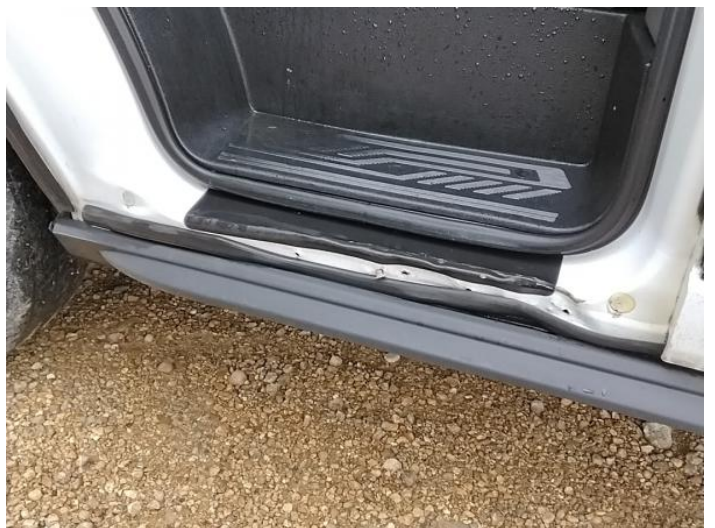
14: Sill ns
Dented
With Paint Damage

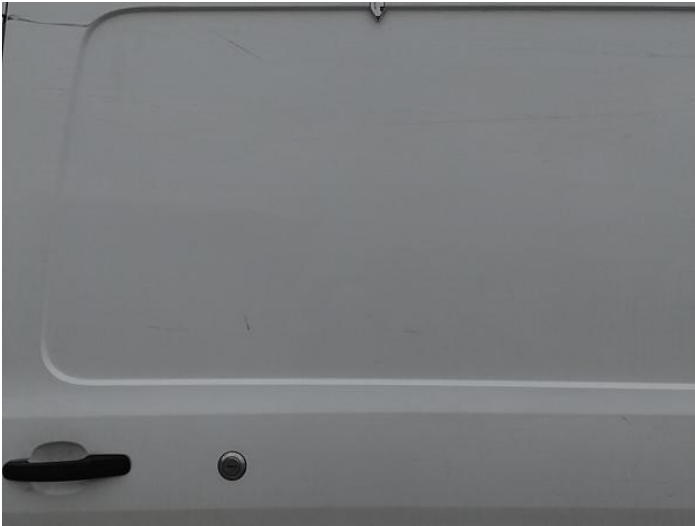
15: Door nsr
Scratched
Over 25mm Not Thru Paint

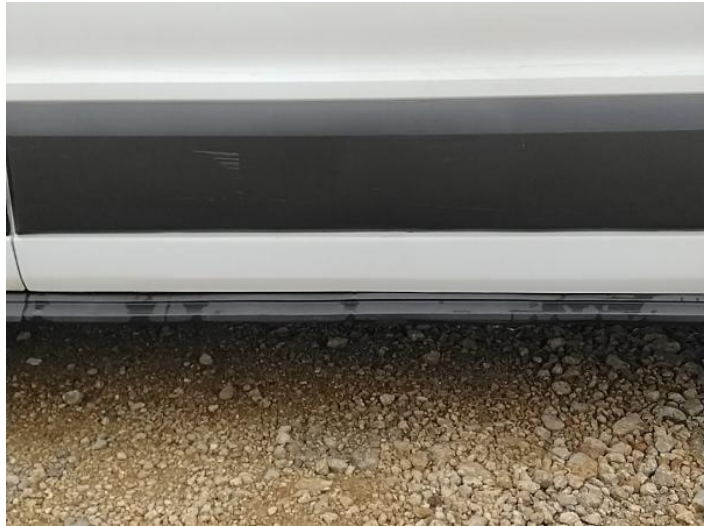
16: Door Moulding nsr
Scuffed (Unpainted)
Over 100mm

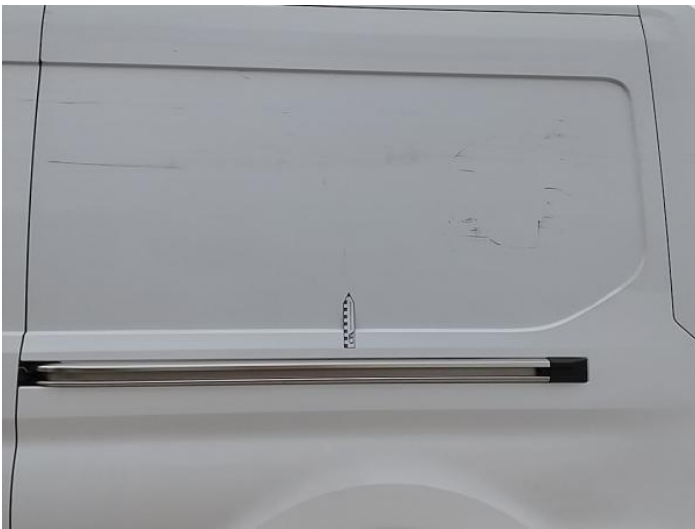
17: Qtr Panel nsr
Scratched
Over 25mm Not Thru Paint

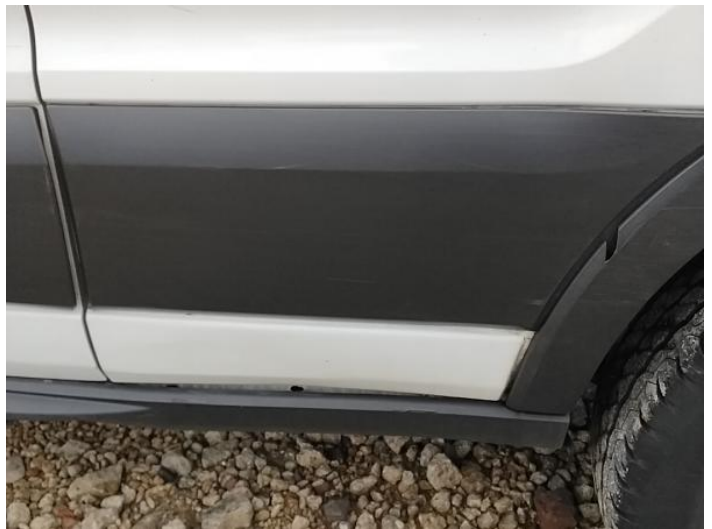
18: Qtr Panel Moulding ns
Scuffed (Unpainted)
UpTo 100mm

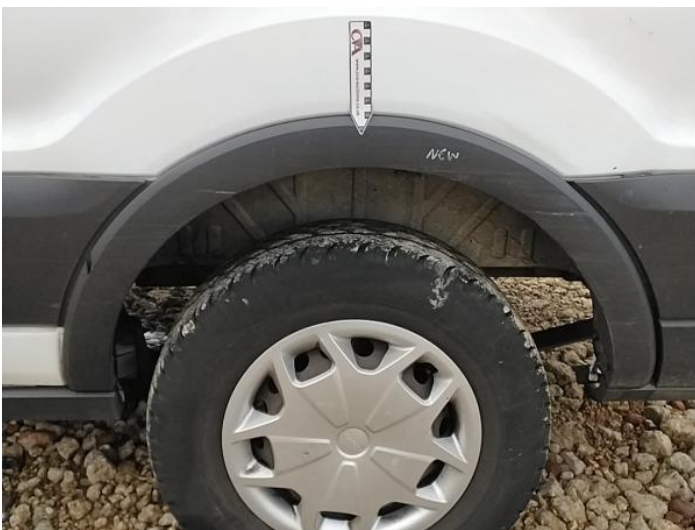
19: Qtr Panel Arch Extension ns
Broken
Replace

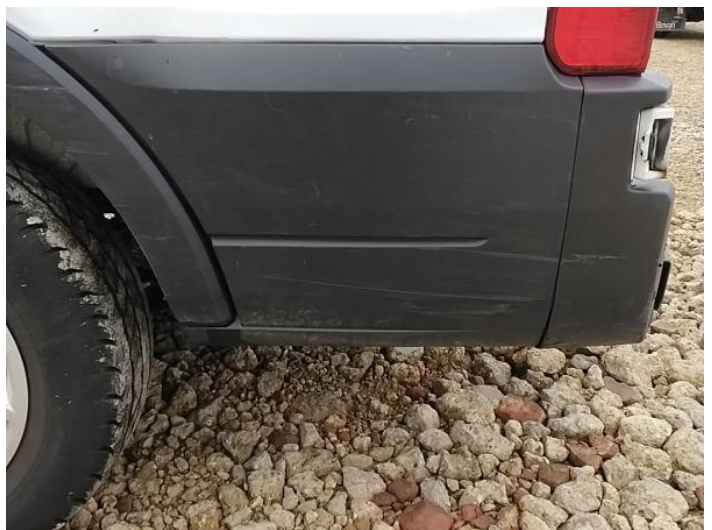
20: Qtr Panel Trim ns
Scuffed
Over 25mm

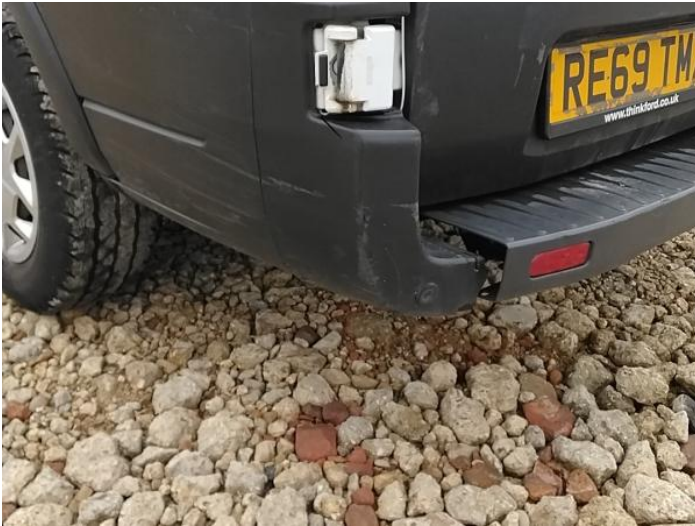
21: Bumper Rear Moulding
Broken
Replace

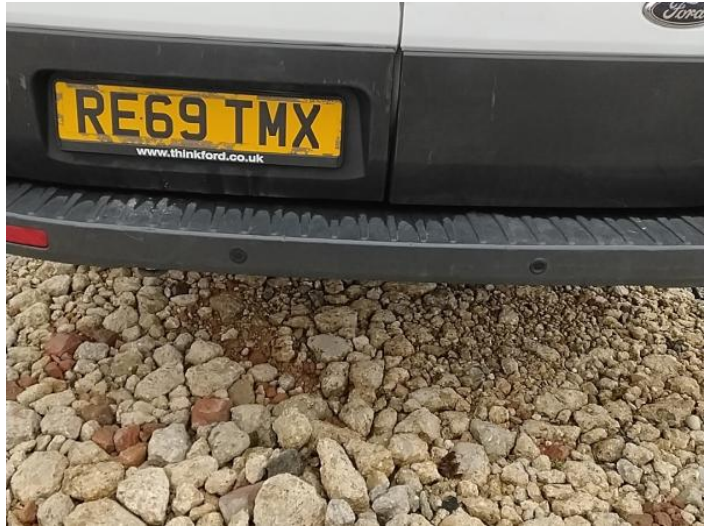
22: Bumper Rear
Insecure
Action Required

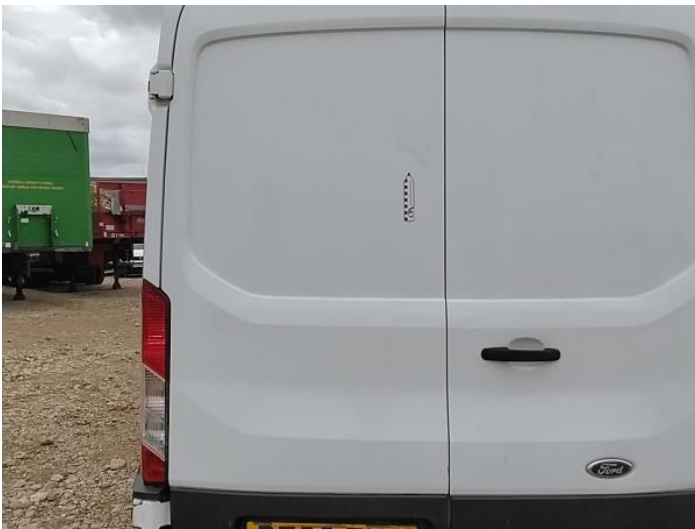
23: Door nsr
Dented
Between 10mm + 30mm

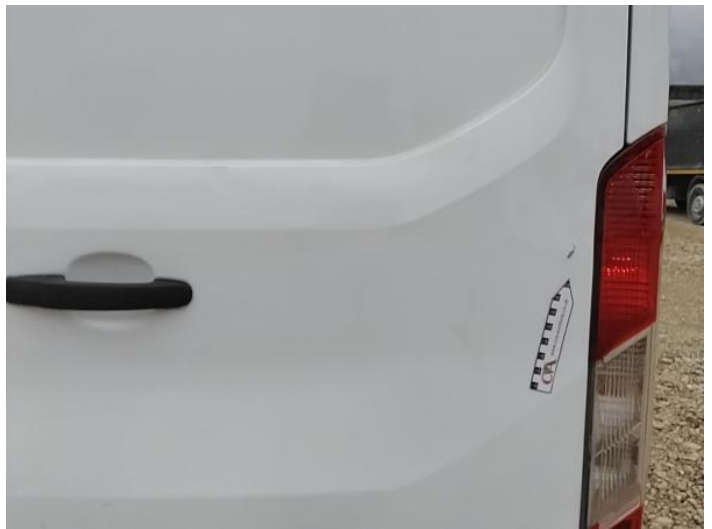
24: Door osr
Dented
With Paint Damage

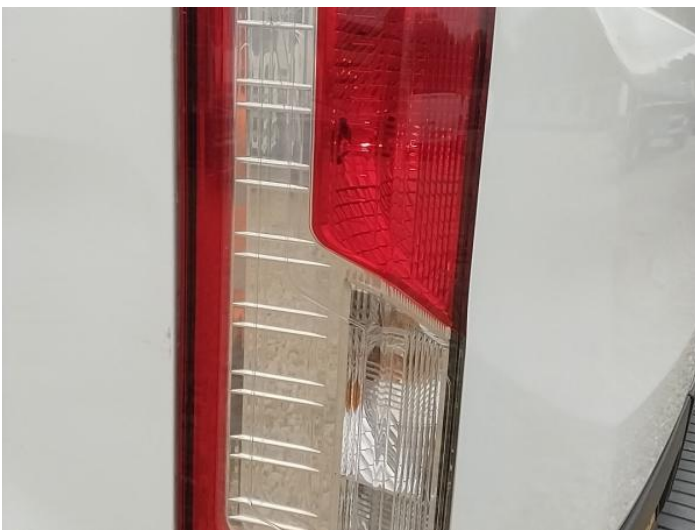
25: Lamp nsr
Broken
Replace

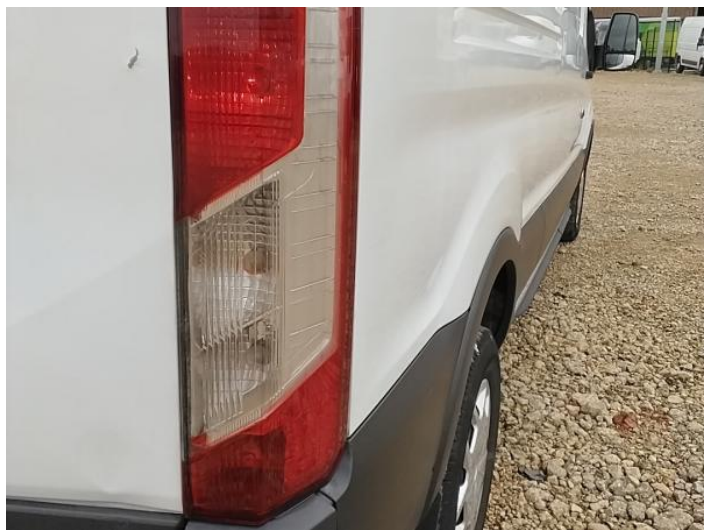
26: Lamp osr
Broken
Replace

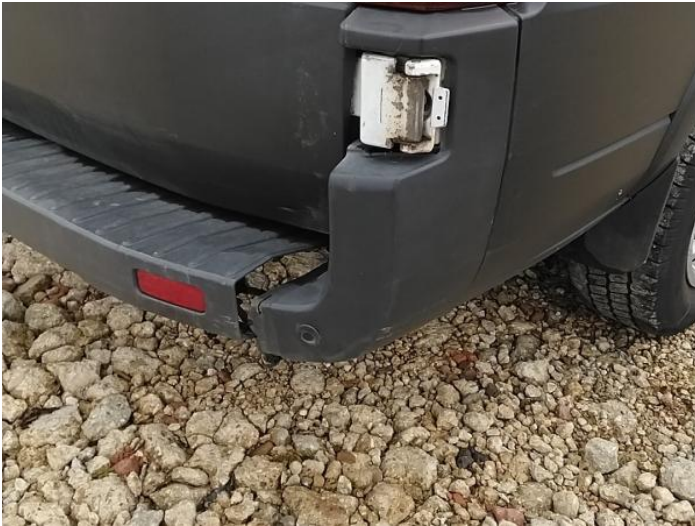
27: Bumper Rear Moulding
Broken
Replace

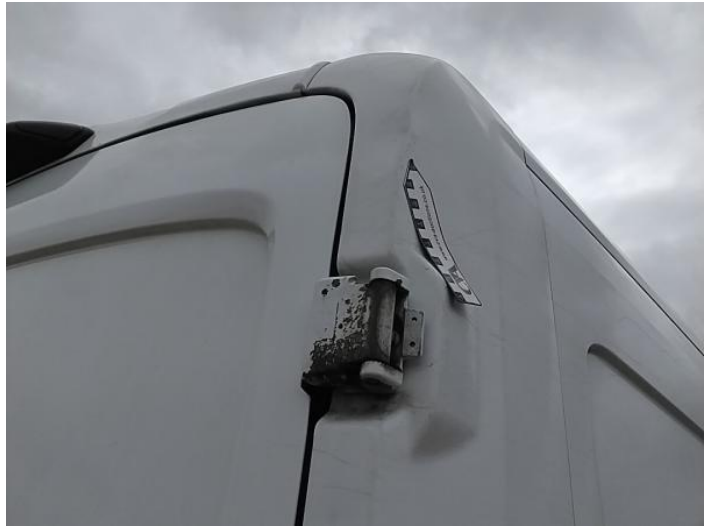
28: Panel Rear
Dented
Between 10mm + 30mm

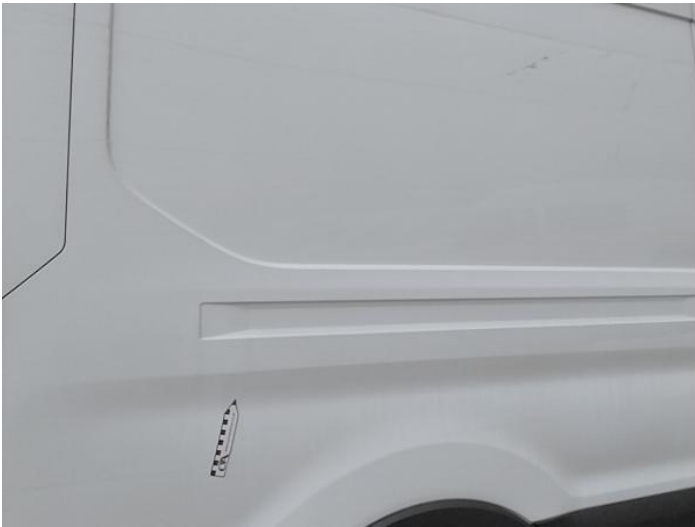
29: Qtr Panel osr
Scratched
Over 25mm Not Thru Paint

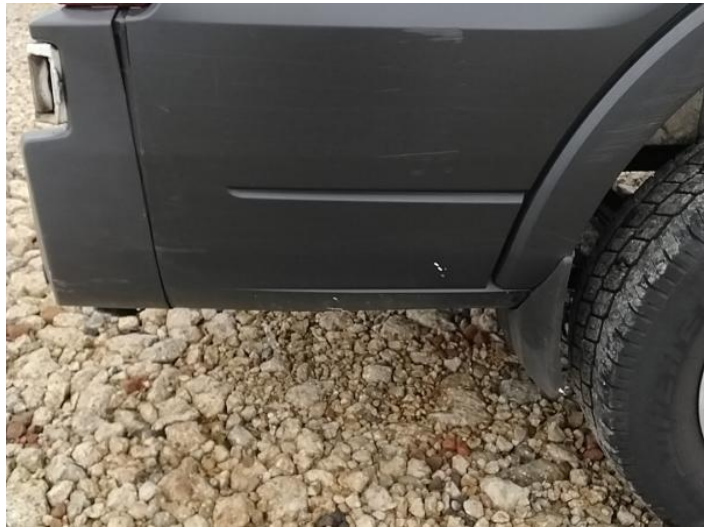
30: Qtr Panel Moulding os
Scuffed (Unpainted)
UpTo 100mm

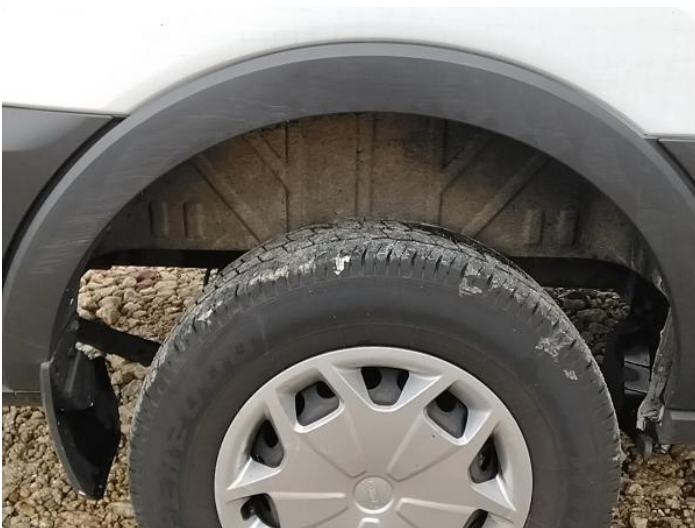
31: Qtr Panel Arch Extension os
Scuffed (Unpainted)
Over 100mm

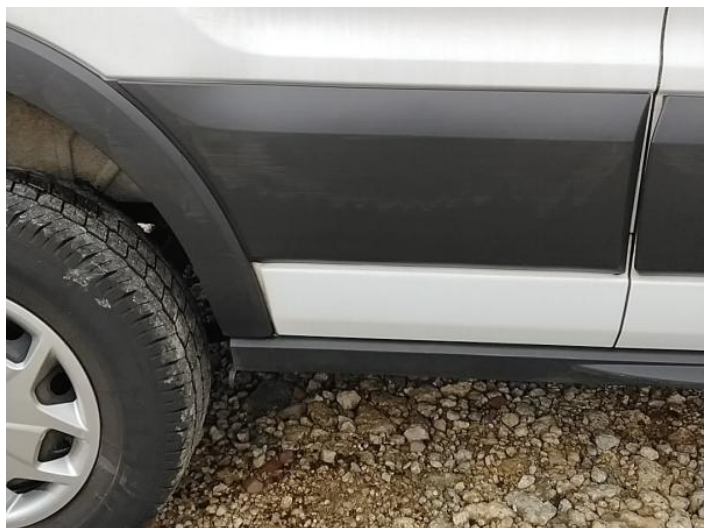
32: Qtr Panel Moulding os
Scuffed (Unpainted)
UpTo 100mm

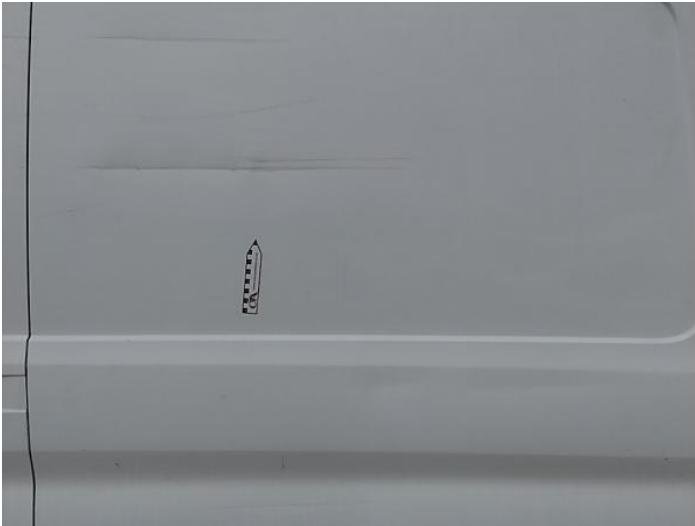
33: Qtr Panel osr
Dented
With Paint Damage

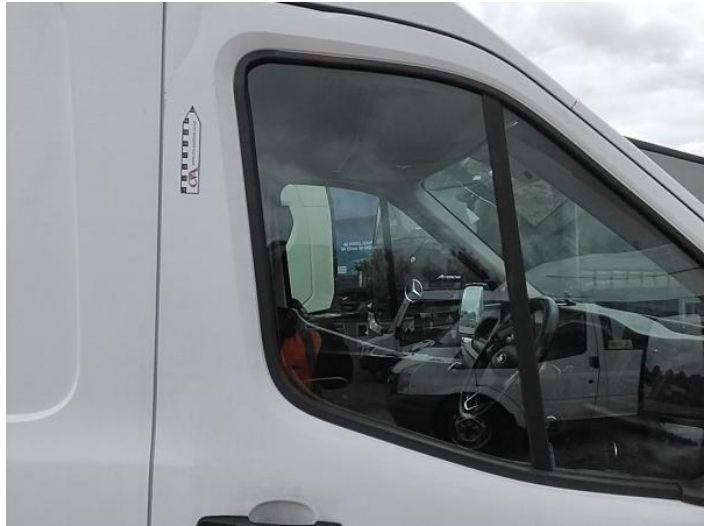
34: Door osf
Dented
Between 10mm + 30mm

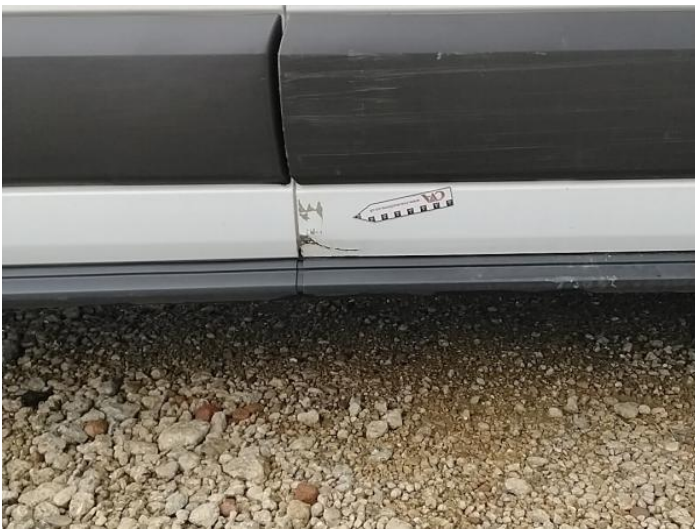
35: Door osf
Dented
With Paint Damage

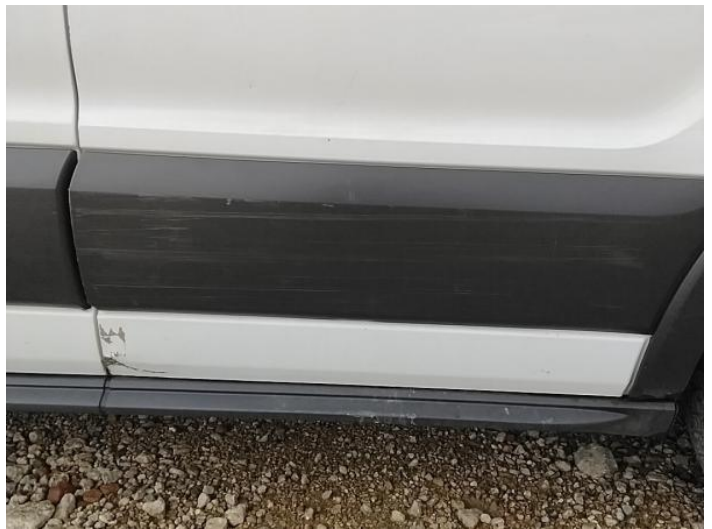
36: Door Moulding osf
Scuffed (Unpainted)
Over 100mm

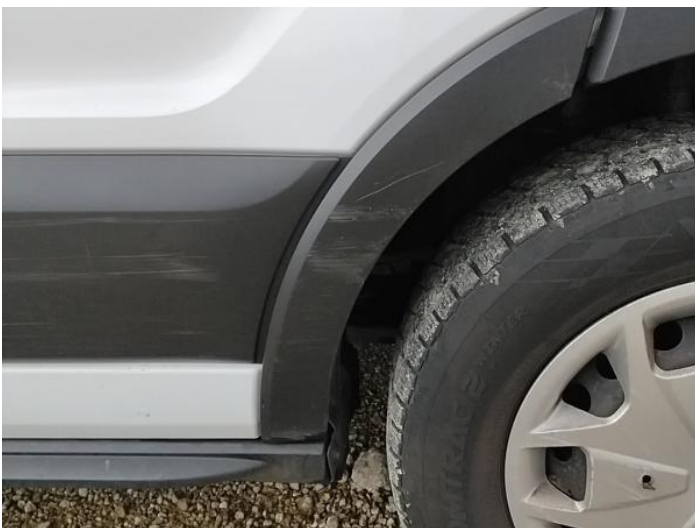
37: Moulding osf Wing
Scuffed (Unpainted)
UpTo 100mm

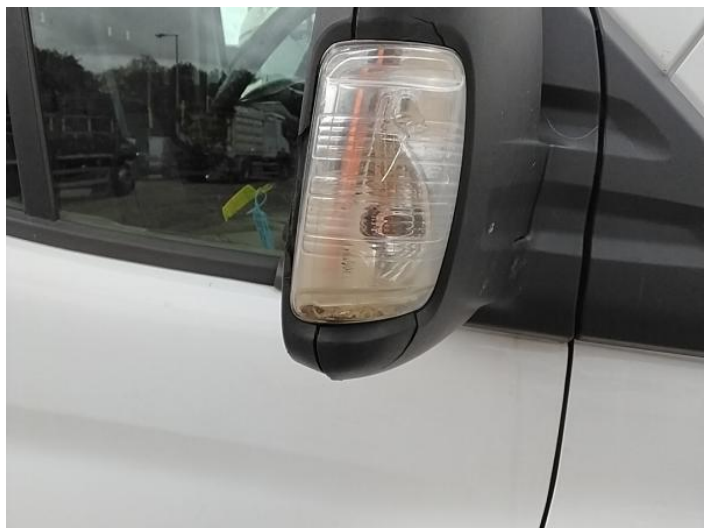
38: Flasher Side Repeater os
Broken
Replace
