# VEHICLE INSPECTION REPORT

**DG17WZC**

## Man TGS 26.360

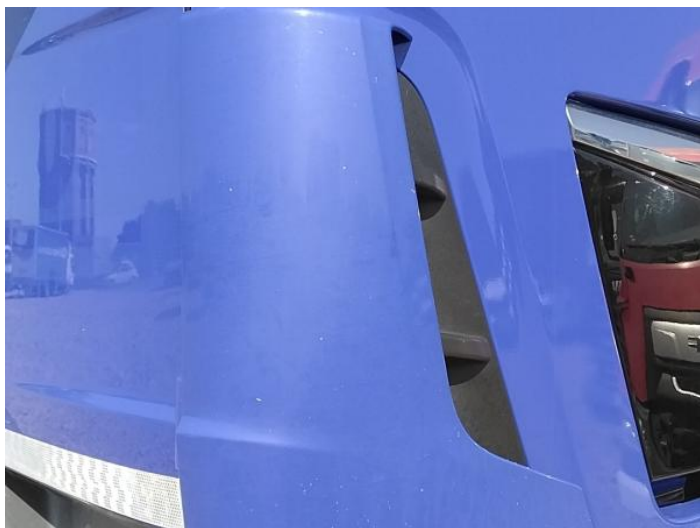
1: Wing osf  
Chipped  
Multiple Chips

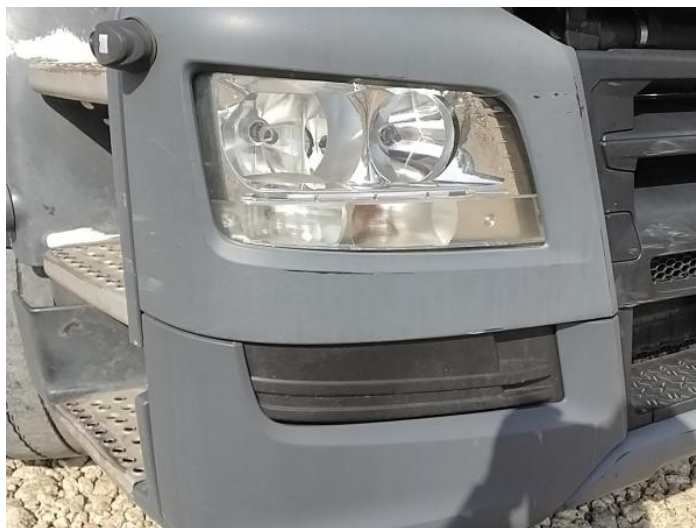
2: Fog Lamp Surround os  
Scuffed (Unpainted)  
Over 100mm

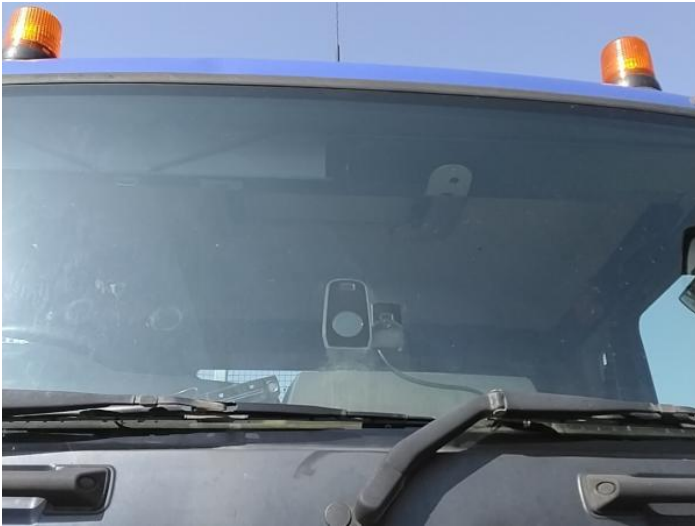
3: Screen Front  
Chipped  
UpTo 10mm

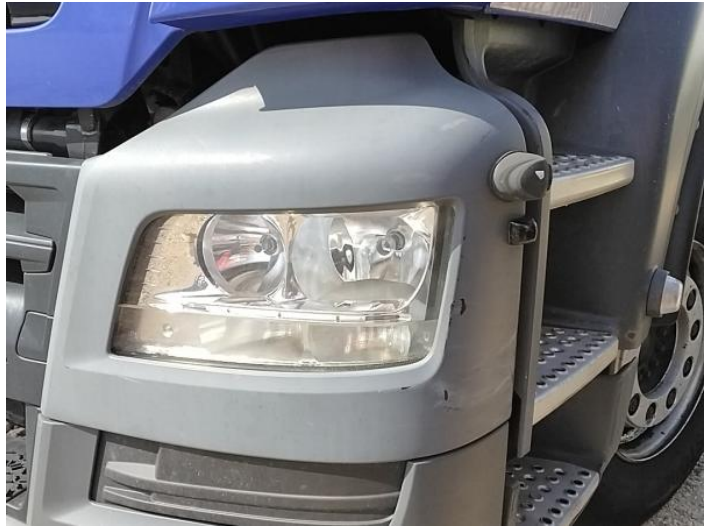
4: Fog Lamp Surround ns  
Scuffed (Unpainted)  
Over 100mm

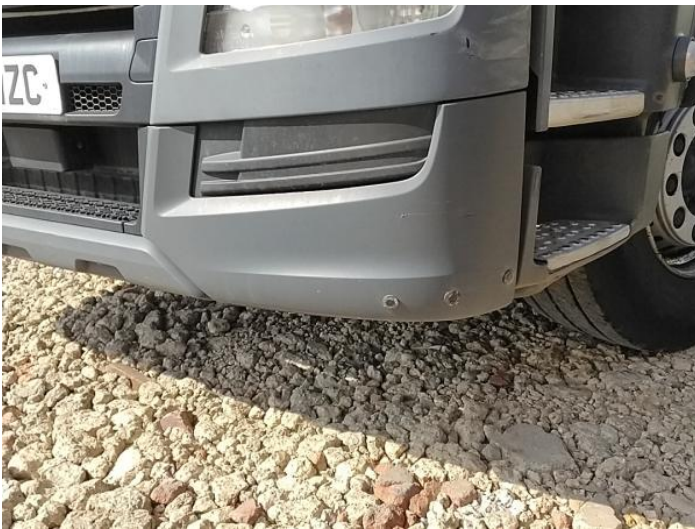
5: Bumper Front Moulding  
Scuffed (Unpainted)  
UpTo 100mm

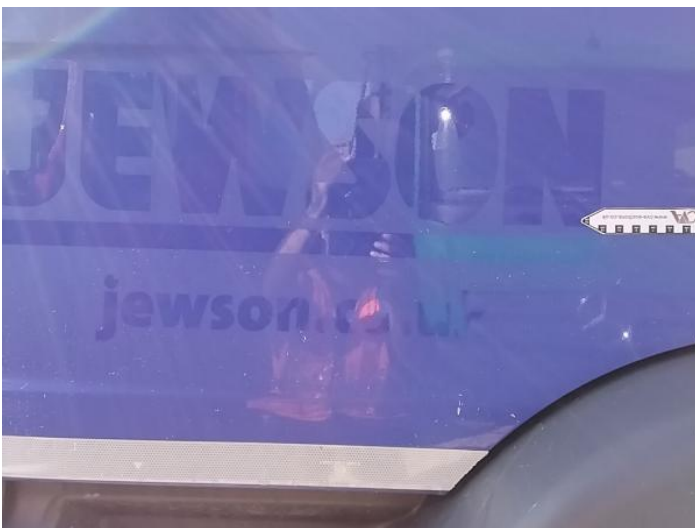
7: Door nsf  
Chipped  
Multiple Chips

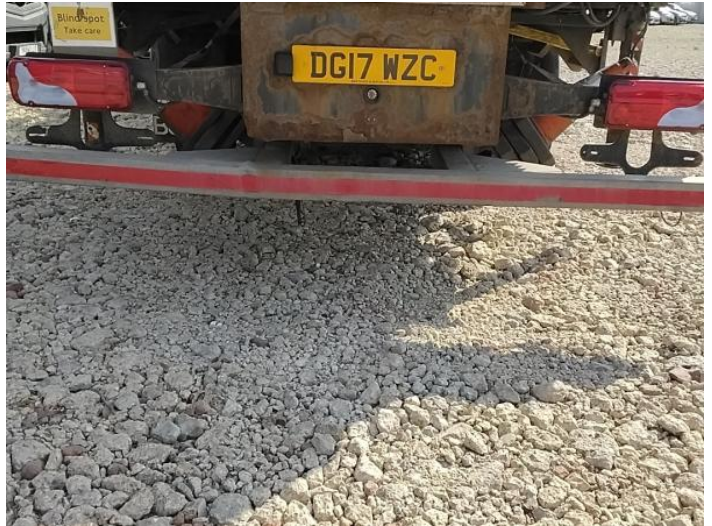
10: Bumper Rear  
Dented  
Between 10mm + 30mm

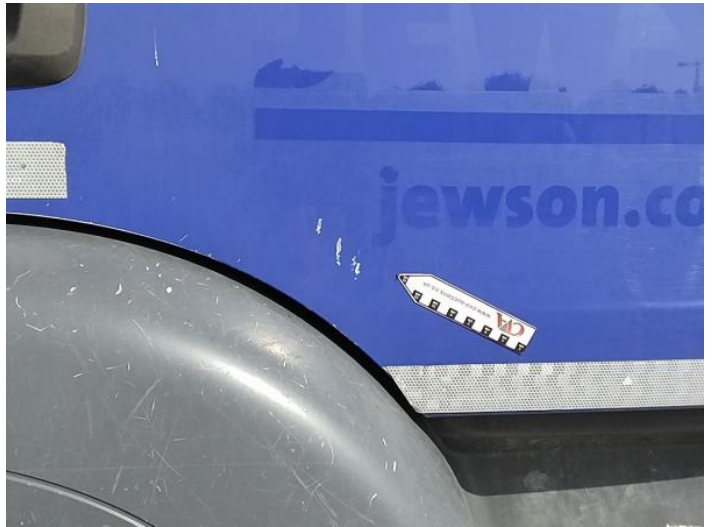
12: Door osf  
Scratched  
UpTo 25mm Thru Paint

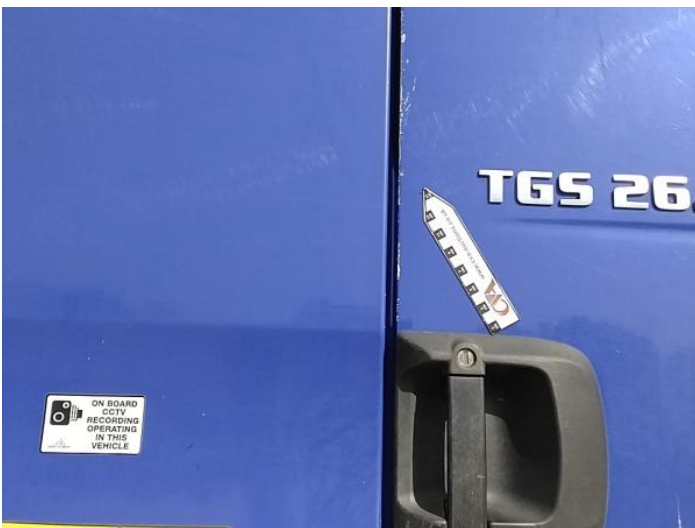
13: Door osf  
Chipped  
Edge Chip

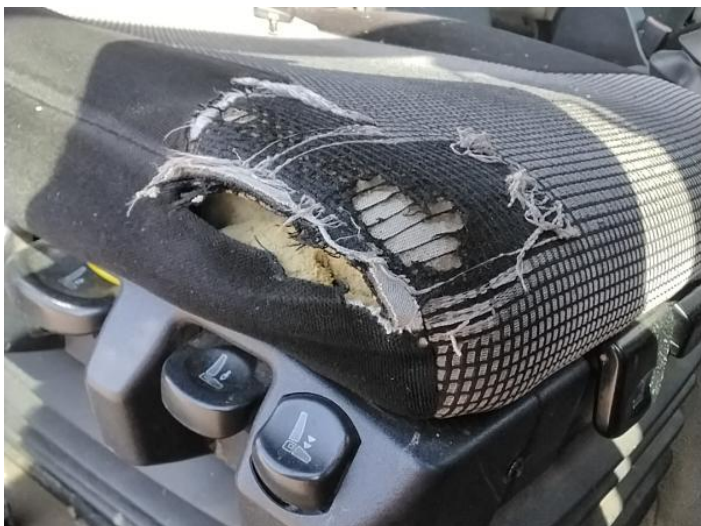
15: Seat Base Cover osf  
Torn  
Over 3mm
