VEHICLE INSPECTION REPORT

SJ16NXT

Mercedes-Benz Antos 1827

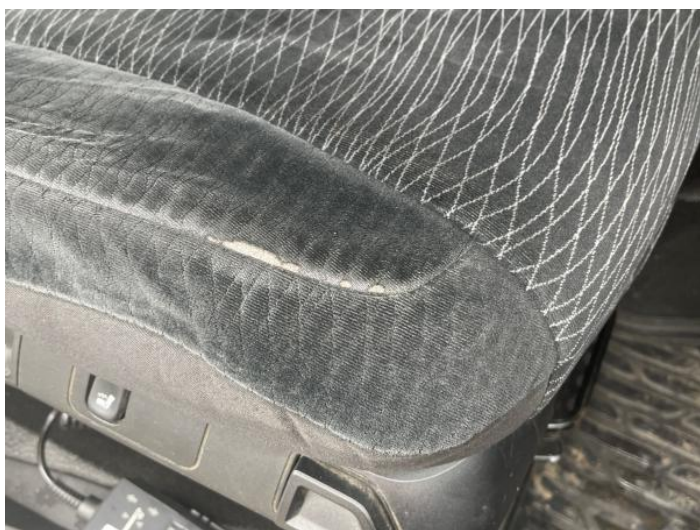
1: Seat Base Cover osf
Torn
Over 3mm

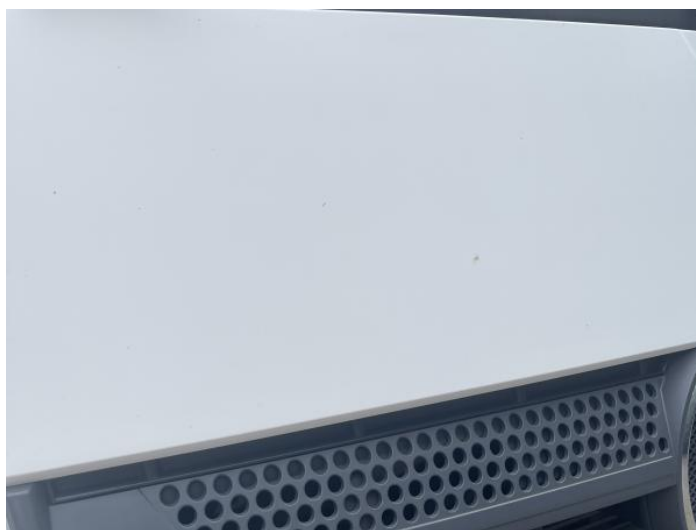
2: Bonnet
Chipped
Multiple Chips

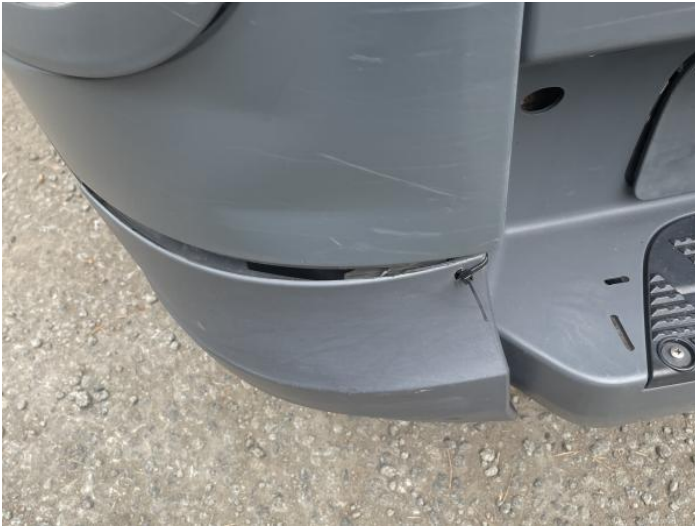
3: Bumper Front Moulding
Scuffed (Unpainted)
Over 100mm

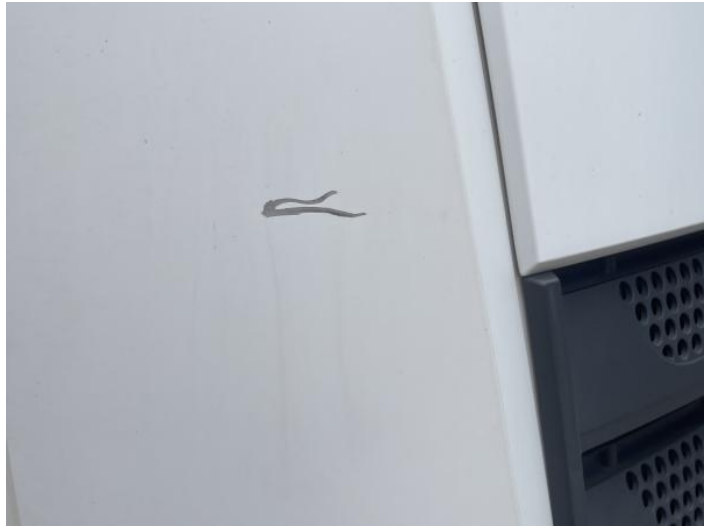
4: Wing osf
Scratched
Over 25mm Thru Paint

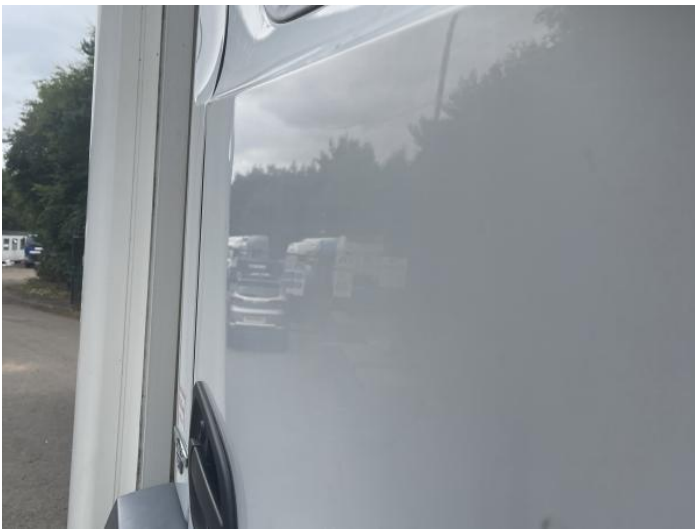
5: Door osf
Dented
With Paint Damage

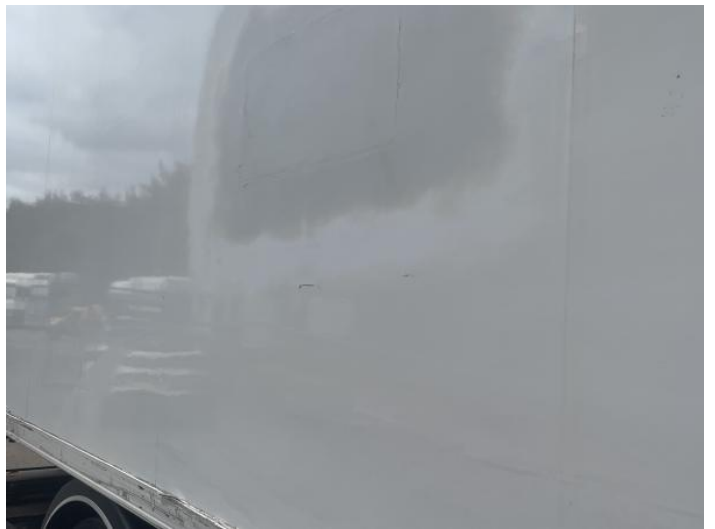
6: Qtr Panel osr
Dented
With Paint Damage

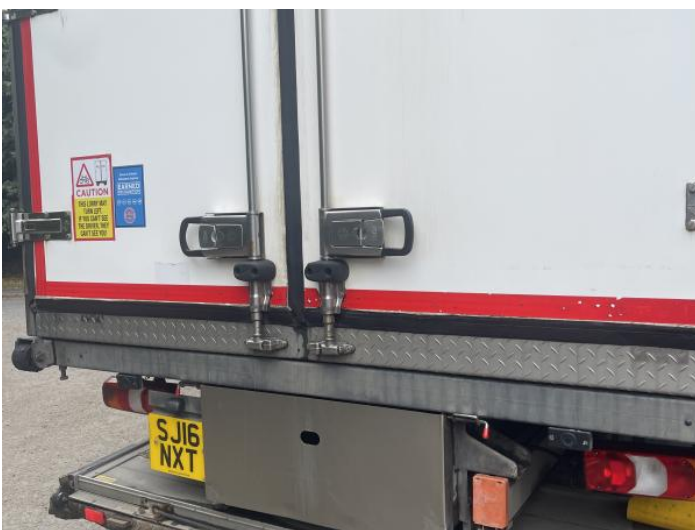
7: Tailgate
Rusted
UpTo 5mm

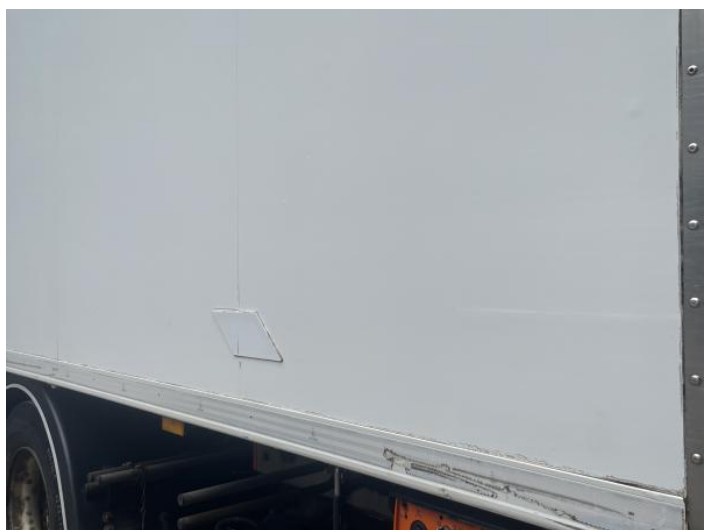
8: Qtr Panel nsr
Dented
With Paint Damage

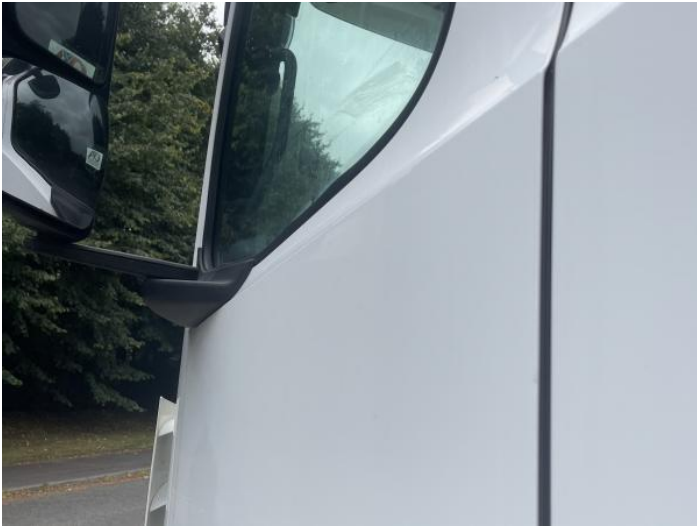
9: Door osf
Dented
2 Or Less UpTo 10mm

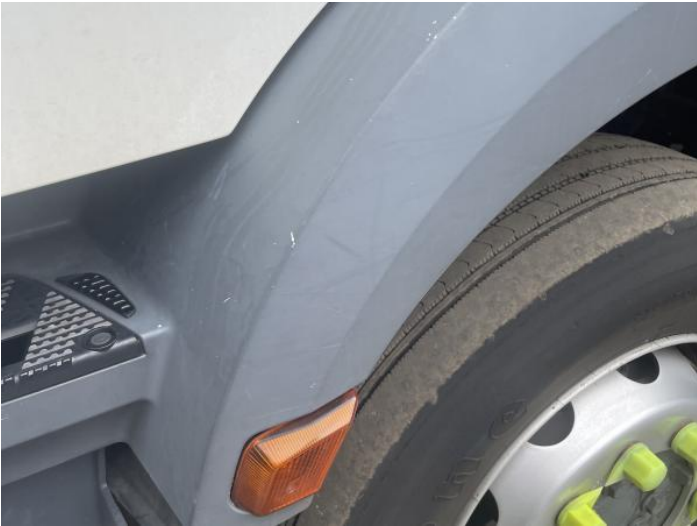
10: Door Moulding nsf
Scuffed (Unpainted)
Over 100mm
