VEHICLE INSPECTION REPORT

PJ69XEO

Daf LF 260

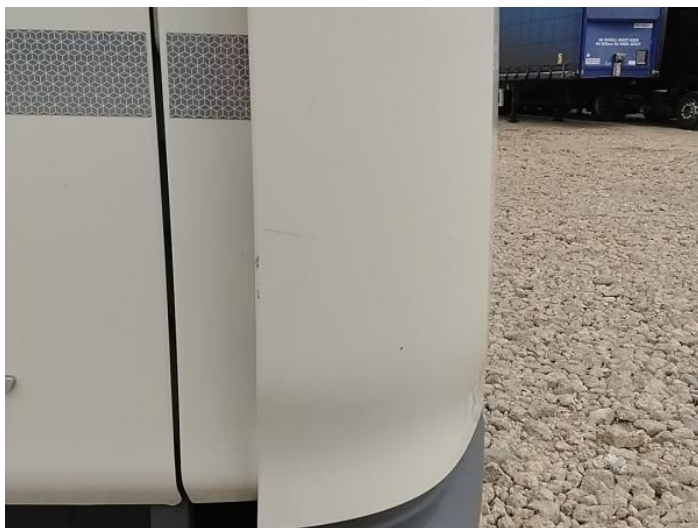
1: Wing osf
Scratched
UpTo 25mm Thru Paint

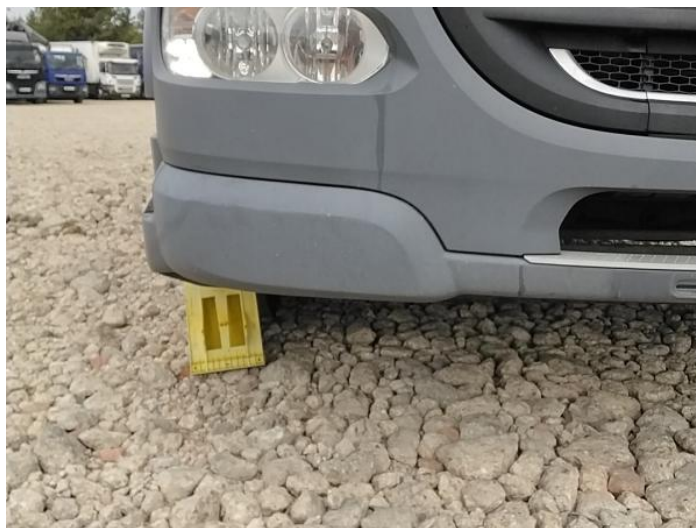
2: Bumper Front
Chipped
Multiple Chips

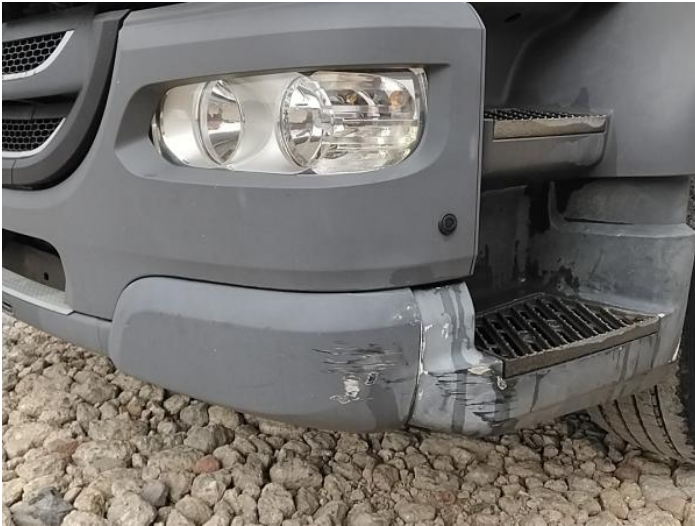
3: Bumper Front
Scratched
25 to 100mm Thru Paint

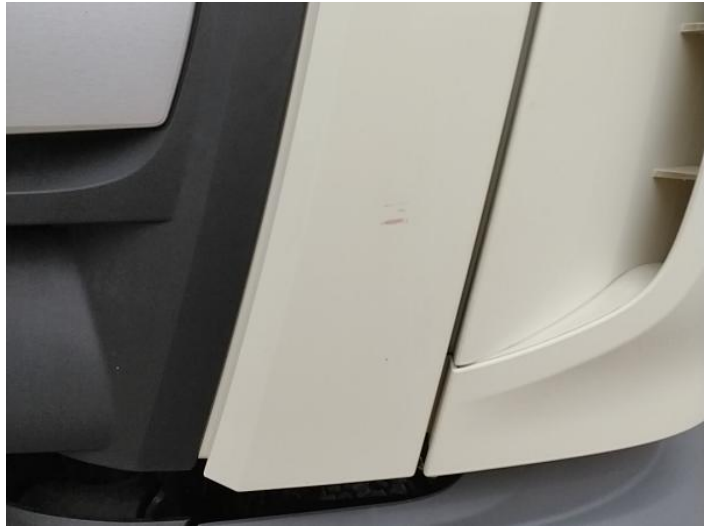
4: Bonnet
Scratched
UpTo 25mm Thru Paint

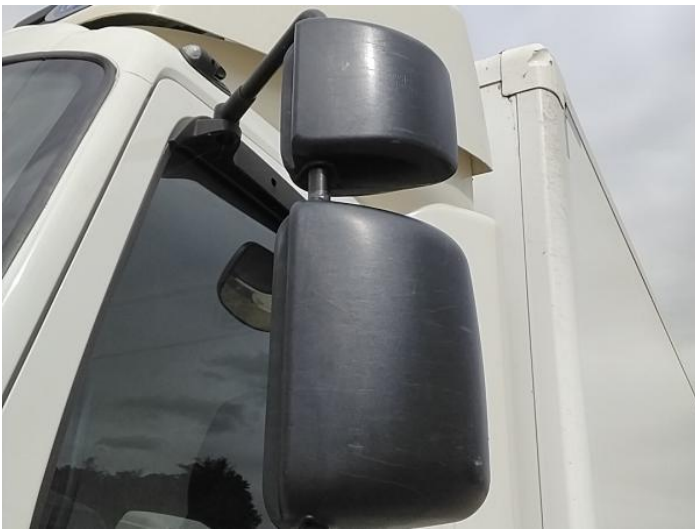
5: Door Mirror Assy nsf
Scuffed (Unpainted)
UpTo 100mm

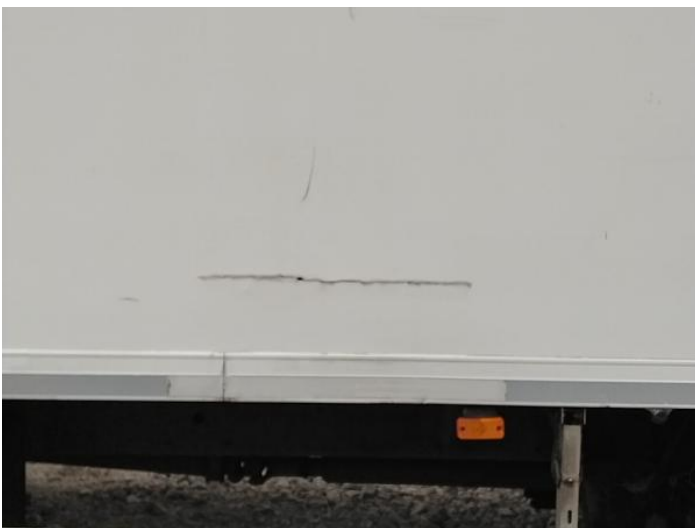
7: Qtr Panel nsr
Cracked
Replace

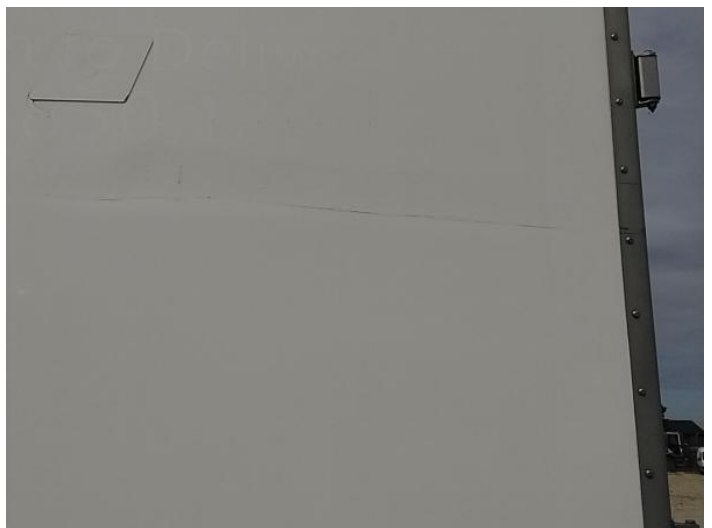
8: Qtr Panel nsr
Scratched
Over 25mm Not Thru Paint

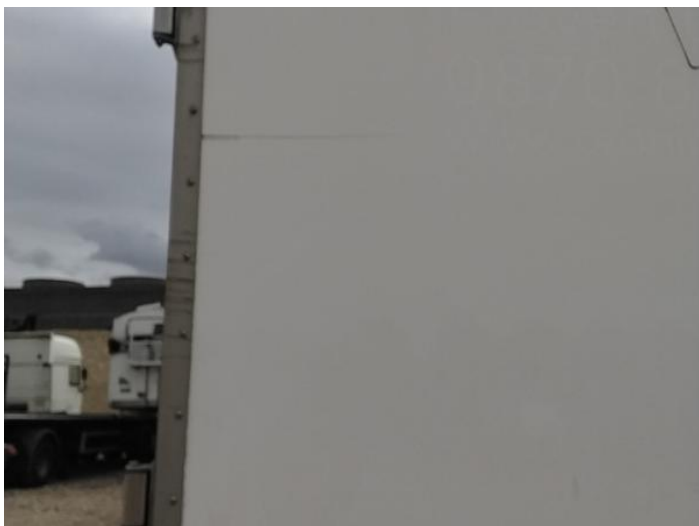
9: Qtr Panel osr
Scratched
Over 25mm Not Thru Paint

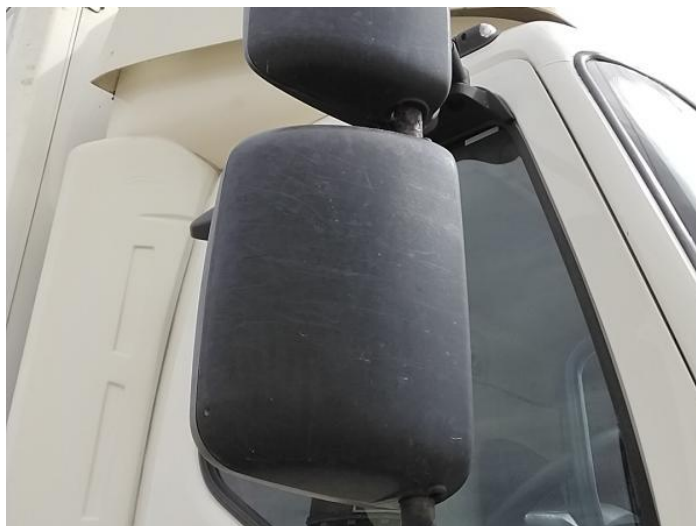
10: Door Mirror Assy osf
Scuffed (Unpainted)
UpTo 100mm

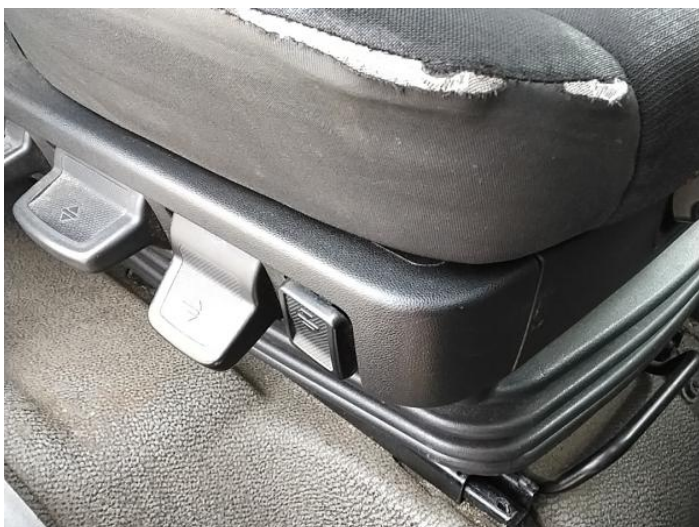
11: Seat Base Cover osf
Torn
Over 3mm

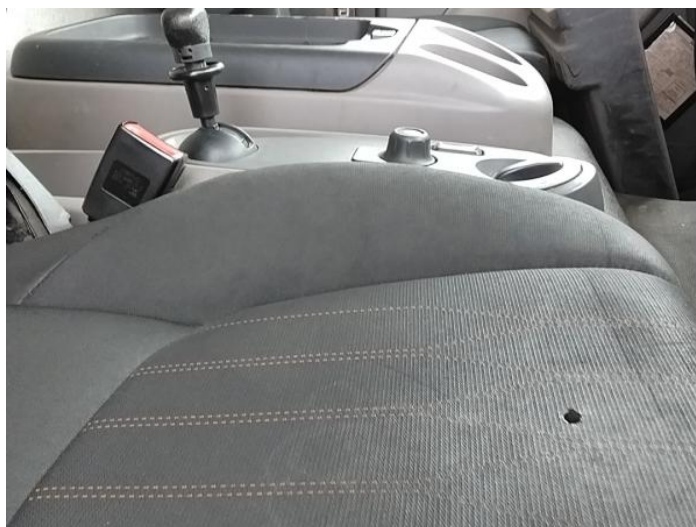
12: Seat Base Cover osf
Burn
Over 3mm
