# VEHICLE INSPECTION REPORT

**DA69GNZ**

## Isuzu N75 190

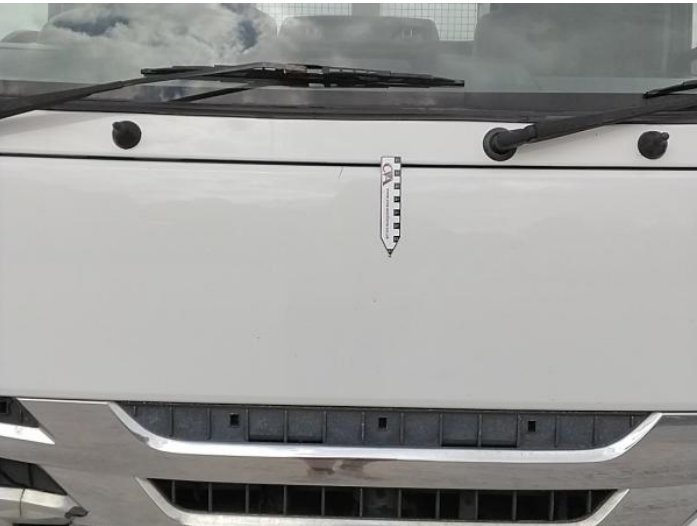
1: Bonnet  
Chipped  
Multiple Chips

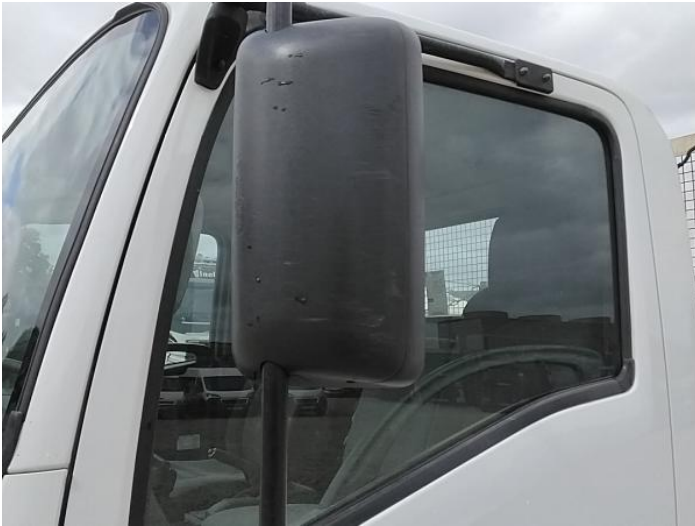
3: Door Mirror Assy nsf  
Scuffed (Unpainted)  
UpTo 100mm

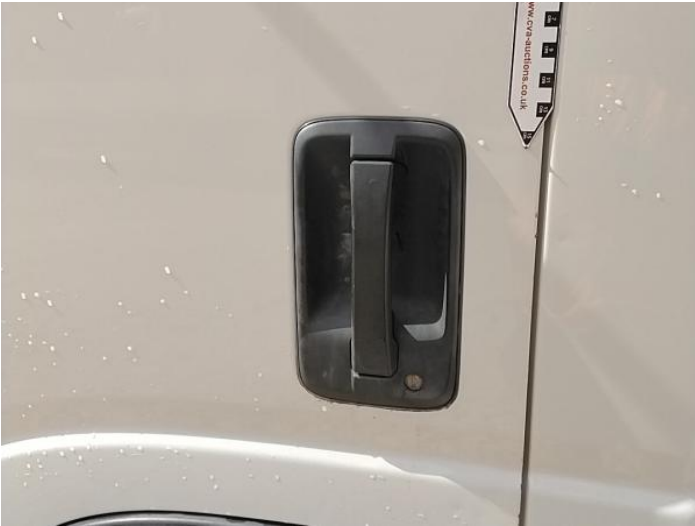
4: Door nsf  
Chipped  
Edge Chip

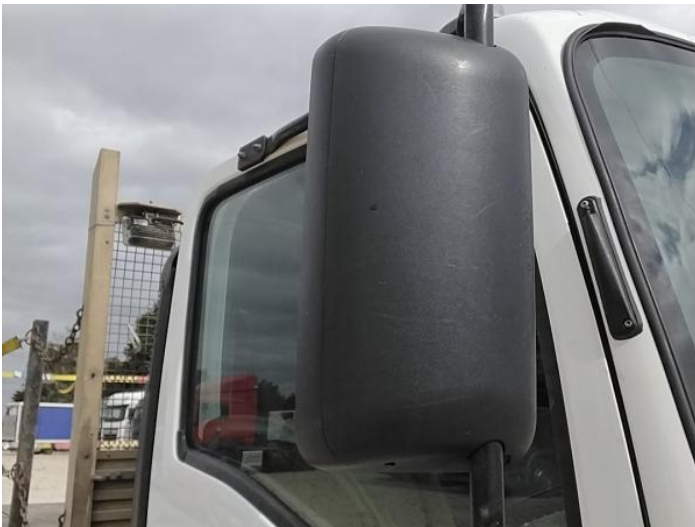
7: Door Mirror Assy osf  
Scuffed (Unpainted)  
UpTo 100mm
