VEHICLE INSPECTION REPORT

NK15ZVA

SCANIA P 250

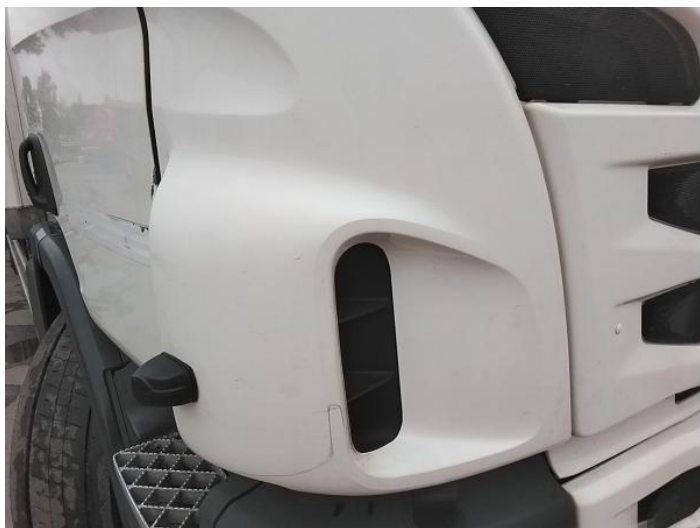
1: Panel Front
Scratched
Over 25mm Thru Paint

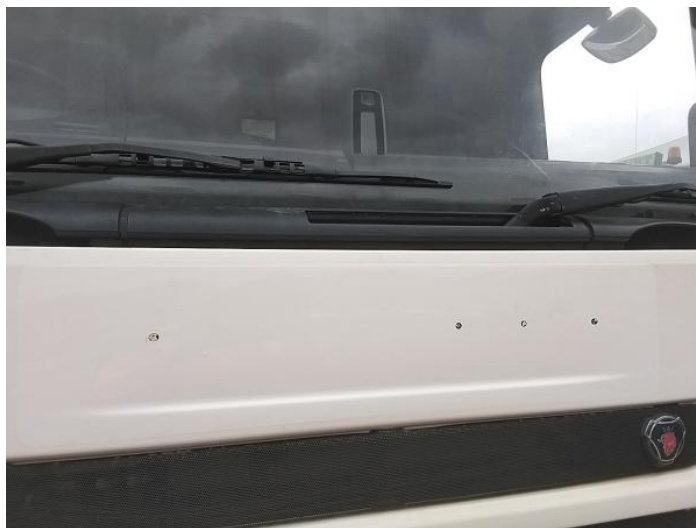
2: Bonnet
Hole
Over 10mm

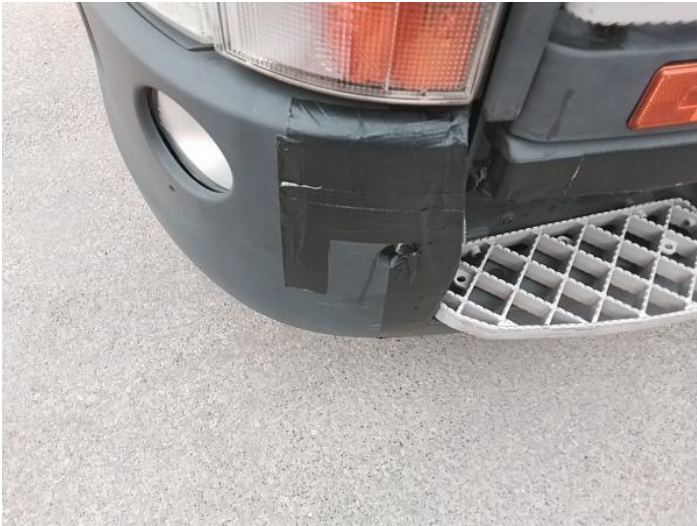
3: Bumper Front
Cracked
Over 25mm

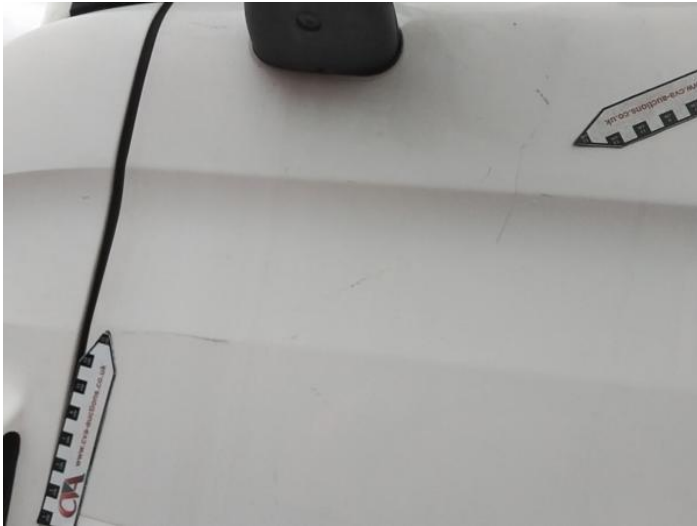
4: Door nsf
Scratched
Over 25mm Thru Paint

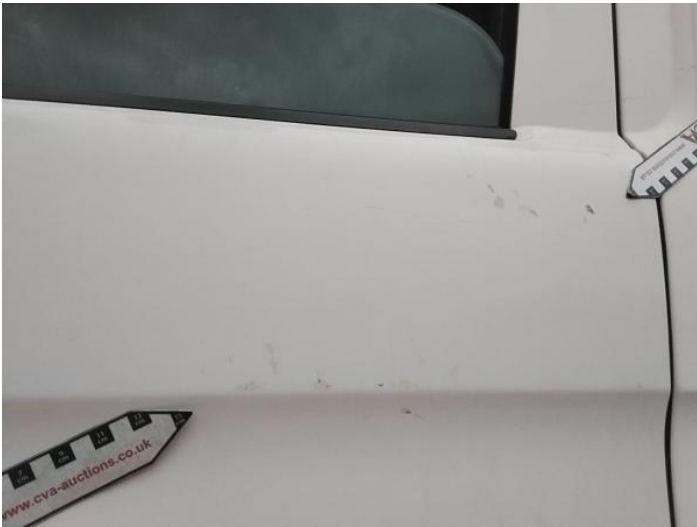
5: Door nsf
Scratched
Over 25mm Thru Paint

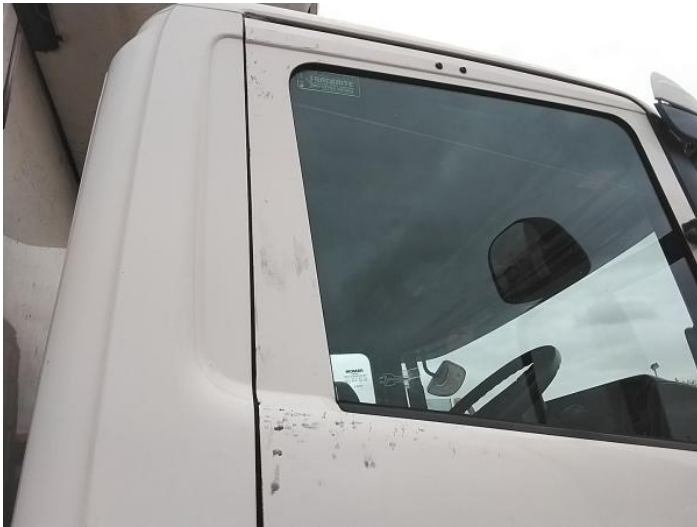
6: Door osf
Scratched
Over 25mm Thru Paint
