# VEHICLE INSPECTION REPORT

**YG17HWV**

## Daf LF 150

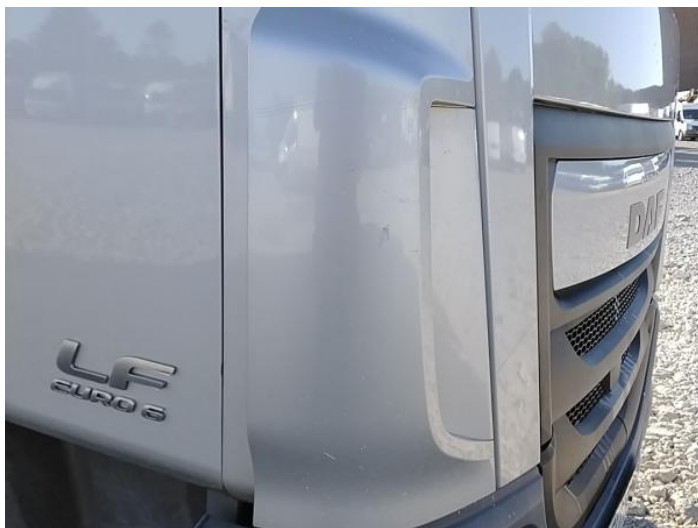
1: Wing osf  
Scratched  
Over 25mm Thru Paint

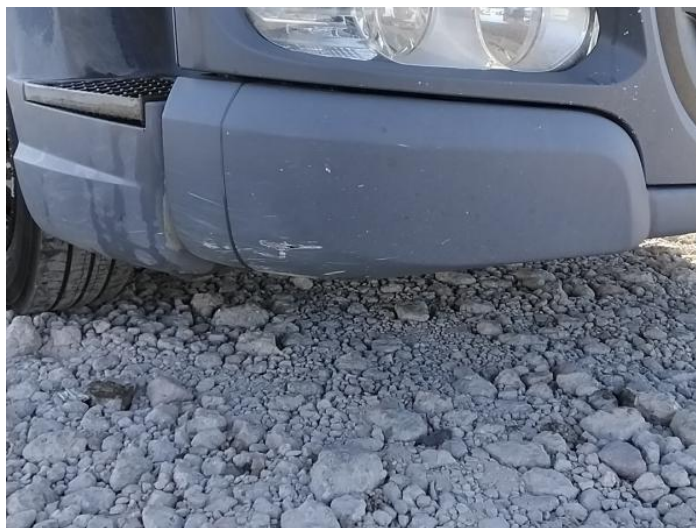
2: Bumper Front Moulding  
Scuffed (Unpainted)  
Over 100mm

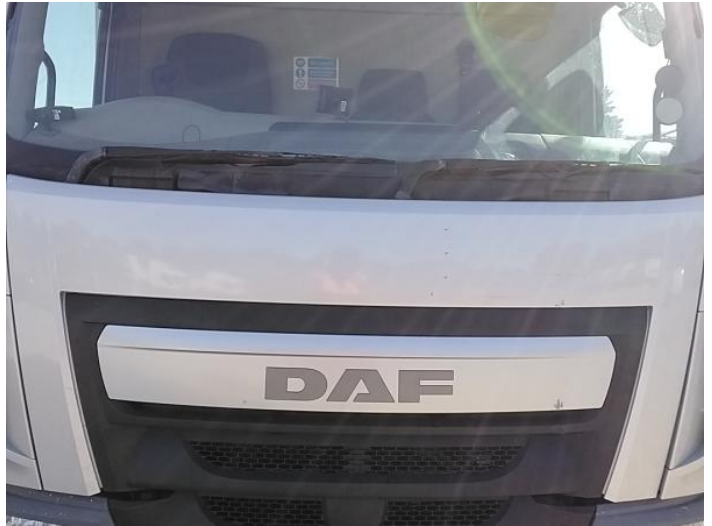
4: Bonnet  
Chipped  
Multiple Chips

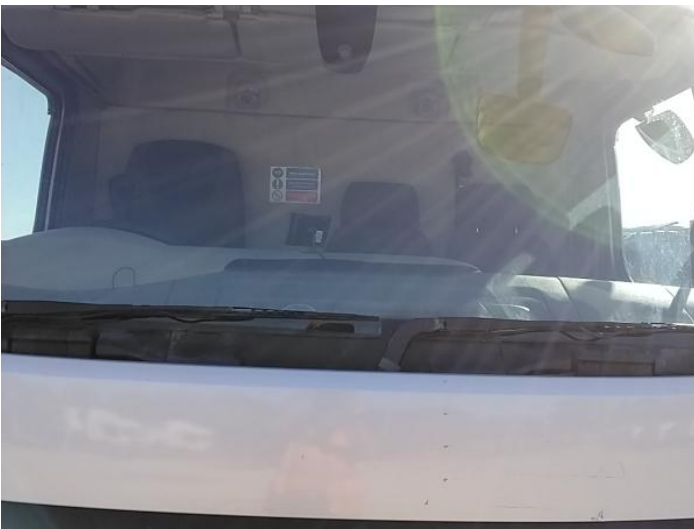
5: Screen Front  
Chipped  
UpTo 10mm

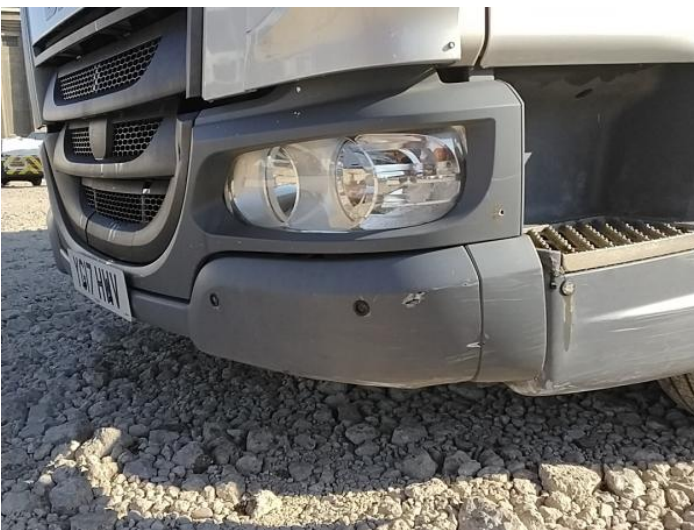
7: Bumper Front Moulding  
Scuffed (Unpainted)  
Over 100mm

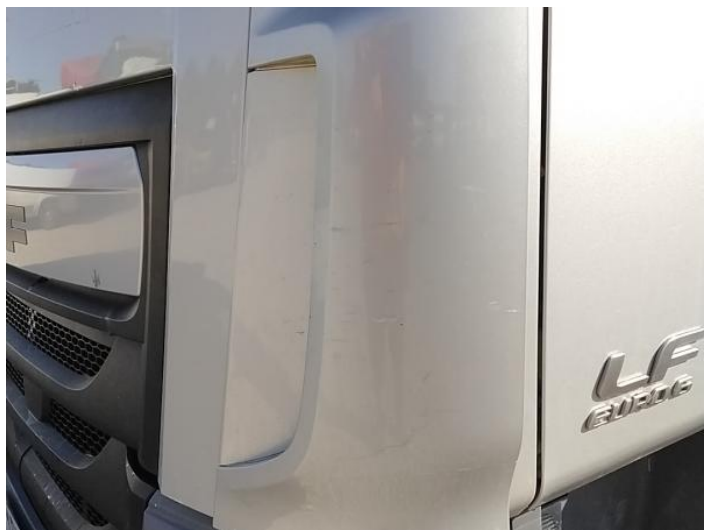
8: Wing nsf  
Scratched  
Over 25mm Thru Paint

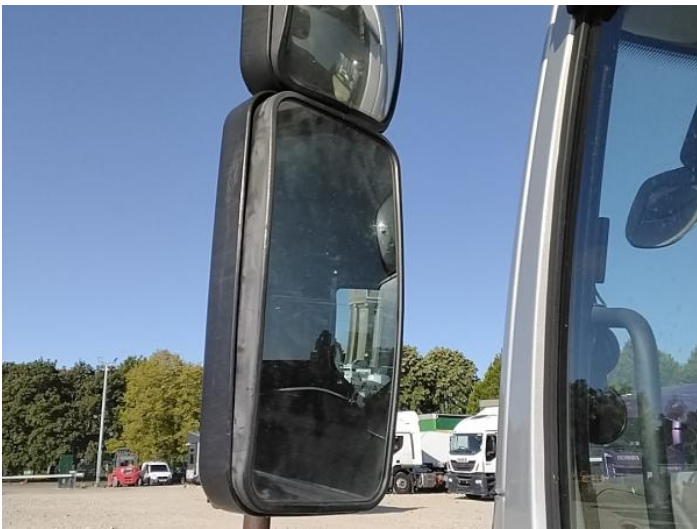
11: Door Mirror Glass ns  
Broken  
Replace

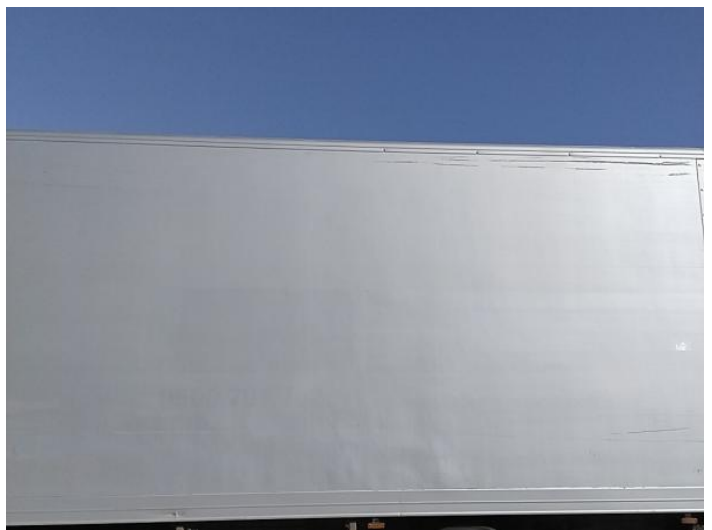
14: Qtr Panel nsr  
Scratched  
Over 25mm Thru Paint

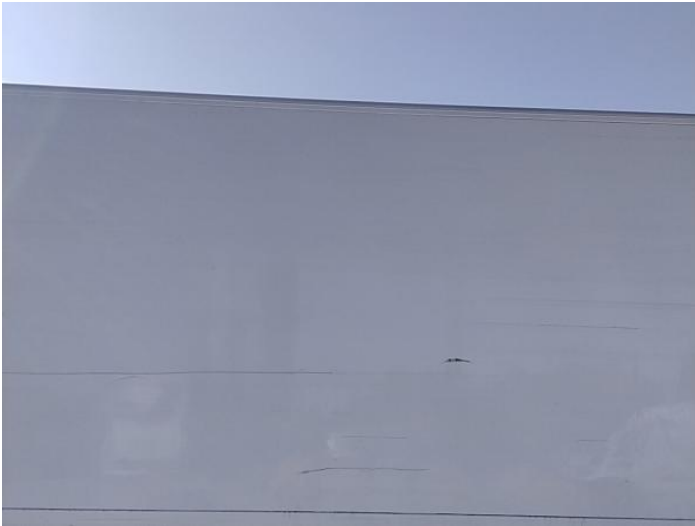
15: Qtr Panel osr  
 Scratched  
 Over 25mm Thru Paint

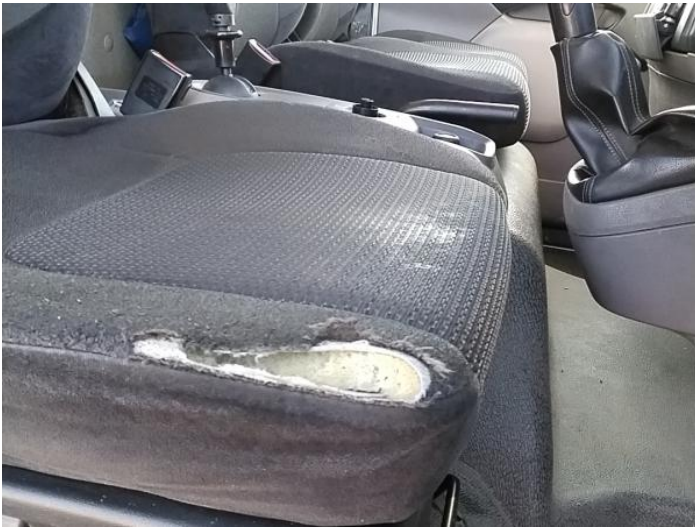
17: Seat Base Cover osf  
 Holed  
 Over 3mm
