# VEHICLE INSPECTION REPORT

**YL16NWN**

## Daf CF 310

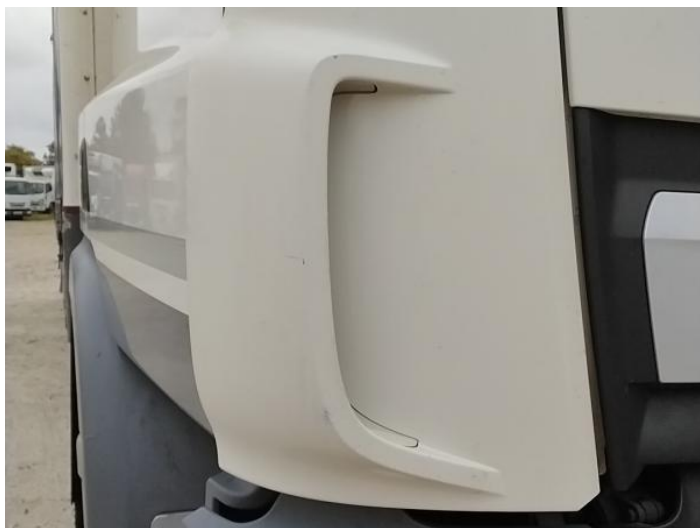
1: Wing osf  
Cracked  
Replace

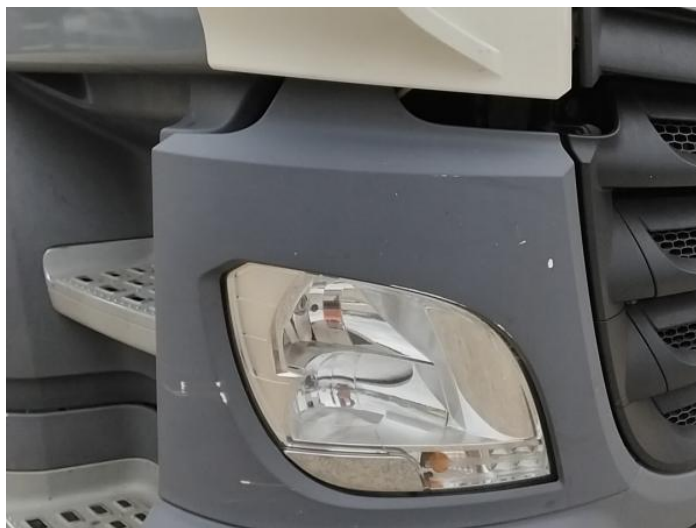
2: Fog Lamp Surround os  
Scuffed (Unpainted)  
UpTo 100mm

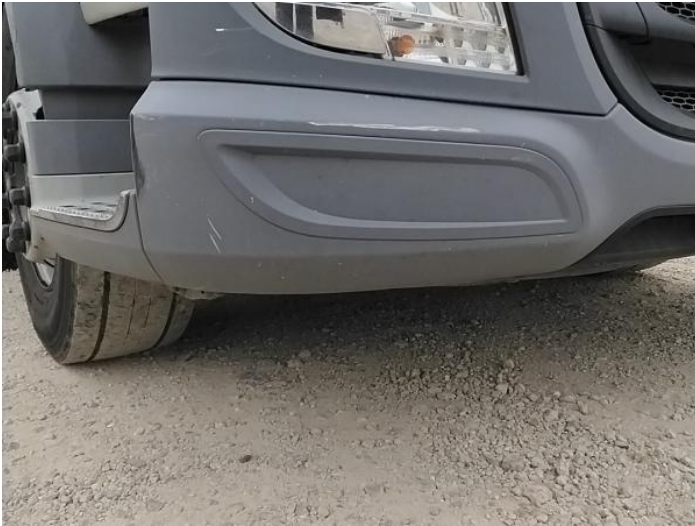
3: Bumper Front Moulding  
Scuffed (Unpainted)  
UpTo 100mm

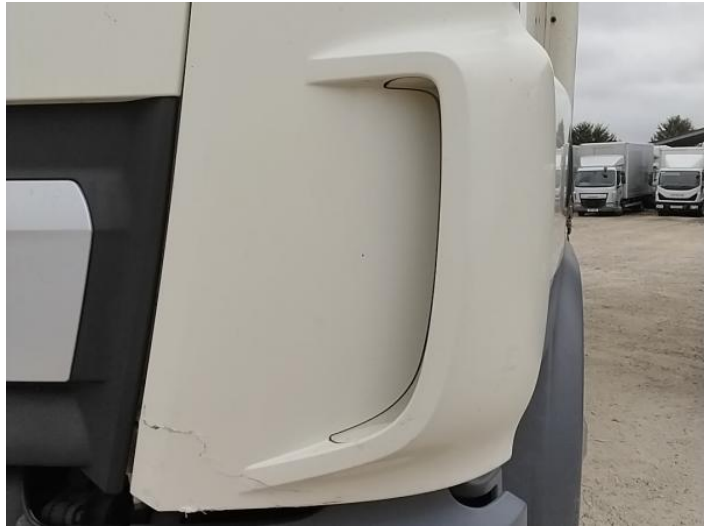
4: Wing nsf  
Cracked  
Replace

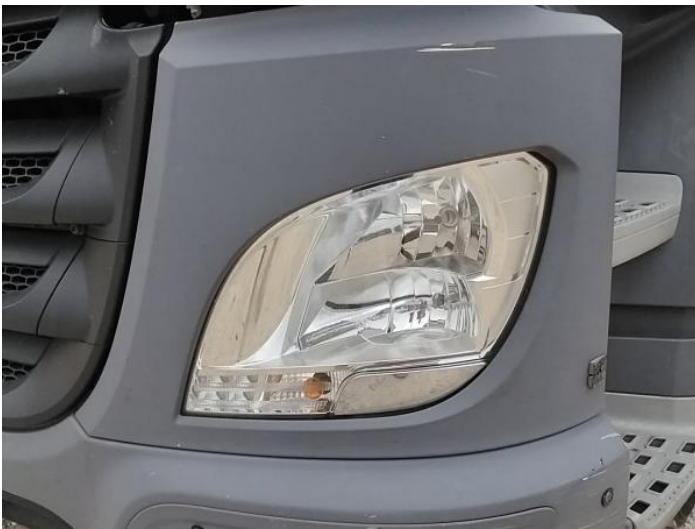
5: Fog Lamp Surround nsf  
Scuffed (Unpainted)  
UpTo 100mm

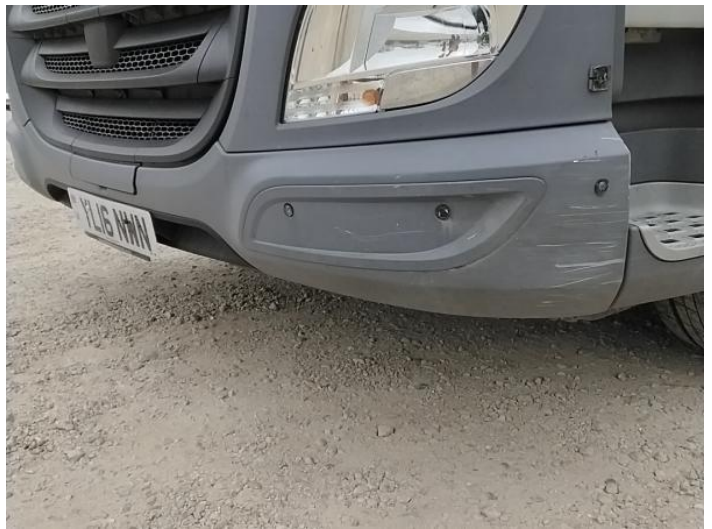
6: Bumper Front Moulding  
Scuffed (Unpainted)  
UpTo 100mm

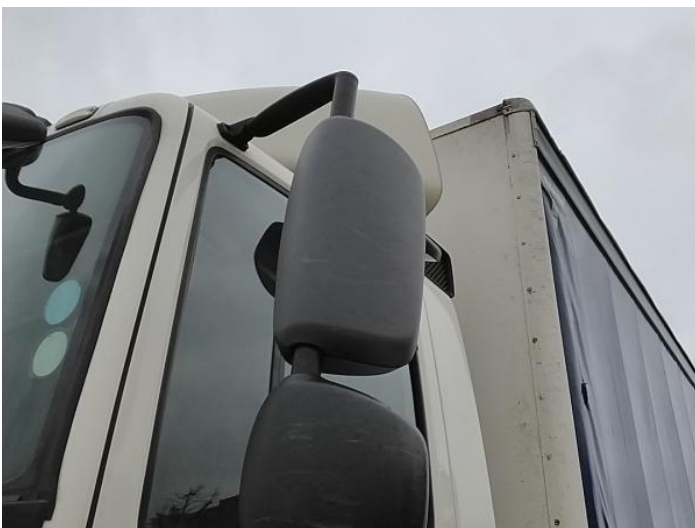
7: Door Mirror Assy nsf  
Scuffed (Unpainted)  
UpTo 100mm

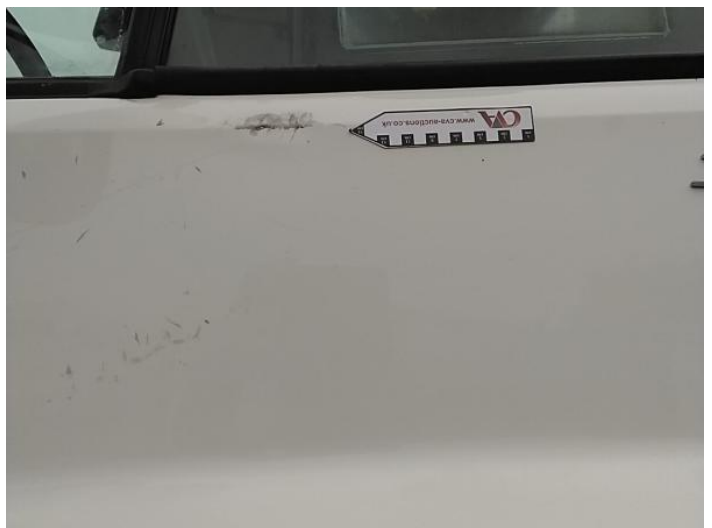
8: Door nsf  
Dented  
Between 10mm + 30mm

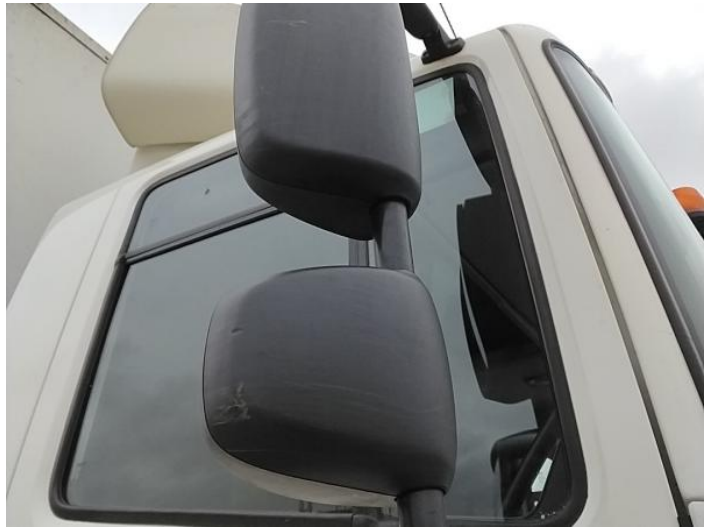
12: Door Mirror Assy osf  
Scuffed (Unpainted)  
UpTo 100mm

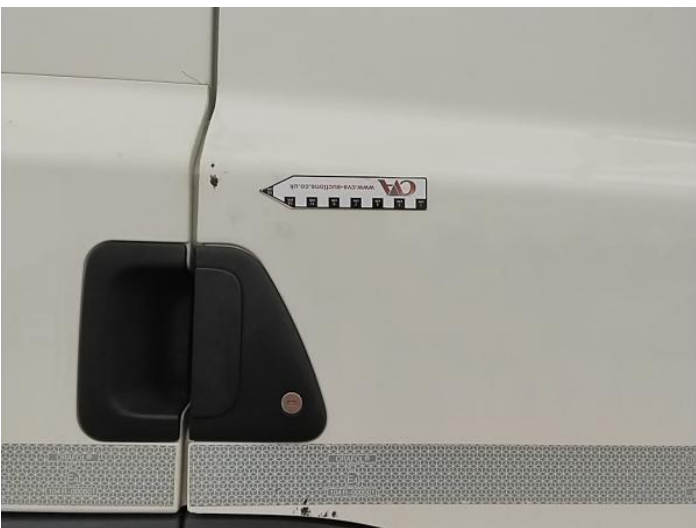
13: Door osf  
Chipped  
Over 5mm
