VEHICLE INSPECTION REPORT

NK15ZVJ

SCANIA P 250

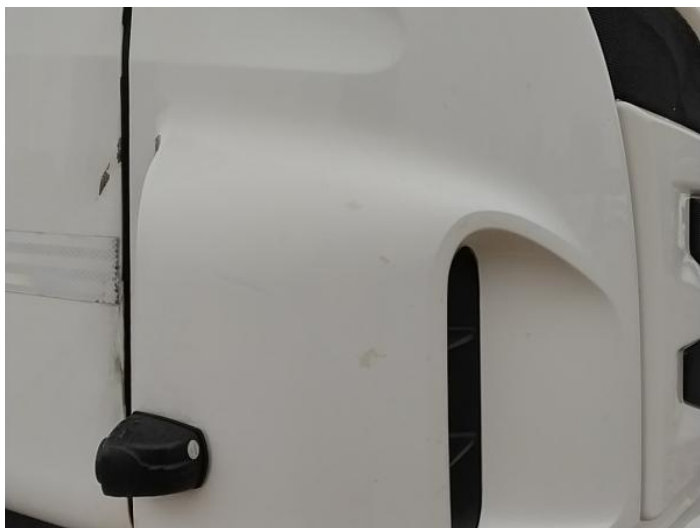
1: Wing osf
Scratched
UpTo 25mm Thru Paint

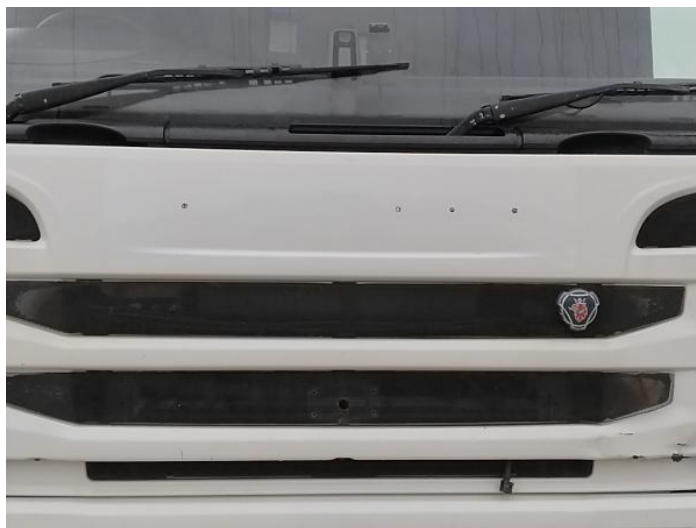
2: Badgedecal Front
Missing
Replace

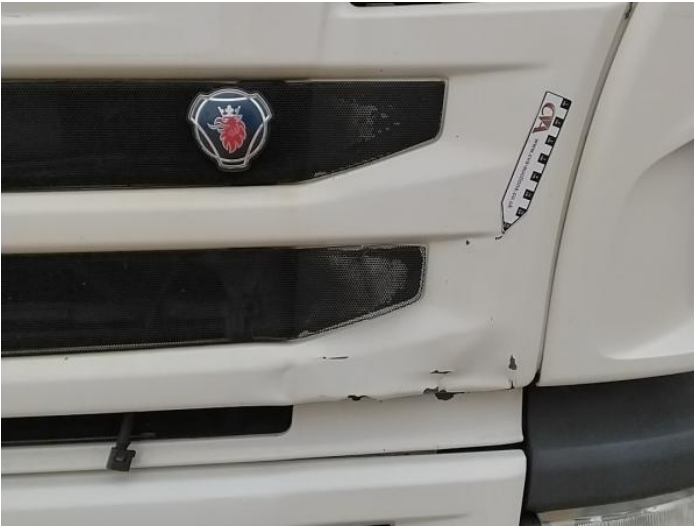
3: Bonnet
Dented
With Paint Damage

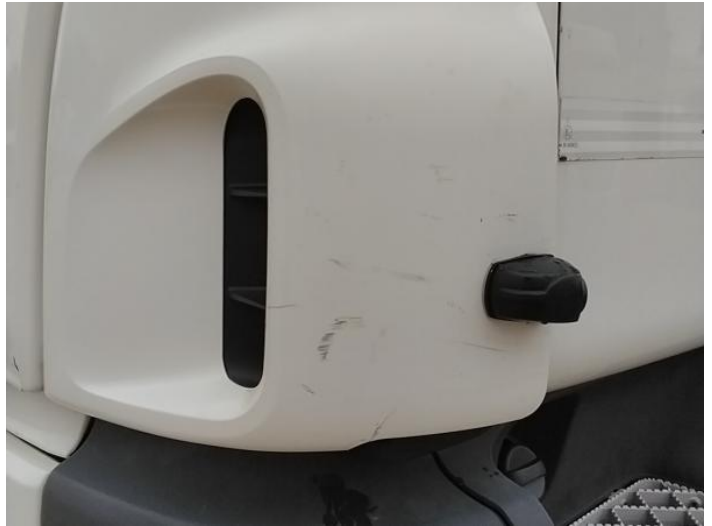
4: Wing nsf
Scratched
UpTo 25mm Thru Paint

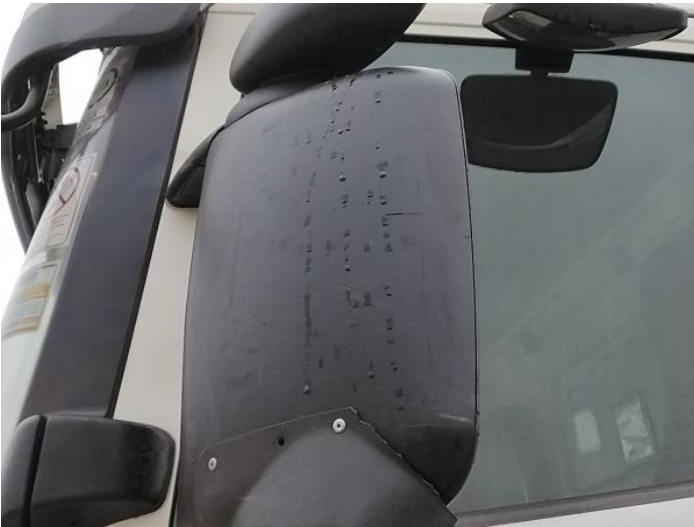
5: Door Mirror Assy nsf
Scuffed (Unpainted)
UpTo 100mm

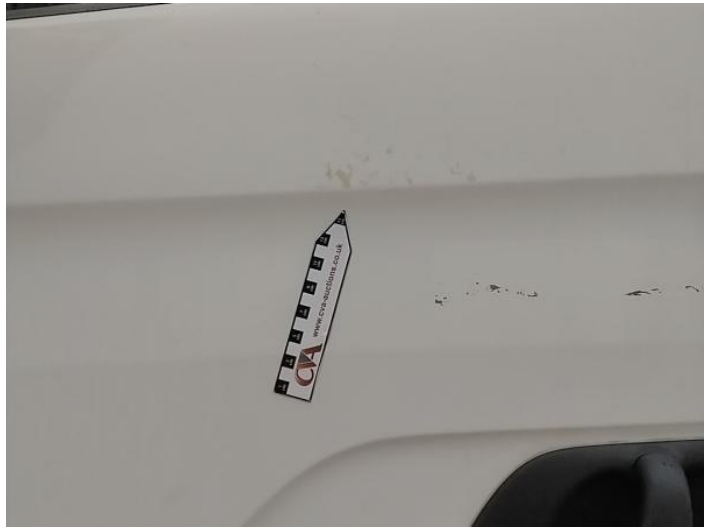
6: Door nsf
Scratched
UpTo 25mm Thru Paint

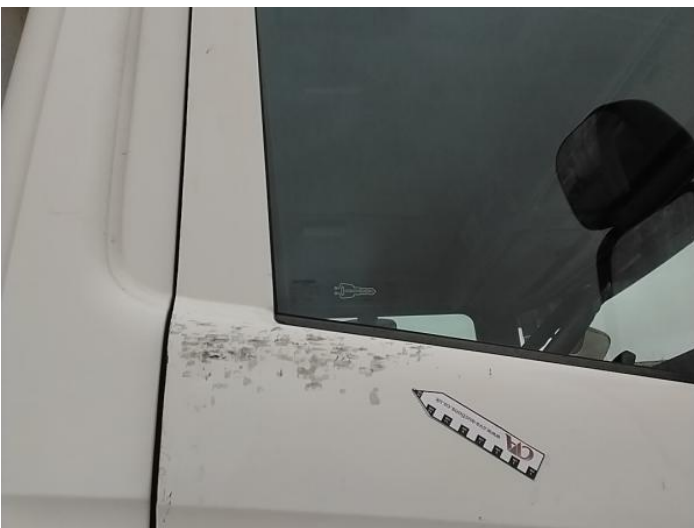
7: Door osf
Scratched
Over 25mm Not Thru Paint
