VEHICLE INSPECTION REPORT

DK67VTY

Man TGM 18.250

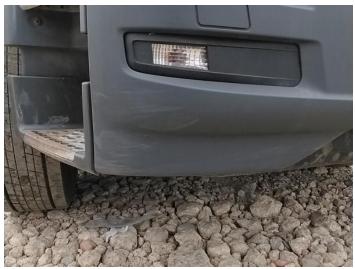
2: Bumper Front Moulding Scuffed (Unpainted) UpTo 100mm

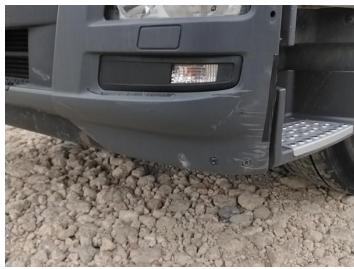
3: Bumper Front Moulding Scuffed (Unpainted) UpTo 100mm

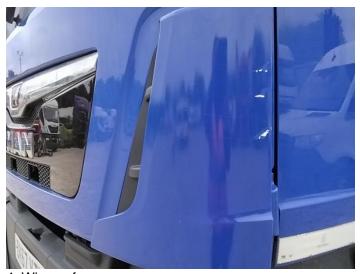
4: Wing nsf Scratched UpTo 25mm Thru Paint

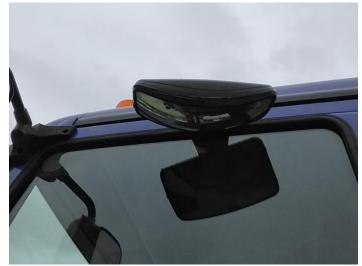
7: Door Mirror Assy nsf Broken Replace

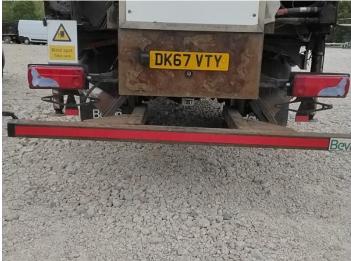
8: Bumper Rear Rusted Over 5mm

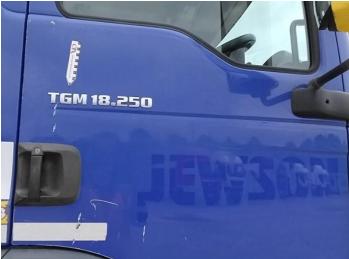
10: Door osf Scratched UpTo 25mm Thru Paint

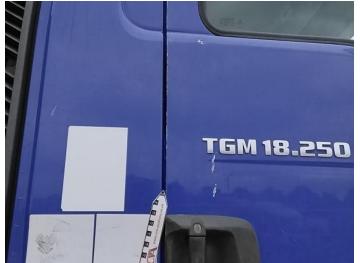
11: Door osf Chipped Edge Chip

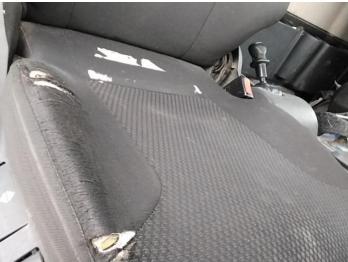
12: Seat Base Cover osf Holed Over 3mm

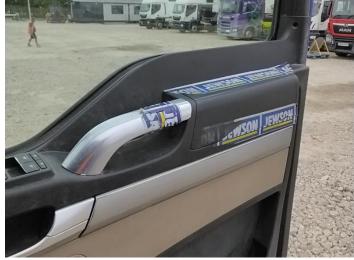
13: Door Pad osf Broken Replace
