## VEHICLE INSPECTION REPORT

**DA69WWN**

### Isuzu N75 190

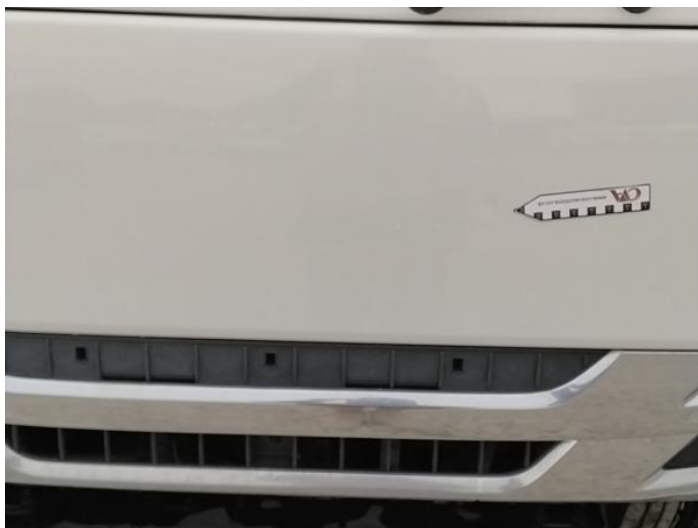
1: Bonnet  
Dented  
2 Or Less UpTo 10mm

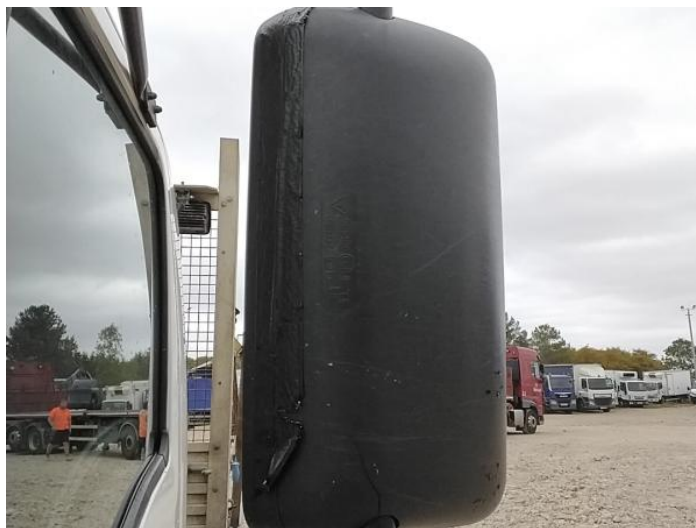
2: Door Mirror Assy nsf  
Broken  
Replace

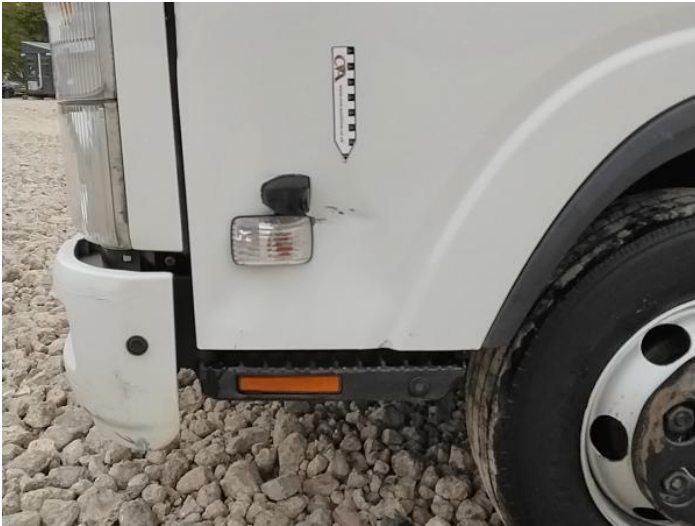
3: Door nsf  
Dented  
With Paint Damage

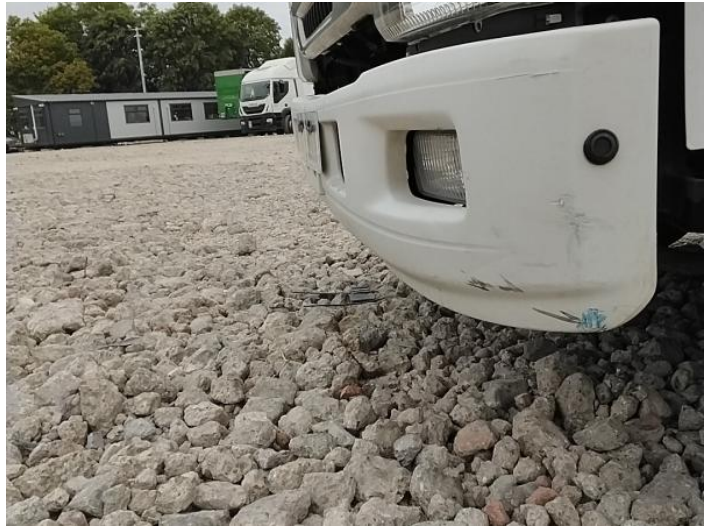
4: Bumper Front Moulding  
Scuffed (Unpainted)  
UpTo 100mm

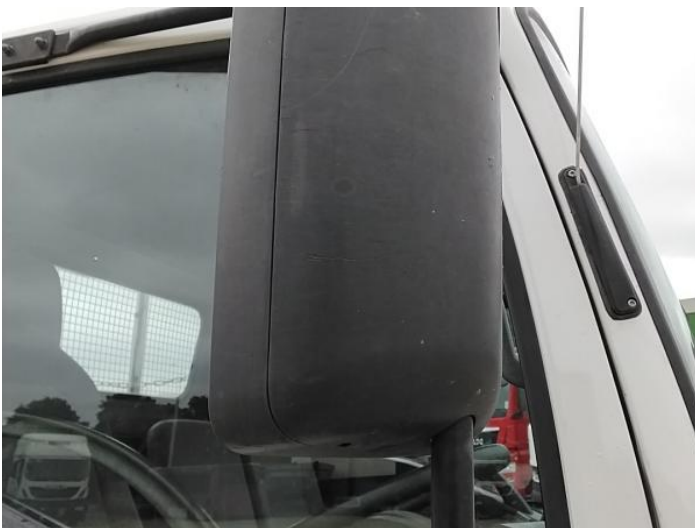
7: Door Mirror Assy osf  
Scuffed (Unpainted)  
UpTo 100mm

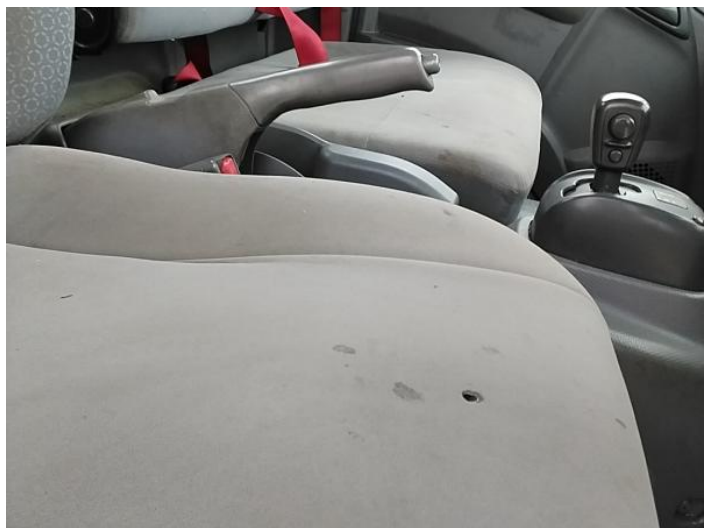
8: Seat Base Cover osf  
Burn  
Over 3mm
