VEHICLE INSPECTION REPORT

DK69WHZ

Isuzu Gafter N35.125

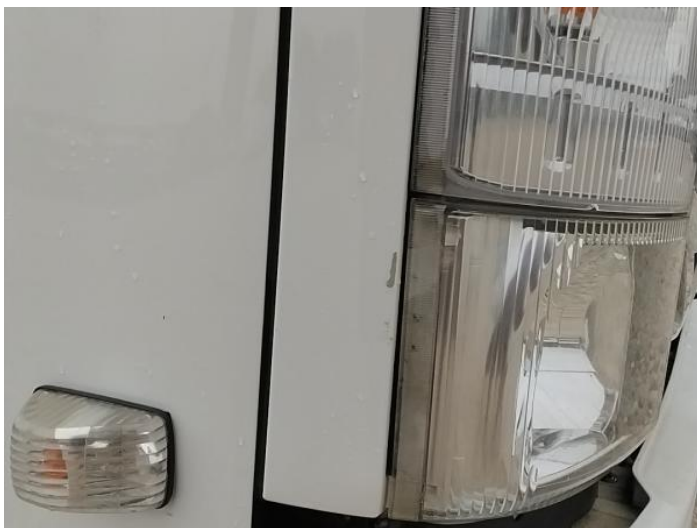
1: Fog Lamp Surround os
Scratched (Painted)
UpTo 25mm Thru Paint

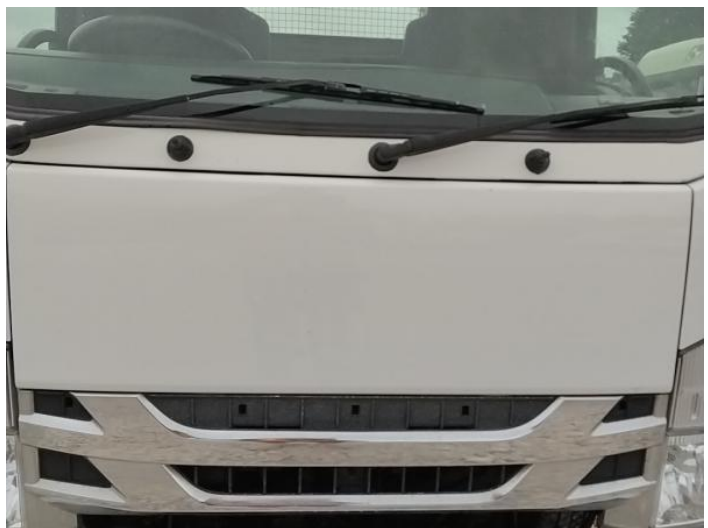
2: Bonnet
Chipped
Multiple Chips

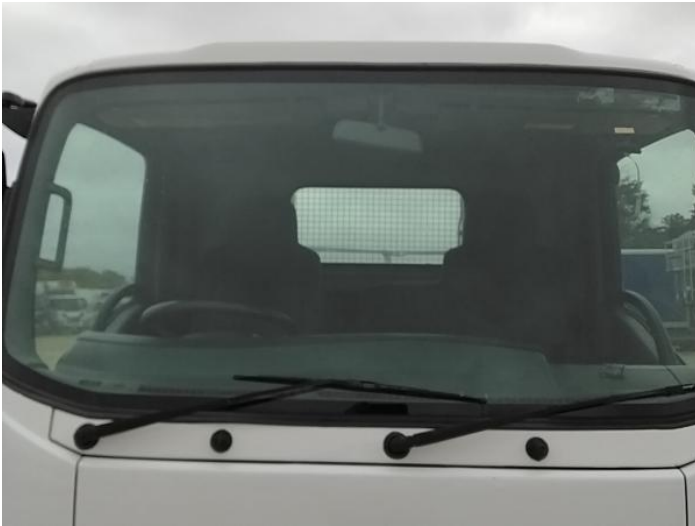
3: Screen Front
Chipped
UpTo 10mm

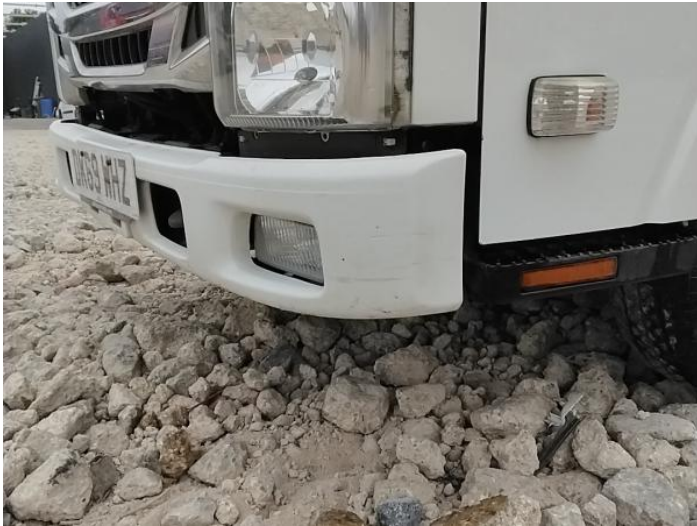
4: Bumper Front Moulding
Scuffed (Unpainted)
UpTo 100mm

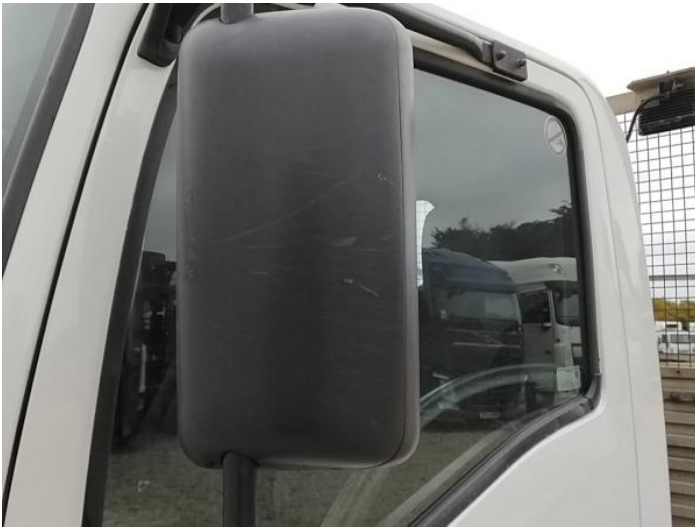
5: Door Mirror Assy nsf
Scuffed (Unpainted)
UpTo 100mm

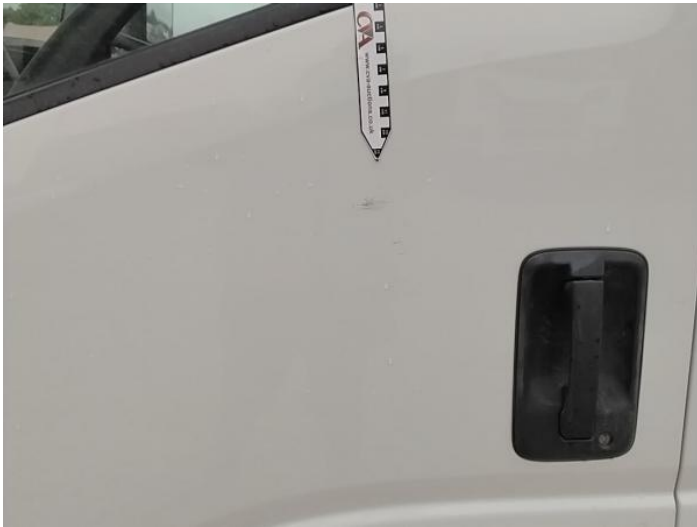
6: Door nsf
Scratched
UpTo 25mm Thru Paint
