# VEHICLE INSPECTION REPORT

**PE63NKA**

## Daf LF 45.140

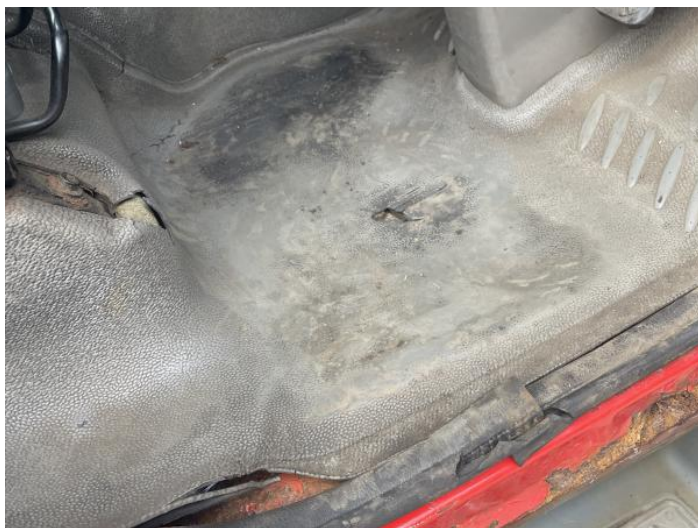
1: Carpets Front  
Torn  
Over 10mm

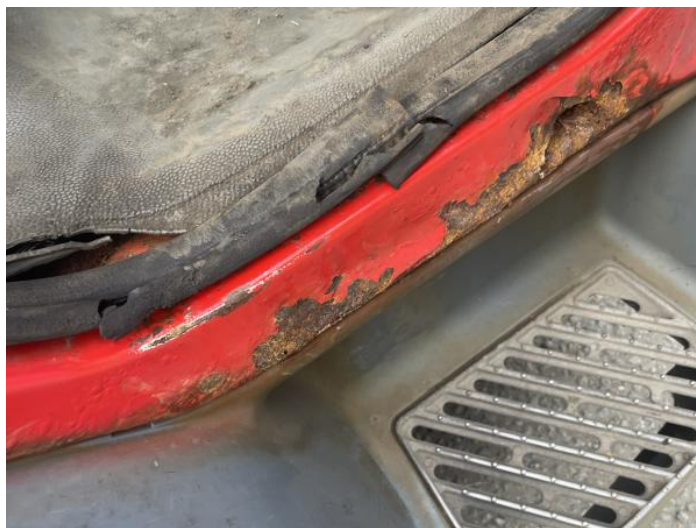
2: Sill os  
Rusted  
Over 5mm

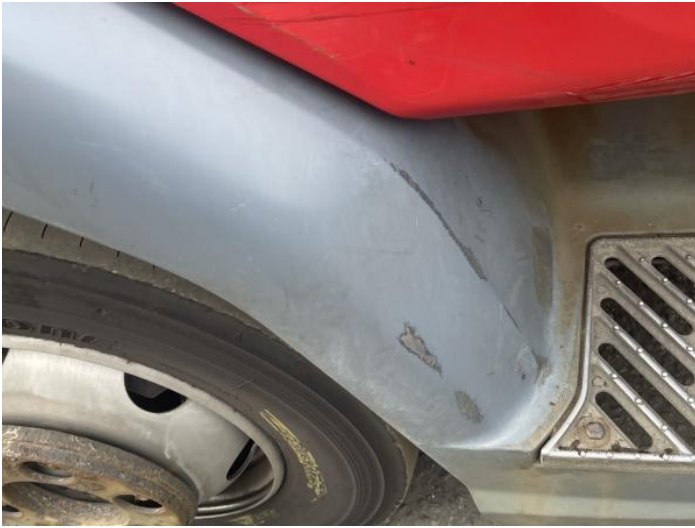
3: Door Moulding osf  
Scuffed (Unpainted)  
Over 100mm

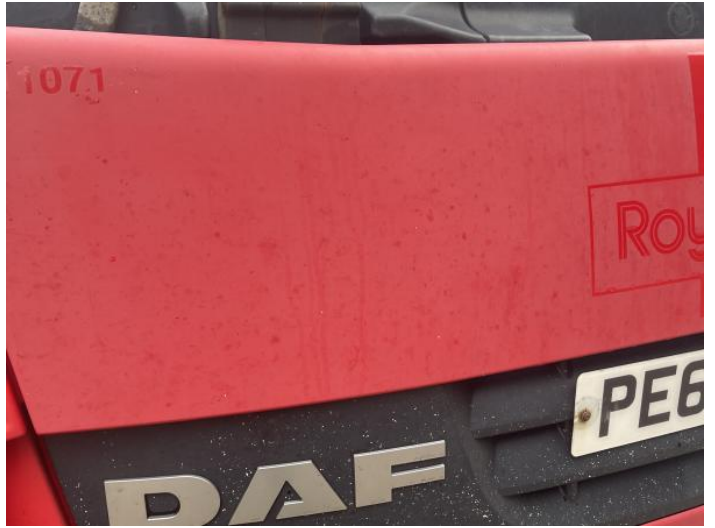
4: Bonnet  
Chipped  
Multiple Chips

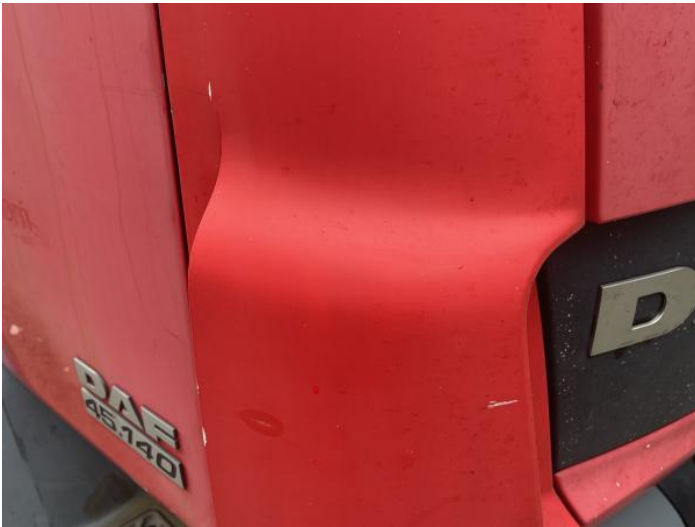
5: Wing osf  
Chipped  
Multiple Chips

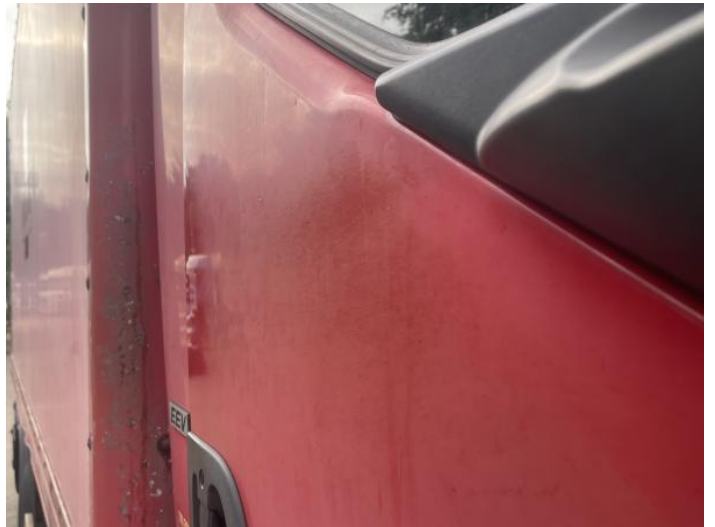
6: Door osf  
Dented  
Over 30mm

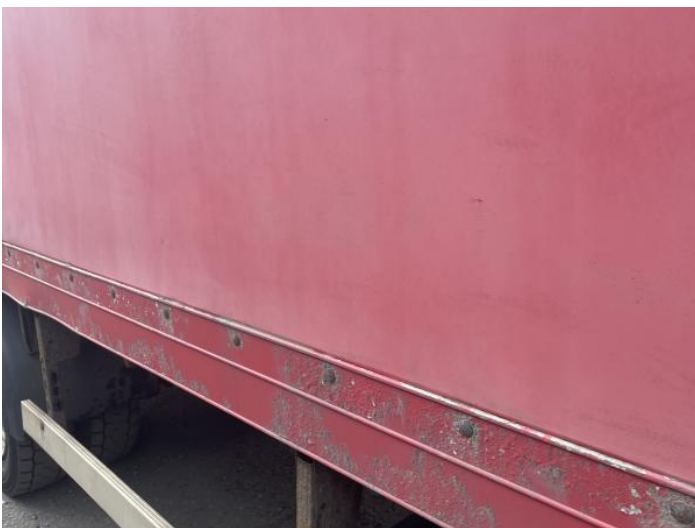
7: Qtr Panel osr  
Dented  
With Paint Damage

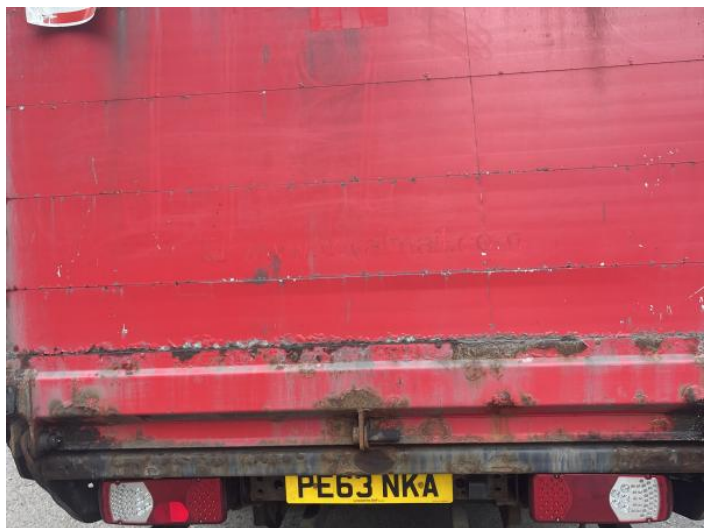
8: Tailgate  
Rusted  
Over 5mm

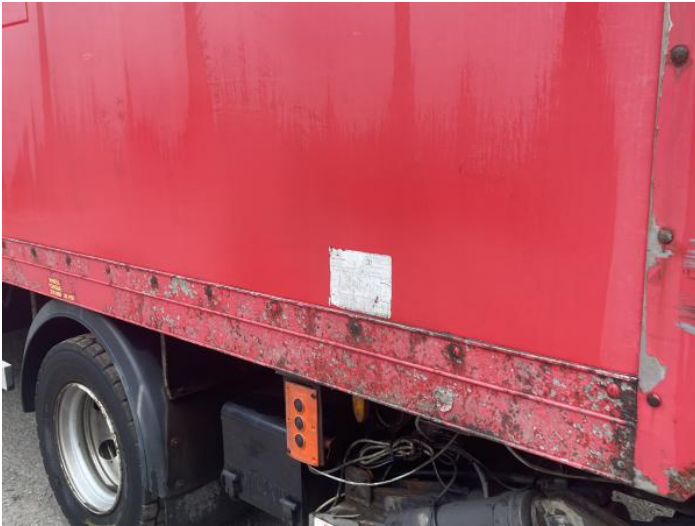
9: Qtr Panel nsr  
Dented  
With Paint Damage

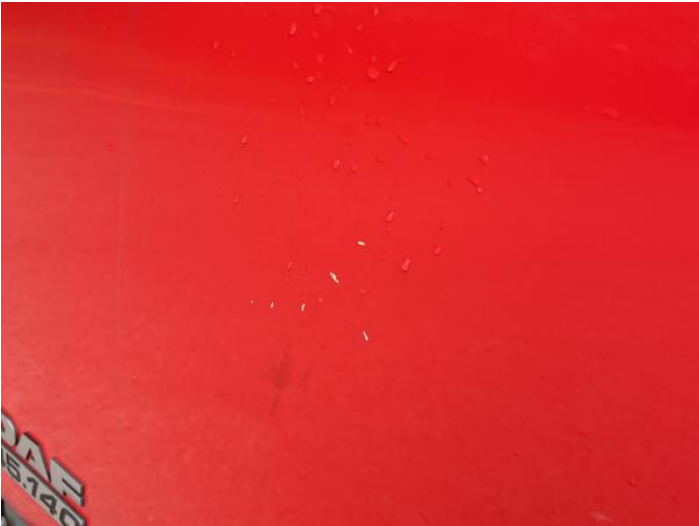
10: Door nsf  
Chipped  
Over 5mm

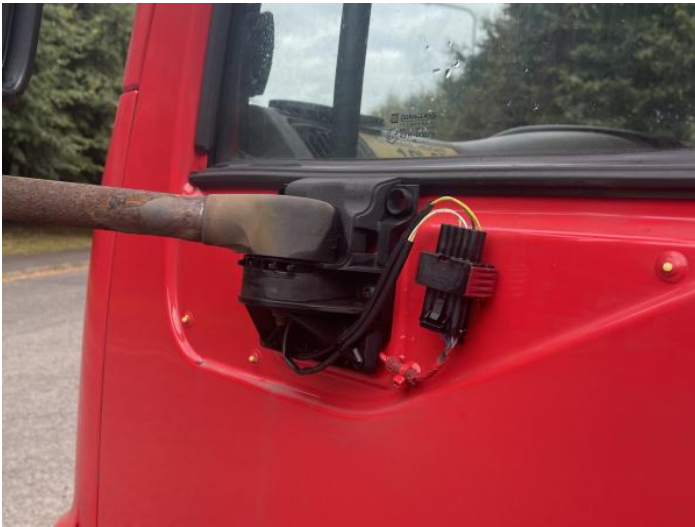
11: Door Mirror Assy nsf  
Missing  
Replace
