# VEHICLE INSPECTION REPORT

**DG680FN**

## Mercedes-Benz Sprinter 314 CDI

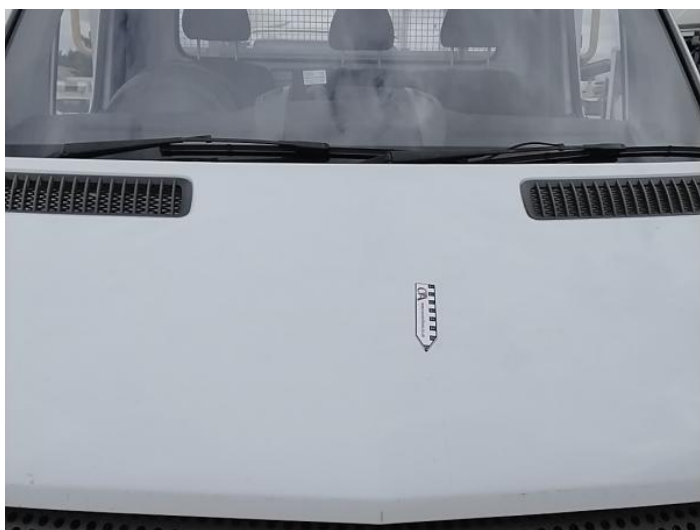
1: Bonnet  
Scratched  
UpTo 25mm Thru Paint

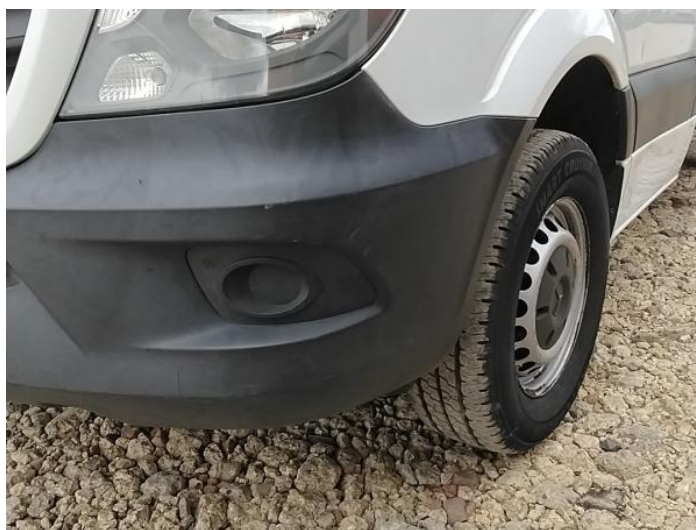
2: Bumper Front Moulding  
Scuffed (Unpainted)  
UpTo 100mm

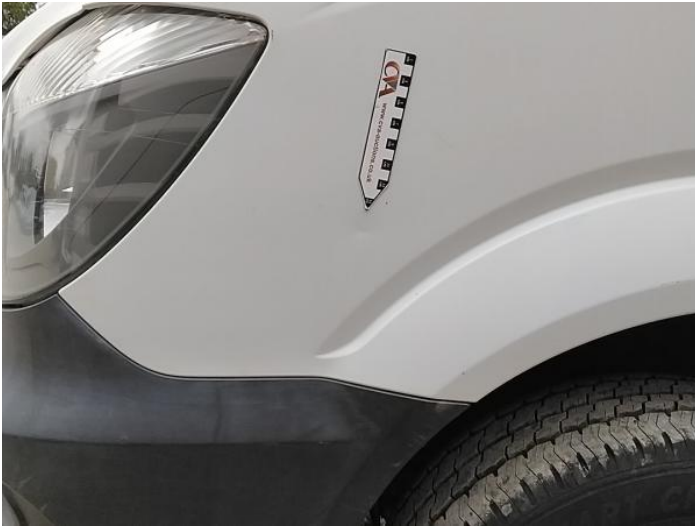
3: Wing nsf  
Dented  
2 Or Less UpTo 10mm

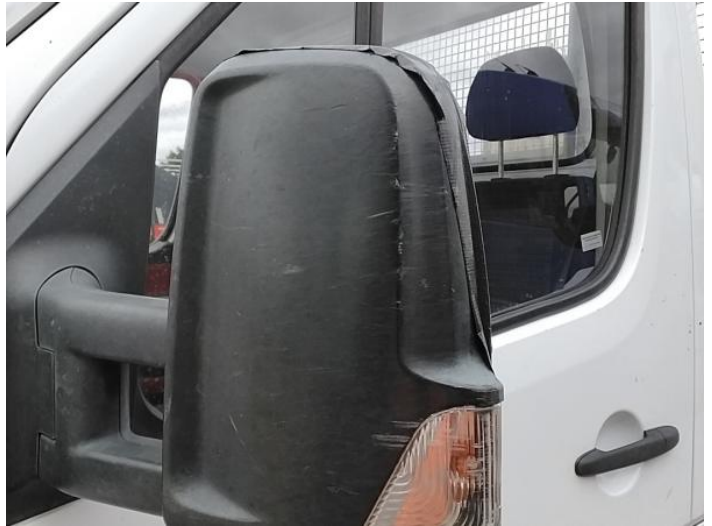
4: Door Mirror Assy nsf  
Broken  
Replace

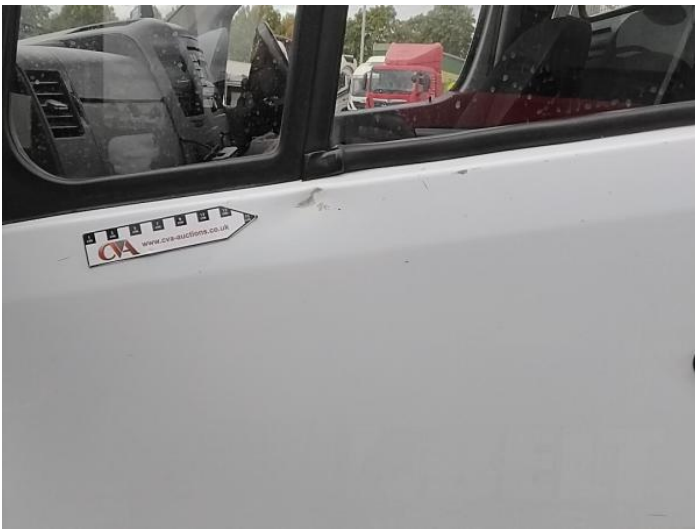
5: Door nsf  
Dented  
With Paint Damage

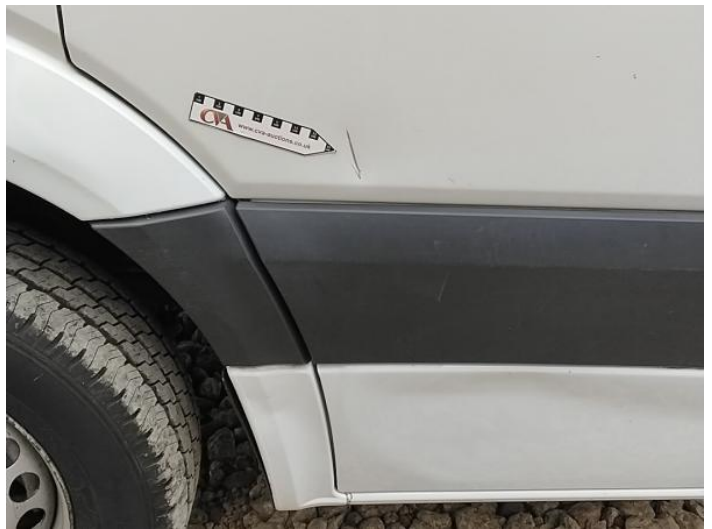
6: Door nsf  
Dented  
With Paint Damage

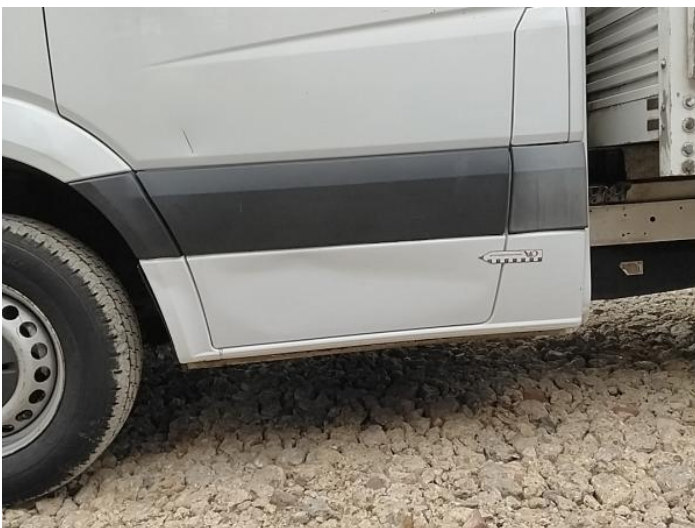
7: Door nsf  
Dented  
Over 30mm

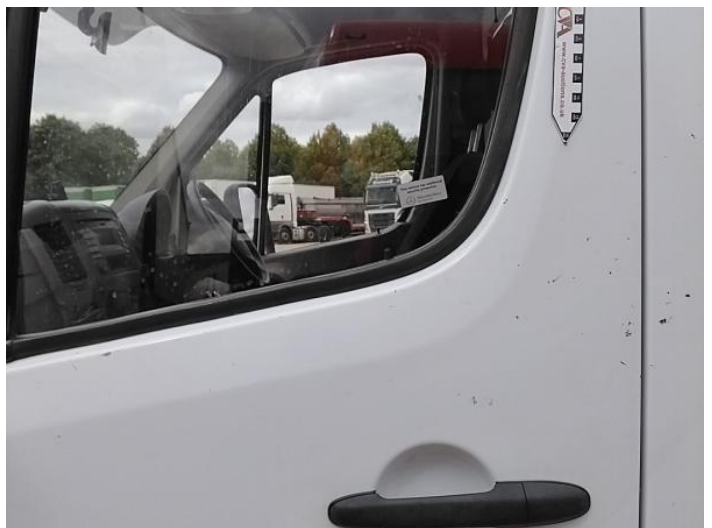
8: Door nsf  
Chipped  
Multiple Chips

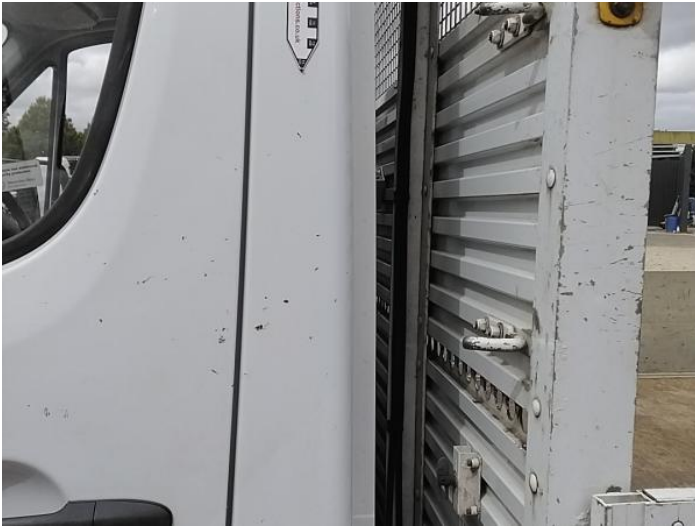
9: B Post ns  
Chipped  
Multiple Chips

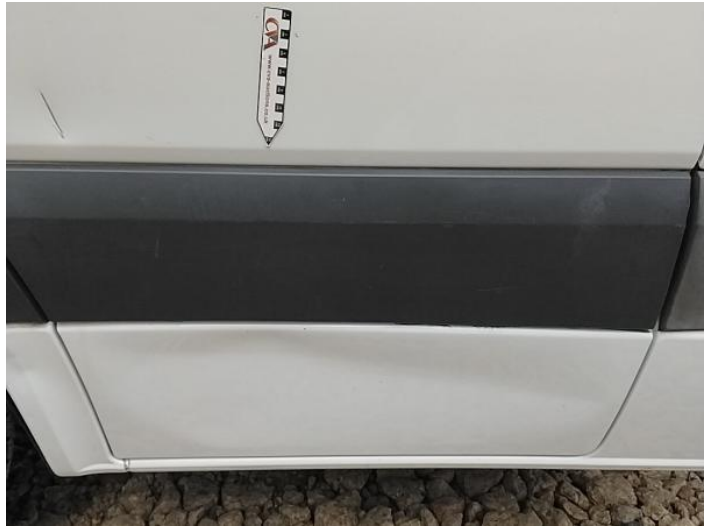
10: Door Moulding nsf  
Scuffed (Unpainted)  
UpTo 100mm

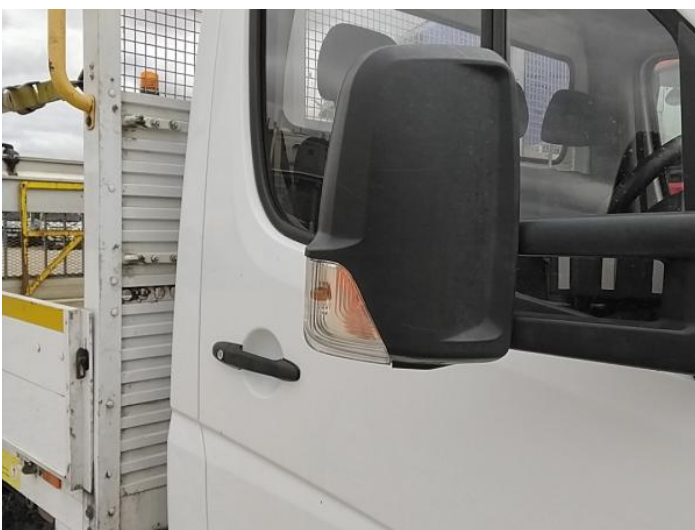
13: Door Mirror Assy osf  
Scuffed (Unpainted)  
UpTo 100mm

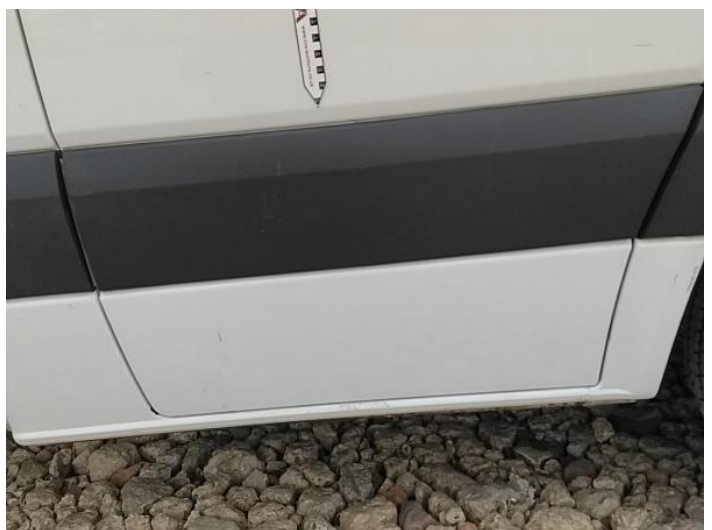
14: Door Moulding osf  
Scuffed (Unpainted)  
UpTo 100mm

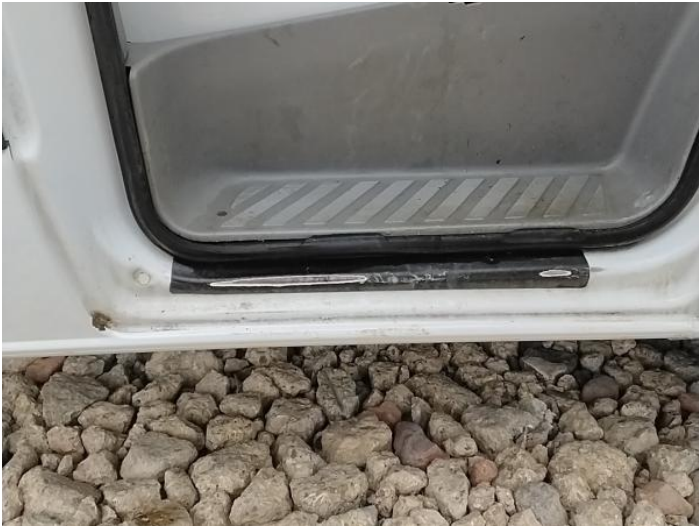
15: Sill os  
Scratched  
Over 25mm Thru Paint
