VEHICLE INSPECTION REPORT

PO70KKN

Fiat Ducato 35 2.3 MULTIJET 140PS

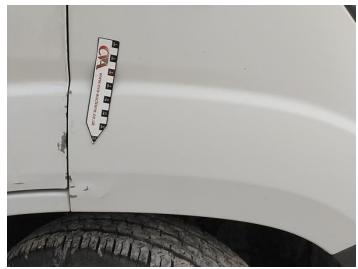
1: Wing osf Dented With Paint Damage

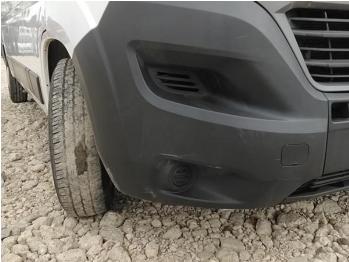
2: Bumper Front Moulding Scuffed (Unpainted) UpTo 100mm

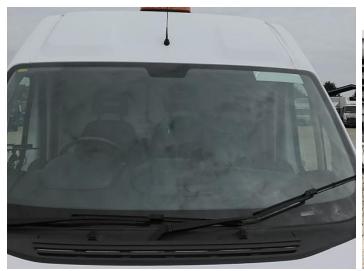
3: Screen Front Chipped UpTo 10mm

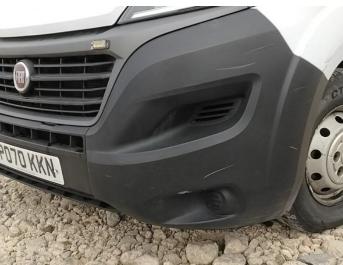
4: Bumper Front Moulding Scuffed (Unpainted) UpTo 100mm

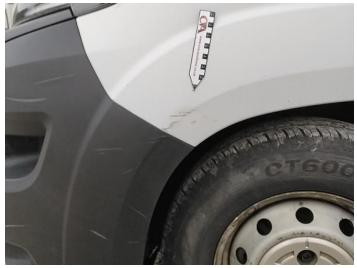
5: Wing nsf Scratched UpTo 25mm Thru Paint

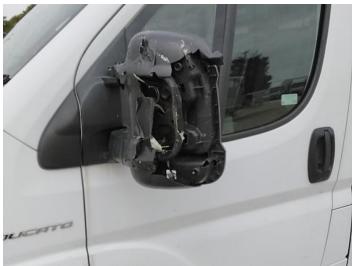
6: Door Mirror Assy nsf Broken Replace

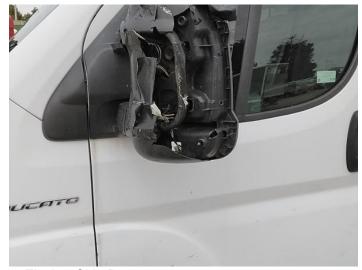
7: Flasher Side Repeater ns Missing Replace

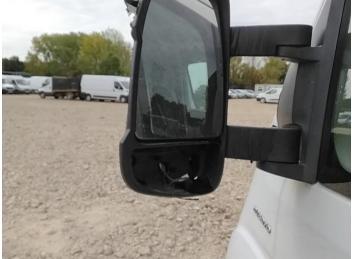
8: Door Mirror Glass ns Broken Replace

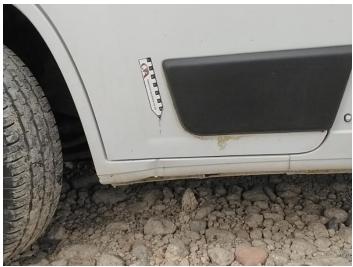
9: Sill ns Dented Between 10mm + 30mm

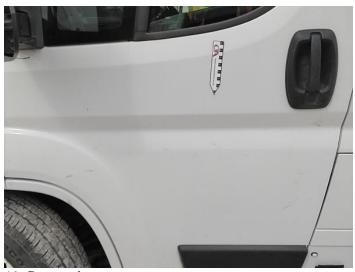
10: Door nsf Scratched Over 25mm Thru Paint

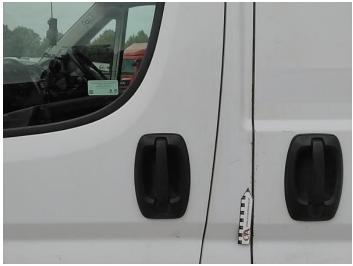
11: B Post ns Dented With Paint Damage

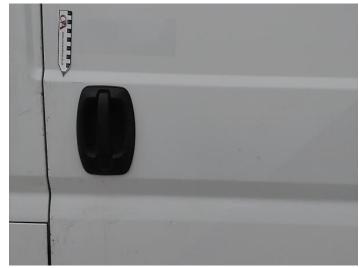
13: Door nsr Scratched UpTo 25mm Thru Paint

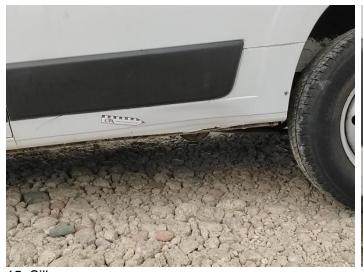
15: Sill ns Dented With Paint Damage

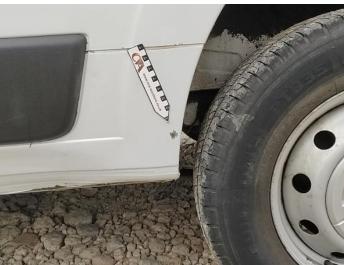
16: Qtr Panel nsr Scratched UpTo 25mm Thru Paint

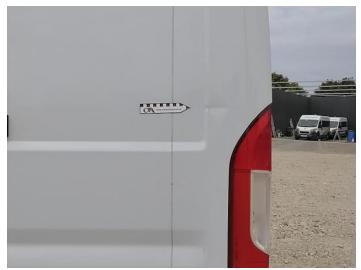
17: Qtr Panel nsr Dented Between 10mm + 30mm

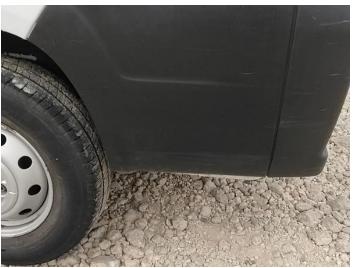
18: Qtr Panel Moulding ns Scuffed (Unpainted) UpTo 100mm

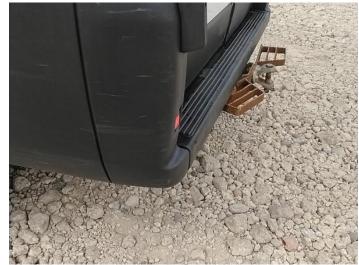
19: Bumper Rear Moulding Scuffed (Unpainted) UpTo 100mm

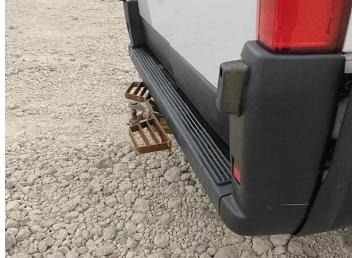
20: Bumper Rear Moulding Scuffed (Unpainted) UpTo 100mm

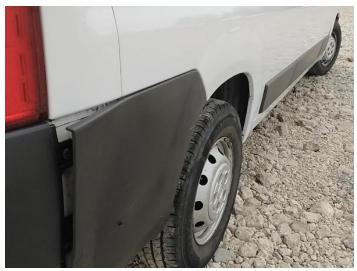
21: Qtr Panel Moulding os Broken Replace

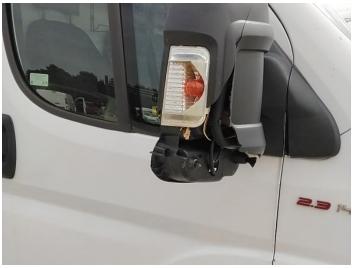
22: Door Mirror Assy osf Broken Replace

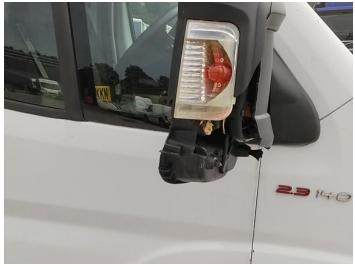
23: Flasher Side Repeater os Broken Replace

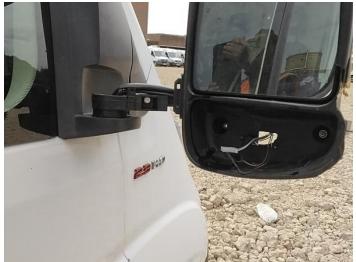
24: Door Mirror Glass os Missing Replace

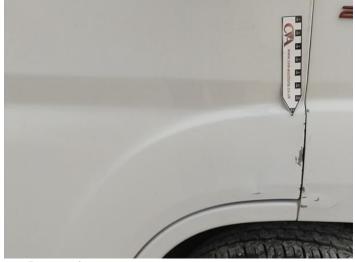
25: Door osf Dented With Paint Damage

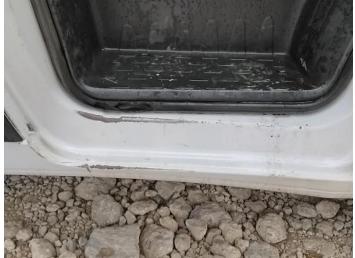
26: Sill os Scratched Over 25mm Thru Paint

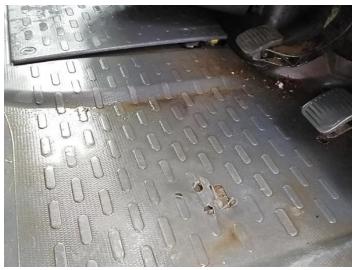
27: Carpets Front Holed Over 3mm
