VEHICLE INSPECTION REPORT

WN12BFJ

MERCEDES-BENZ SPRINTER

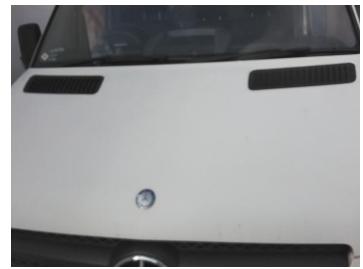
1: Bonnet Chipped Multiple Chips

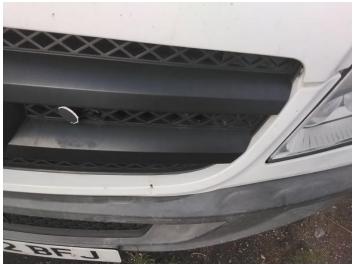
2: Panel Front Dented With Paint Damage

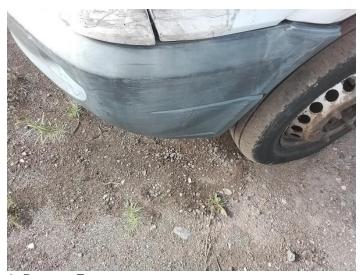
3: Bumper Front Scratched Over 100mm Thru Paint

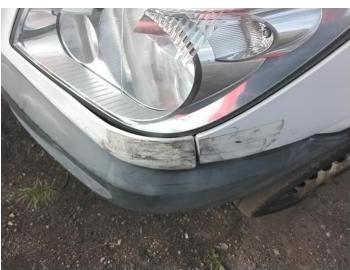
4: Wing nsf Poor Previous Repair Poor Paint

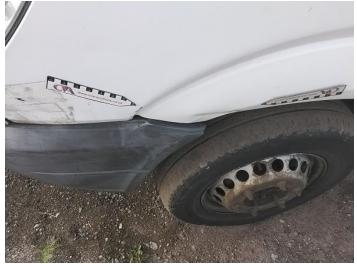
5: Wing nsf Dented With Paint Damage

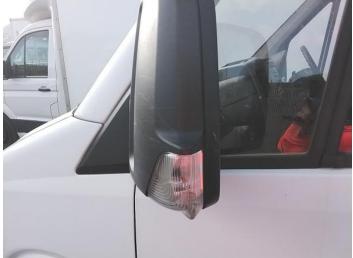
6: Door Mirror Assy nsf Broken Replace

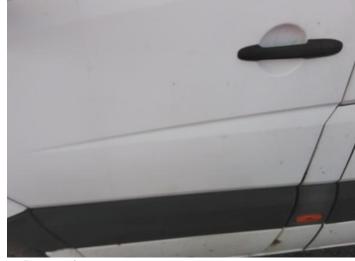
7: Door nsf Chipped Multiple Chips

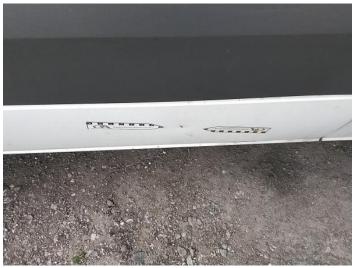
8: Qtr Panel nsr Dented With Paint Damage

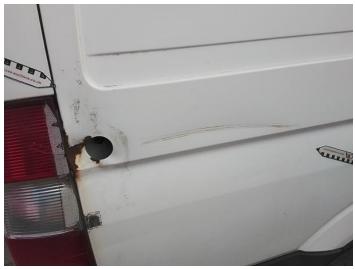
9: Qtr Panel osr Dented With Paint Damage

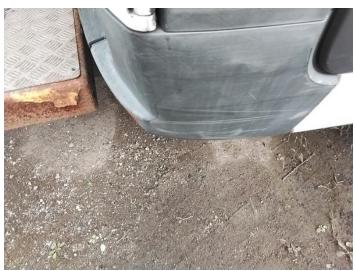
10: Bumper Rear Moulding Scuffed (Unpainted) Over 100mm

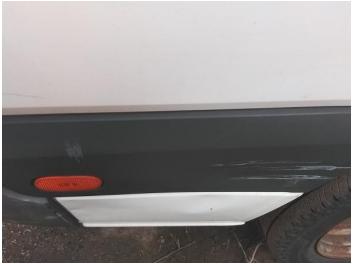
11: Qtr Panel Moulding os Scuffed (Unpainted) Over 100mm

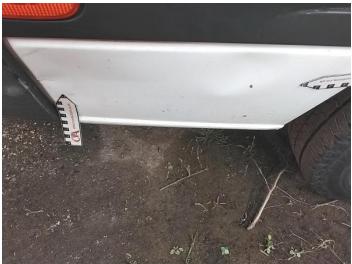
12: Qtr Panel osr Dented With Paint Damage

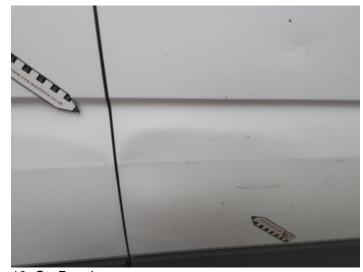
13: Qtr Panel osr Dented Over 30mm

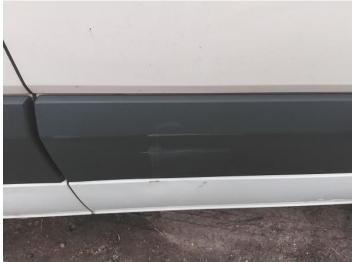
14: Qtr Panel Moulding os Scuffed (Unpainted) Over 100mm

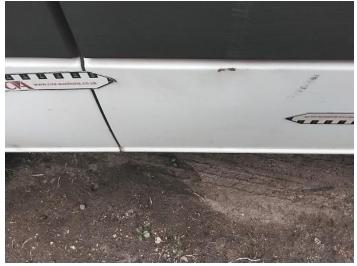
15: Qtr Panel osrDentedWith Paint Damage

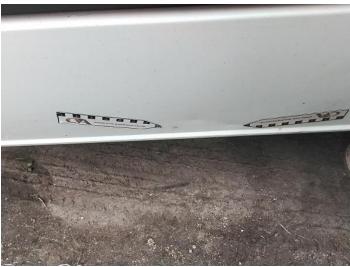
16: Qtr Panel osr Dented Over 30mm

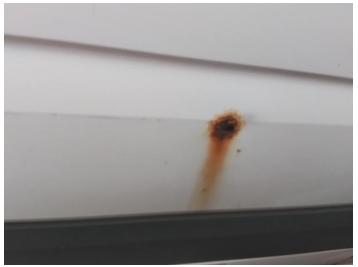
17: Qtr Panel osr Rusted Over 5mm

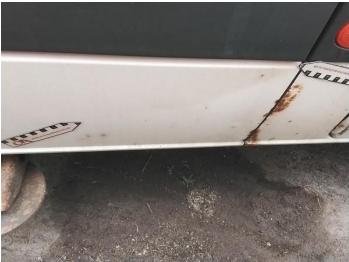
18: Qtr Panel osr Dented Over 30mm

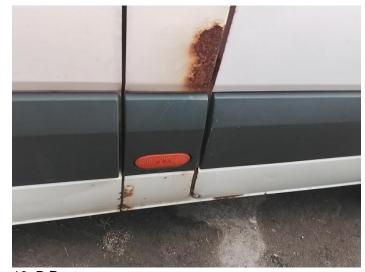
19: B Post os Rusted Over 5mm

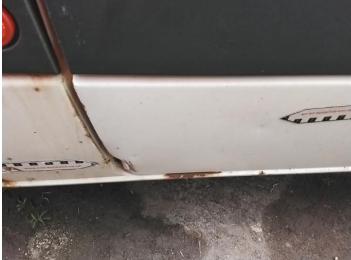
20: Door osf Dented With Paint Damage

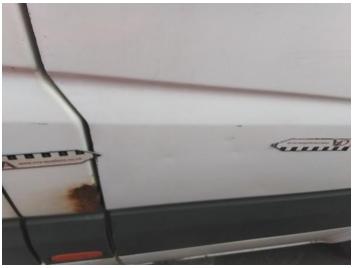
21: Door osf Dented With Paint Damage

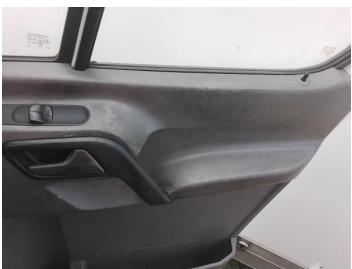
22: Door Pad osf Soiled Heavy

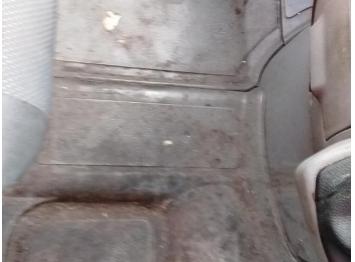
23: Carpets Front Soiled Heavy

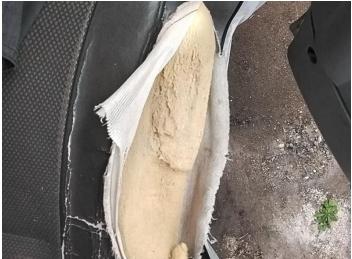
24: Seat Base Cover osf Torn Over 3mm

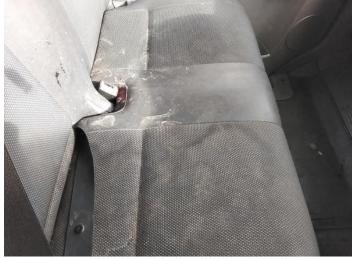
25: Seat Base Cover nsf Soiled Heavy
