# VEHICLE INSPECTION REPORT

**YA17SVJ**

## Daf CF 330

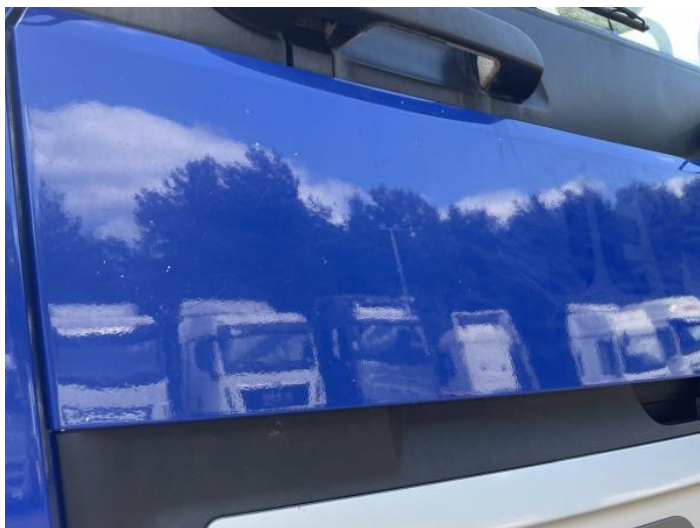
1: Bonnet  
Chipped  
Multiple Chips

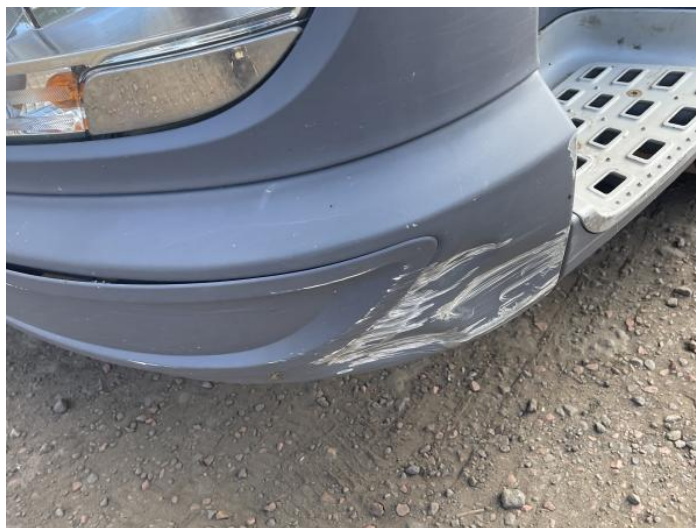
2: Bumper Front Moulding  
Scuffed (Unpainted)  
Over 100mm

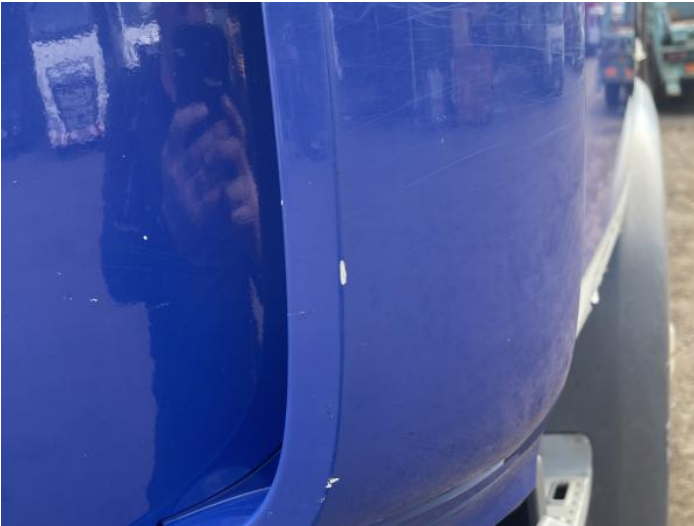
3: Wing nsf  
Chipped  
Multiple Chips

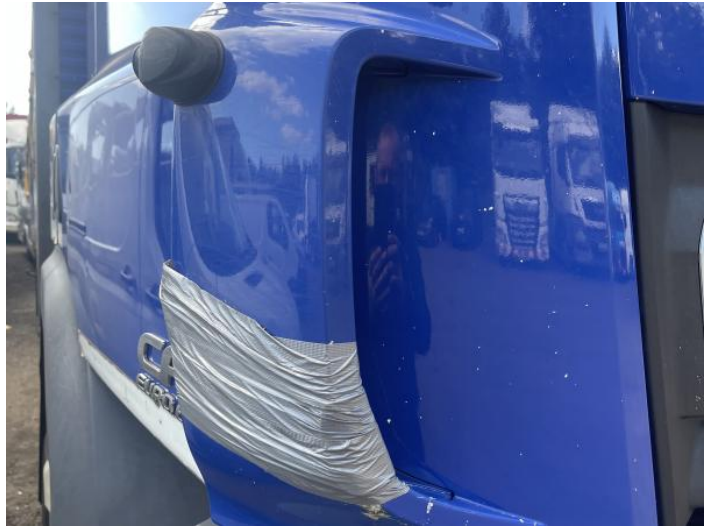
4: Wing osf  
Cracked  
Replace

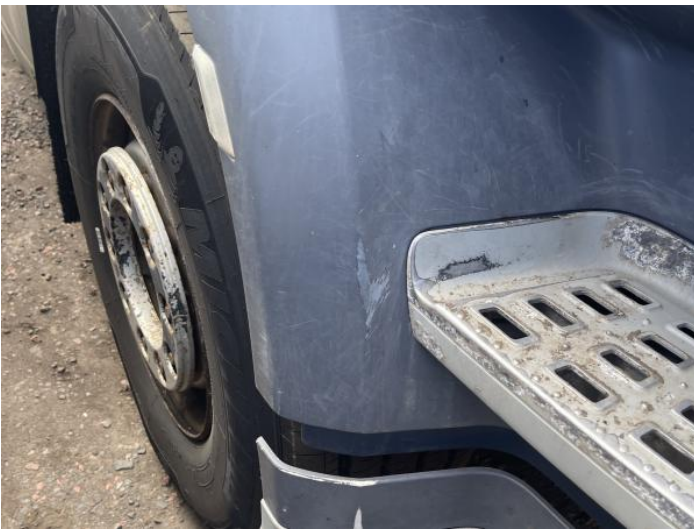
5: Door Moulding osf  
Scuffed (Unpainted)  
Over 100mm

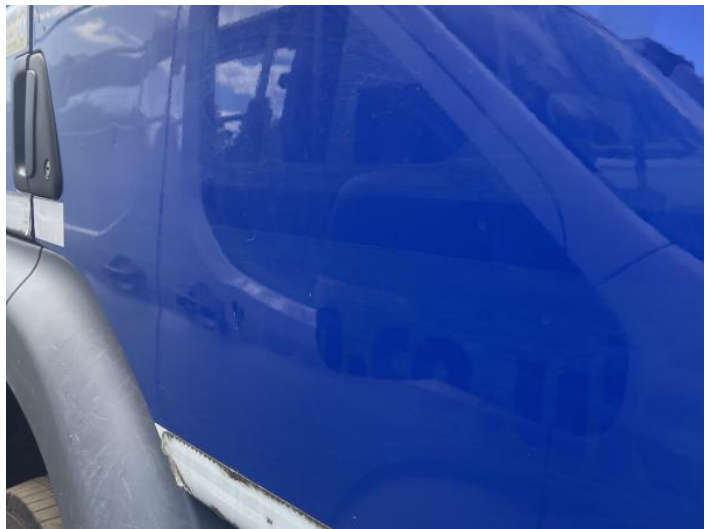
6: Door osf  
Dented  
With Paint Damage

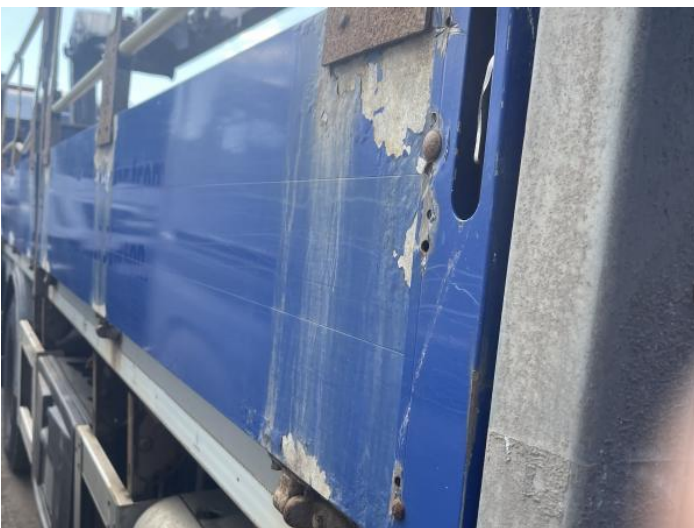
7: Qtr Panel osr  
Rusted  
Over 5mm

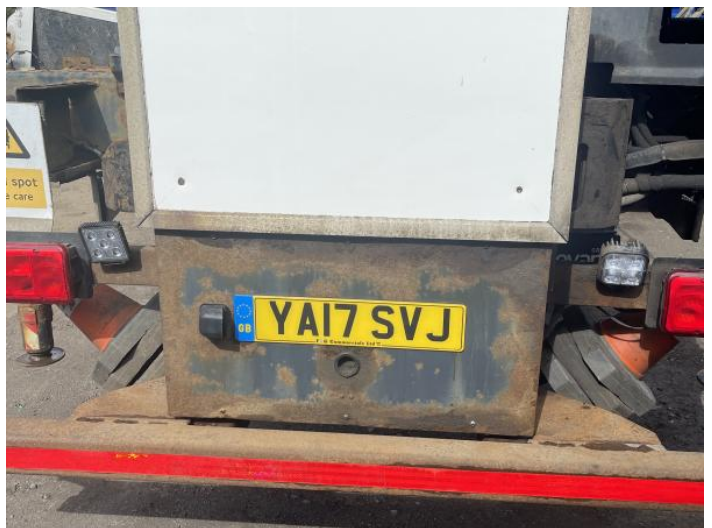
8: Tailgate  
Rusted  
Over 5mm

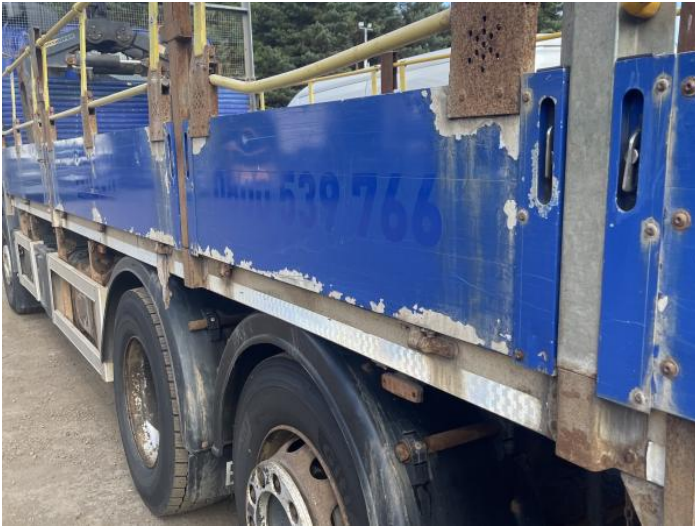
9: Qtr Panel nsr  
Dented  
With Paint Damage

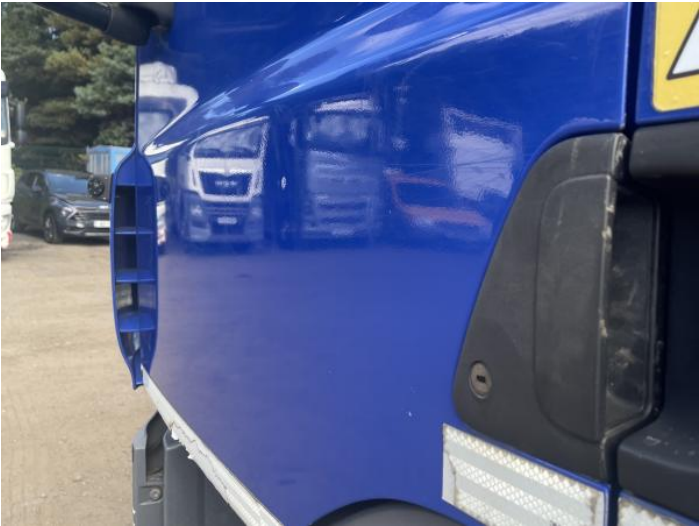
10: Door nsf  
Dented  
Over 2 UpTo 10mm

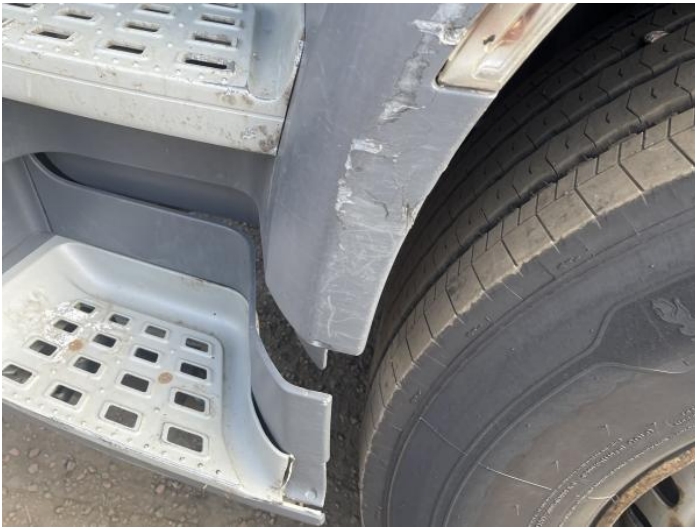
11: Door Moulding nsf  
Scuffed (Unpainted)  
Over 100mm
