VEHICLE INSPECTION REPORT

WV65OKL

Scania P 370

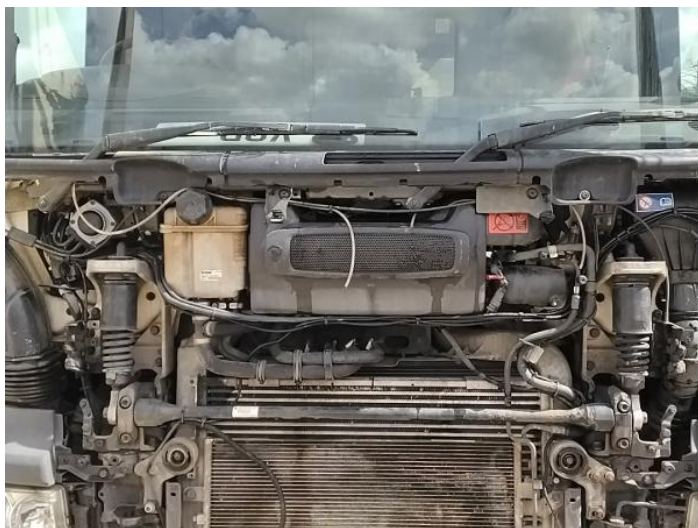
1: Bonnet
Missing
Replace

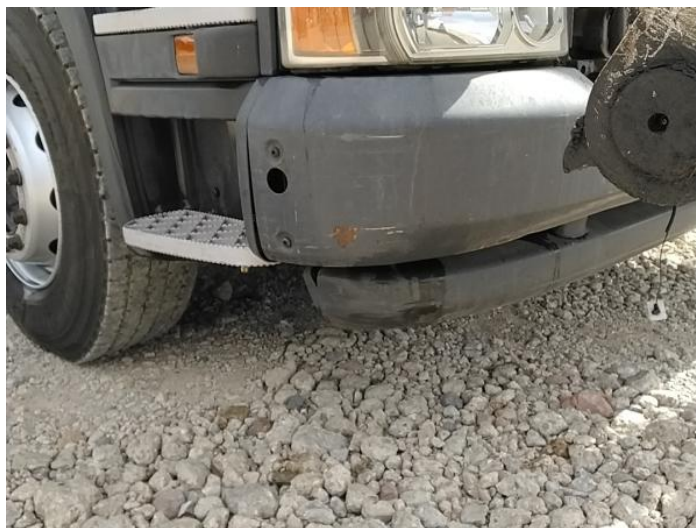
2: Bumper Front Moulding
Scuffed (Unpainted)
UpTo 100mm

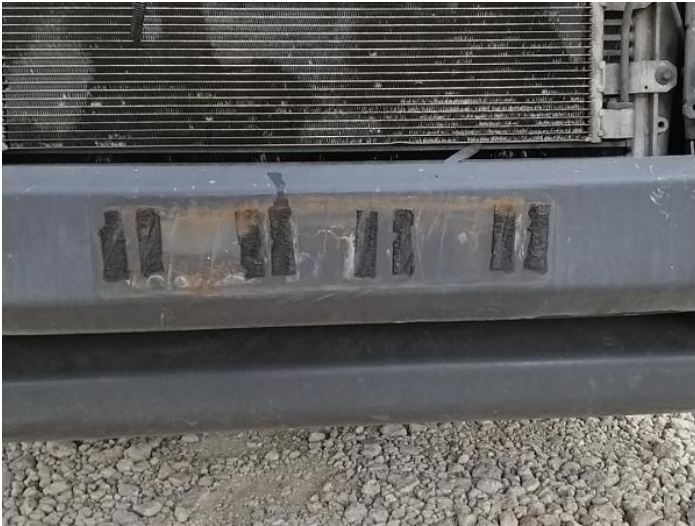
3: Number Plate Front
Missing
Replace

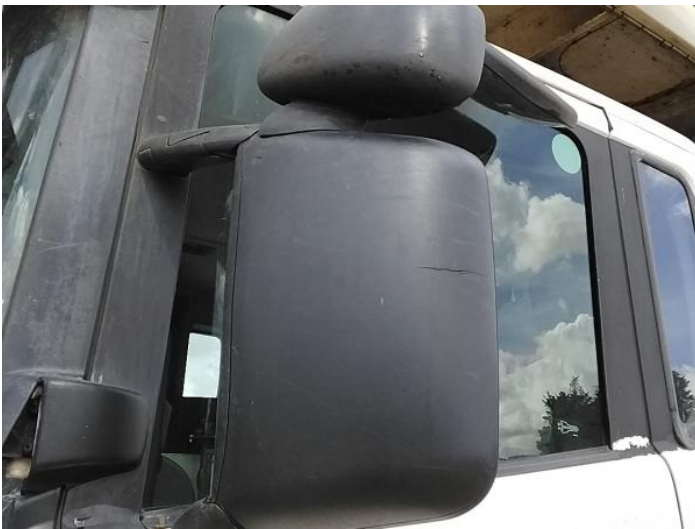
5: Door Mirror Assy nsf
Broken
Replace

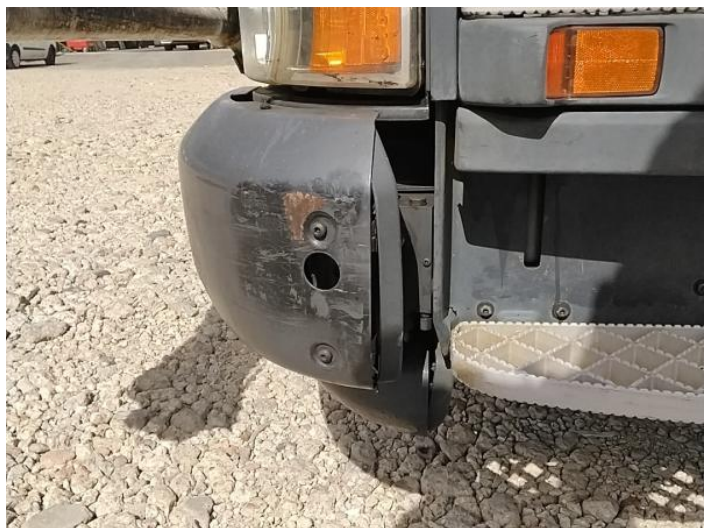
8: Bumper Front Moulding
Scuffed (Unpainted)
UpTo 100mm

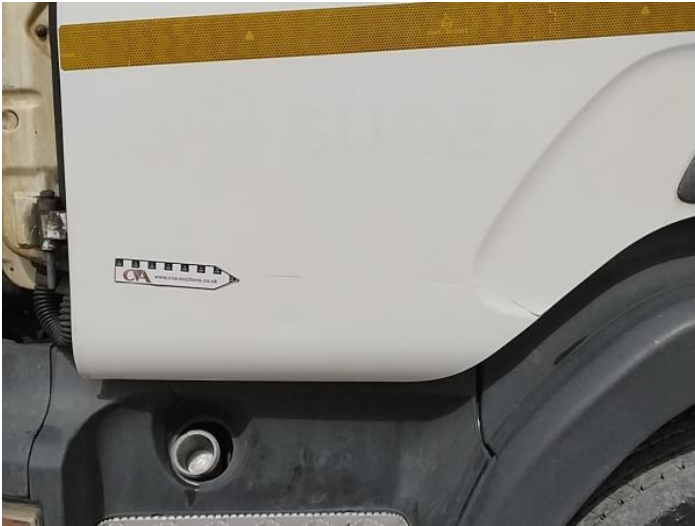
9: Door nsf
Scratched
Over 25mm Thru Paint

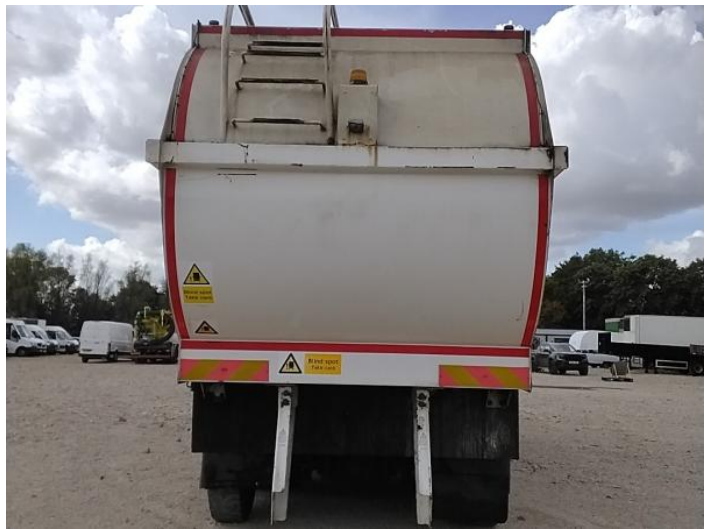
12: Number Plate Rear
Missing
Replace

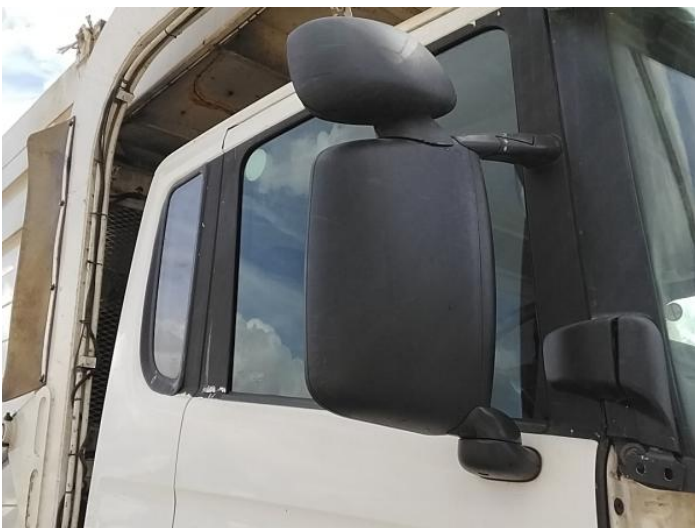
13: Door Mirror Assy osf
Scuffed (Unpainted)
UpTo 100mm
