VEHICLE INSPECTION REPORT

DG16DWE

Man TGS 26.360

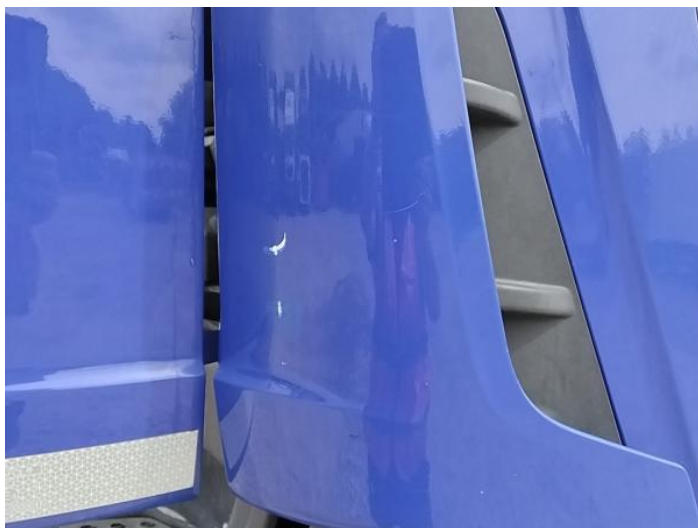
1: Wing osf
Scratched
UpTo 25mm Thru Paint

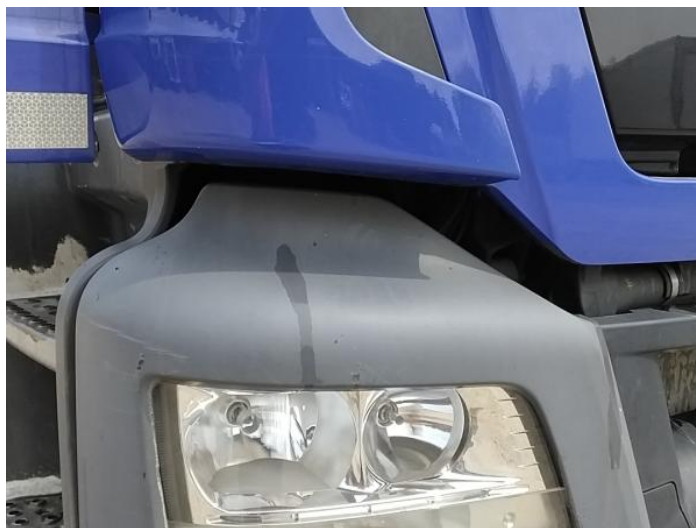
2: Fog Lamp Surround os
Scuffed (Unpainted)
Over 100mm

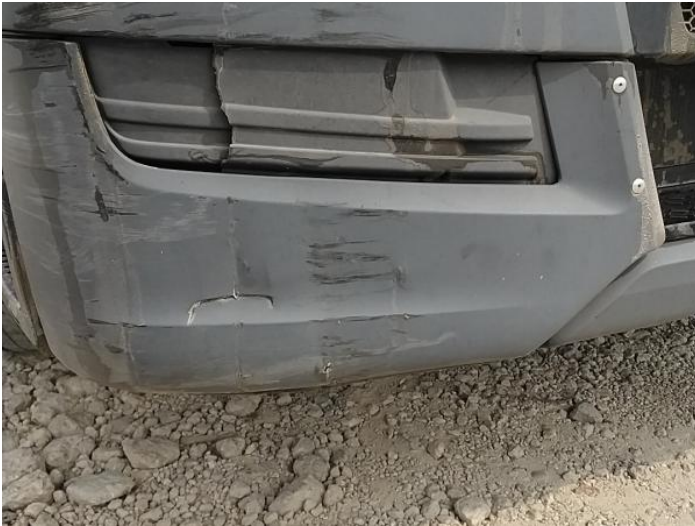
3: Bumper Front Moulding
Broken
Replace

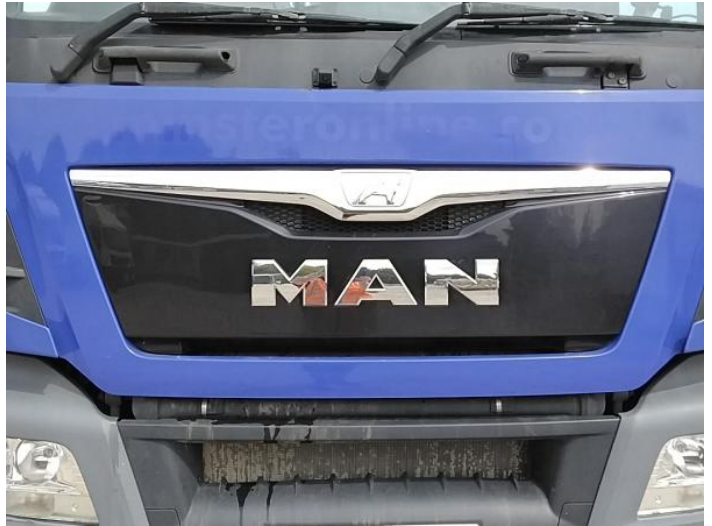
4: Bonnet
Chipped
1 To 5

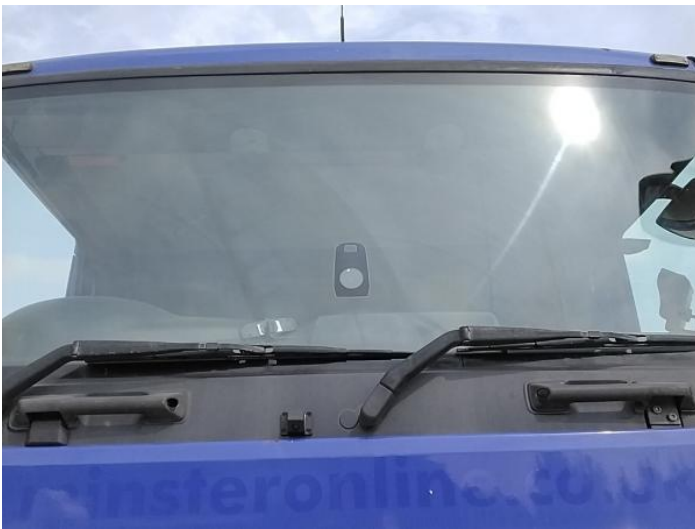
5: Screen Front
Cracked
Replace

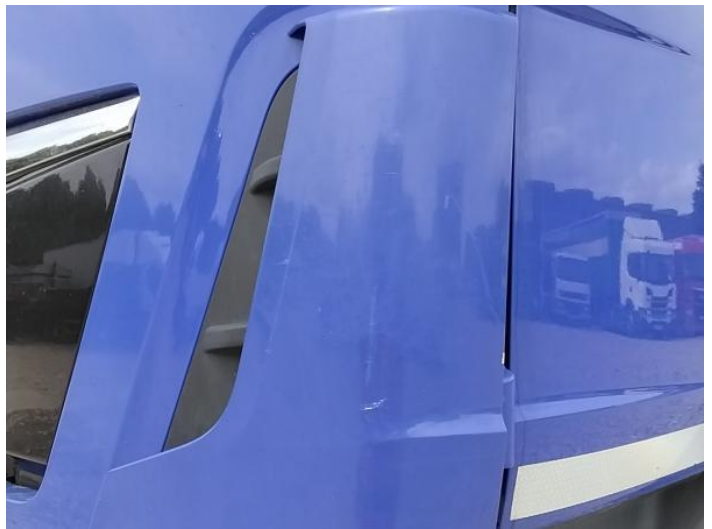
6: Wing nsf
Scratched
UpTo 25mm Thru Paint

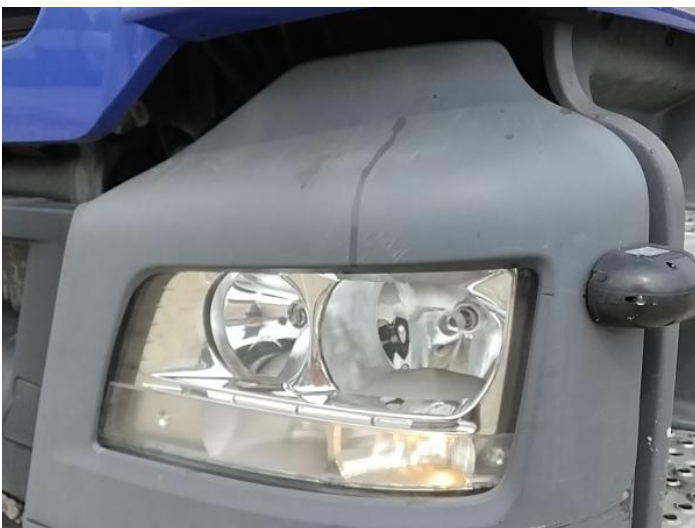
7: Fog Lamp Surround ns
Scuffed (Unpainted)
Over 100mm

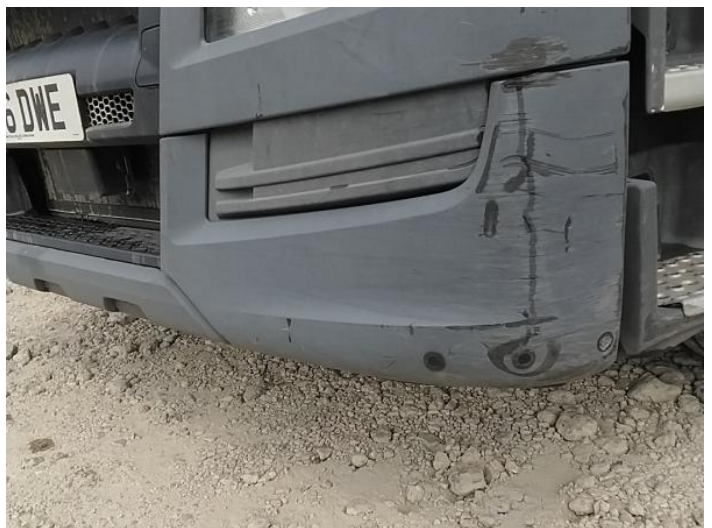
8: Bumper Front Moulding
Scuffed (Unpainted)
Over 100mm

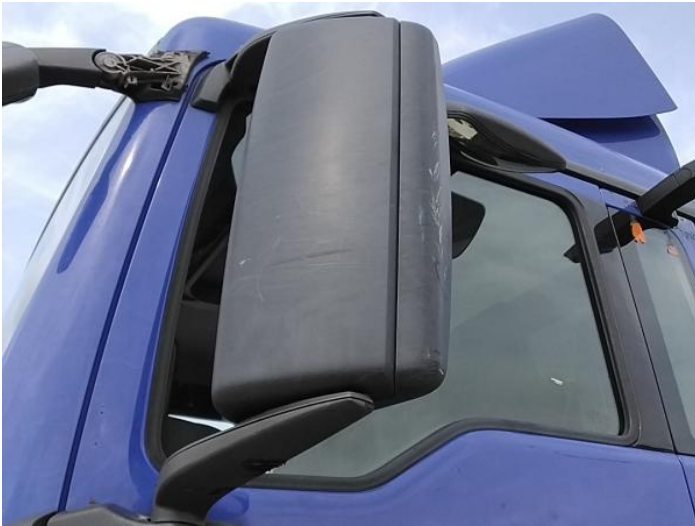
9: Door Mirror Assy nsf
Scuffed (Unpainted)
UpTo 100mm

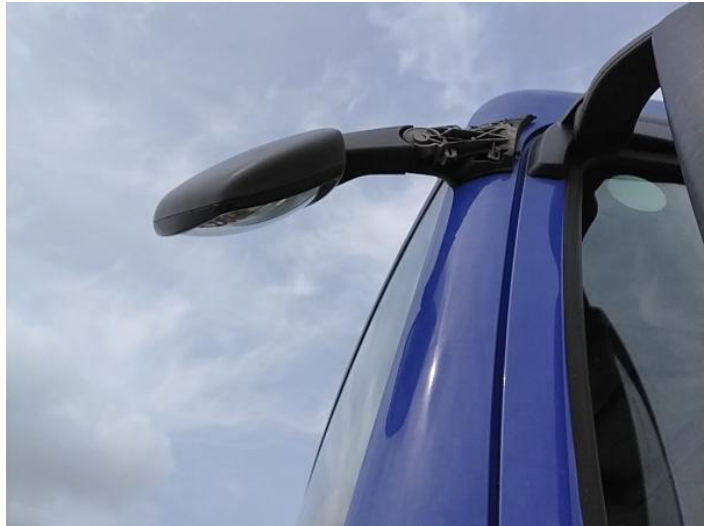
10: Door Mirror Assy nsf
Broken
Replace

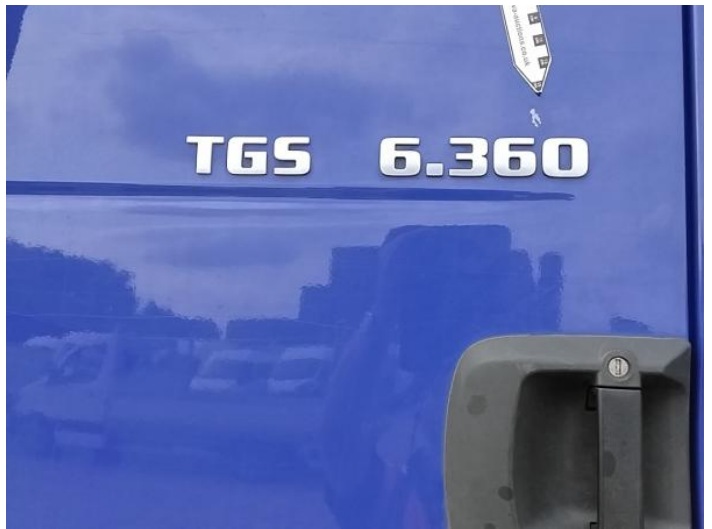
12: Door nsf
Scratched
UpTo 25mm Thru Paint

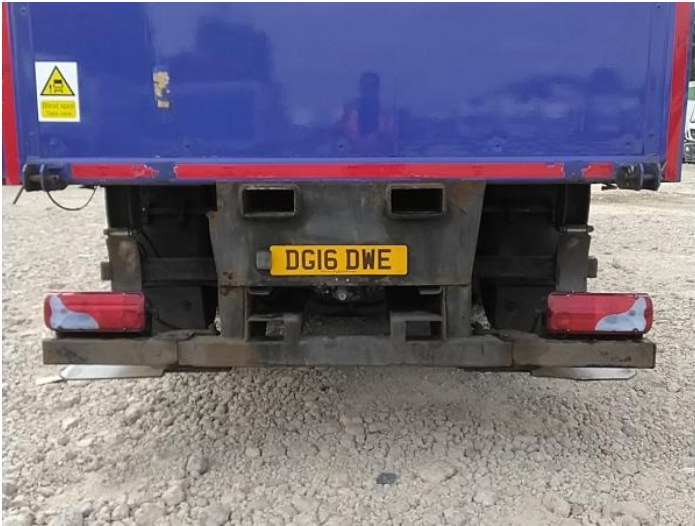
15: Bumper Rear
Rusted
Over 5mm

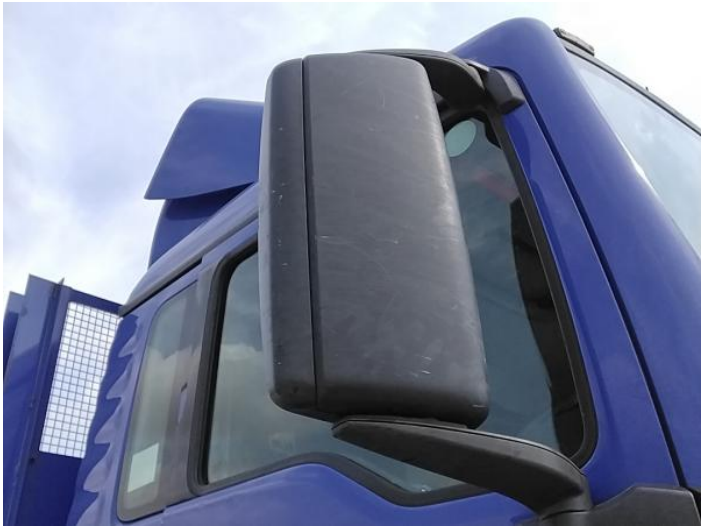
16: Door Mirror Assy osf
Scuffed (Unpainted)
UpTo 100mm

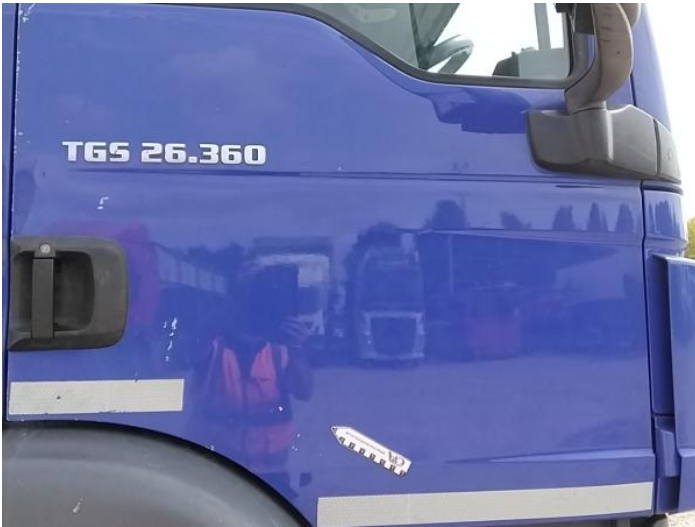
17: Door osf
Scratched
UpTo 25mm Thru Paint

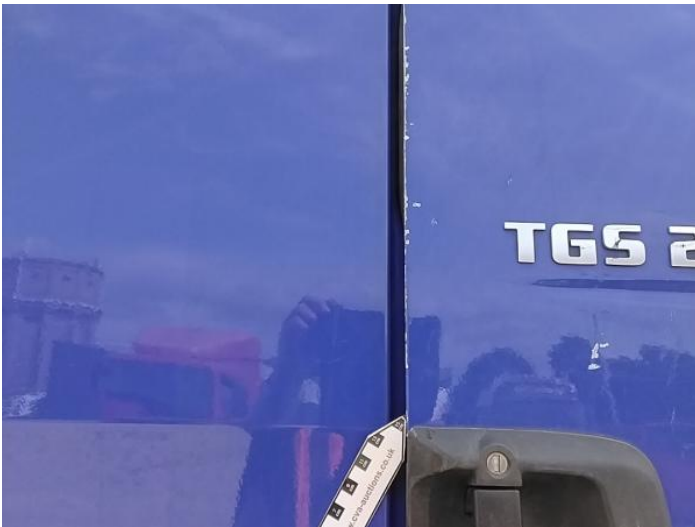
19: Door osf
Chipped
Edge Chip

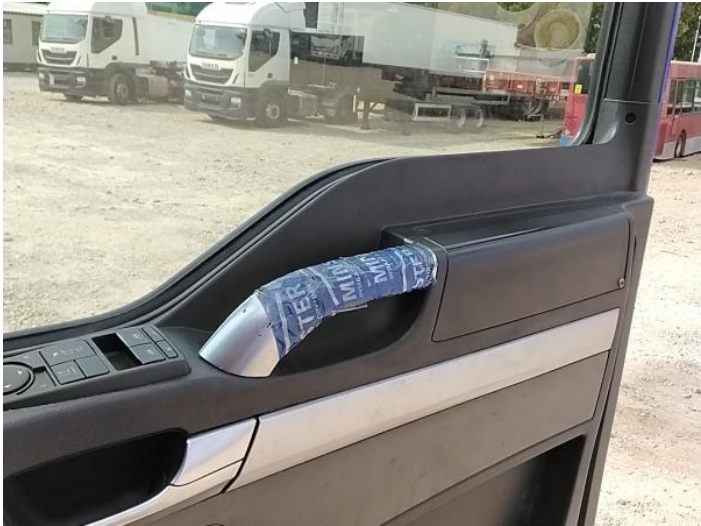
22: Handle Inner osf
Damaged
Replace
