VEHICLE INSPECTION REPORT

PE24UOF

Isuzu Gafter N35.125

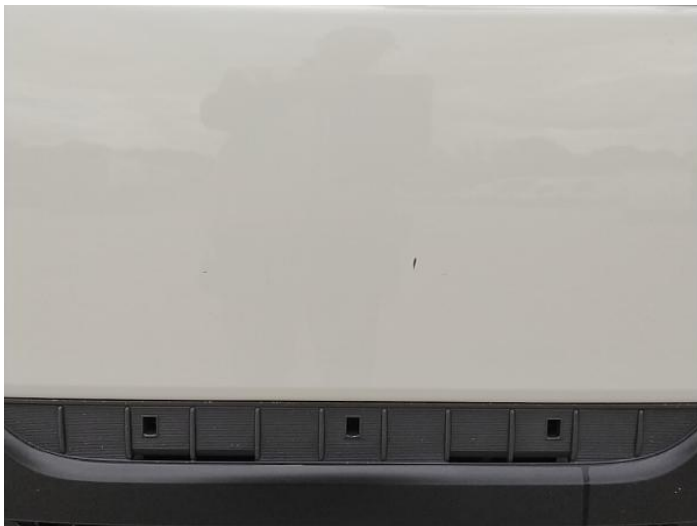
1: Bonnet
Scratched
UpTo 25mm Thru Paint

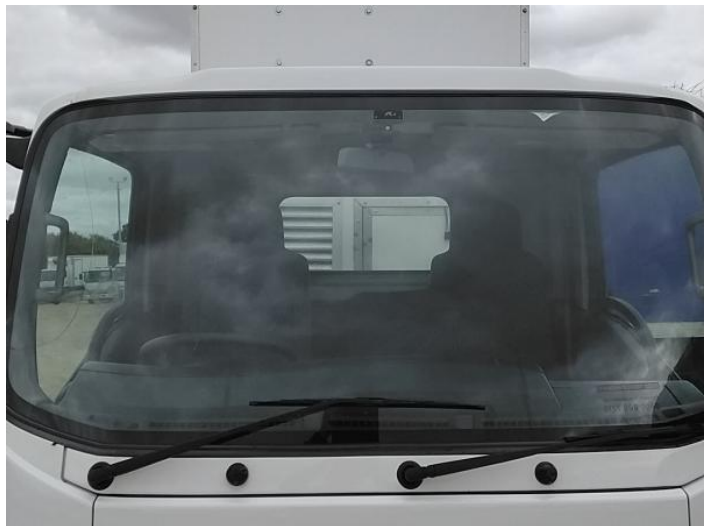
2: Screen Front
Cracked
Replace

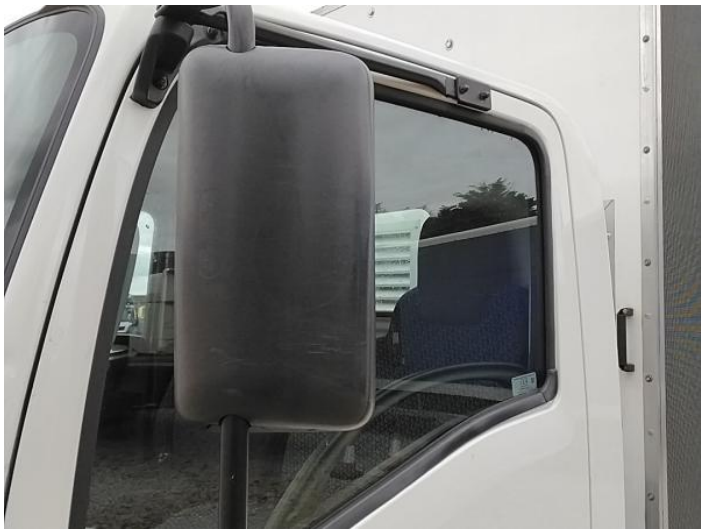
3: Door Mirror Assy nsf
Scuffed (Unpainted)
UpTo 100mm
