VEHICLE INSPECTION REPORT

BX06LBG

Daf LF 45.170

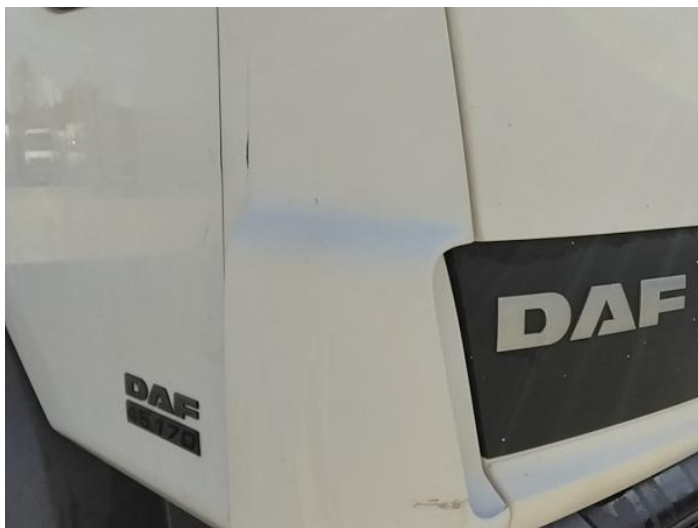
1: Wing osf
Scratched
UpTo 25mm Thru Paint

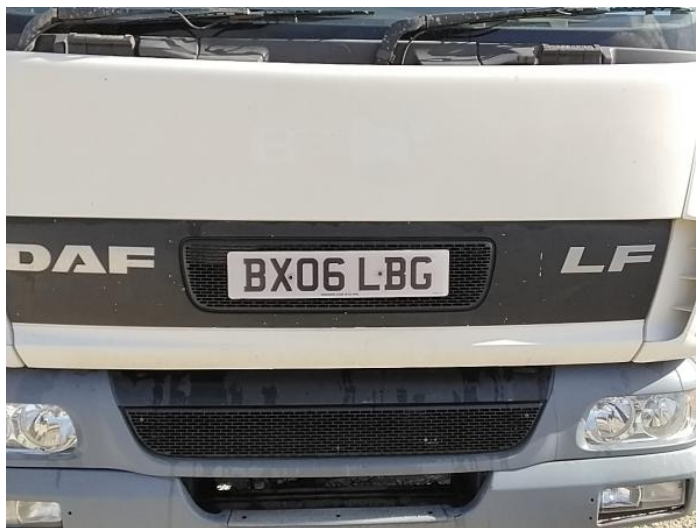
2: Bonnet
Chipped
Multiple Chips

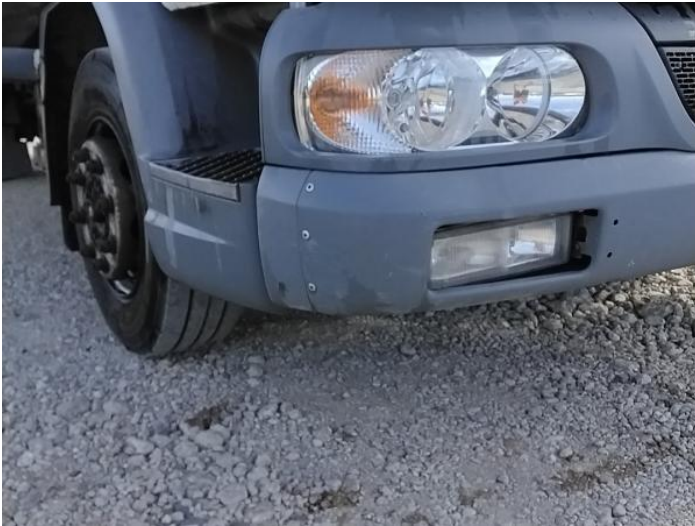
3: Bumper Front Moulding
Scuffed (Unpainted)
UpTo 100mm

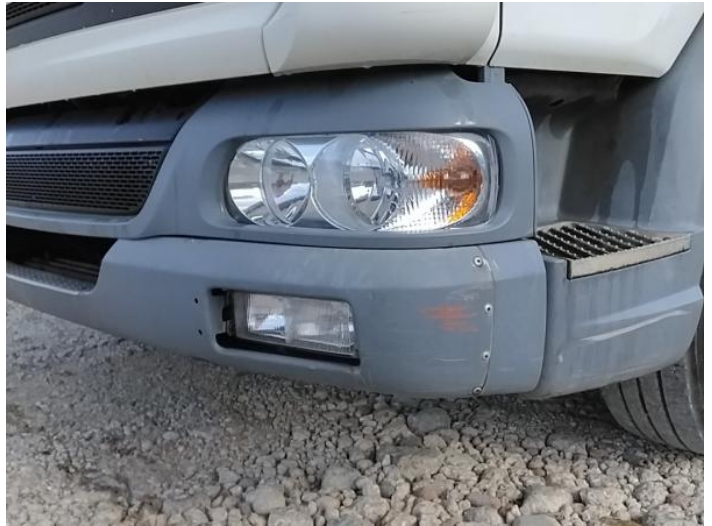
4: Bumper Front Moulding
Scuffed (Unpainted)
UpTo 100mm

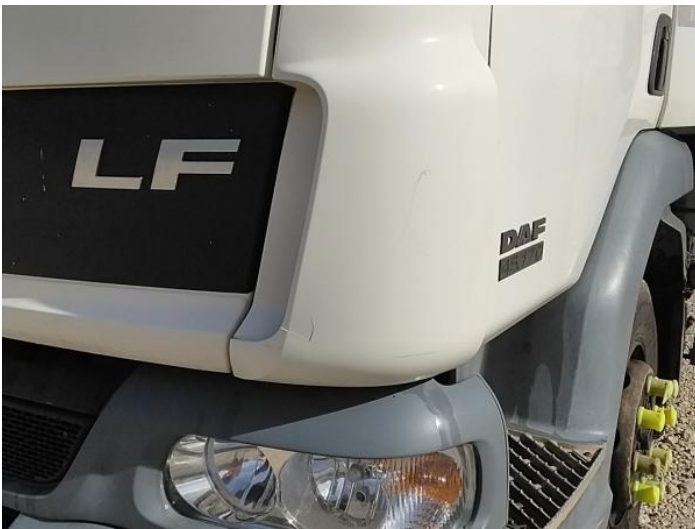
5: Wing nsf
Cracked
Replace

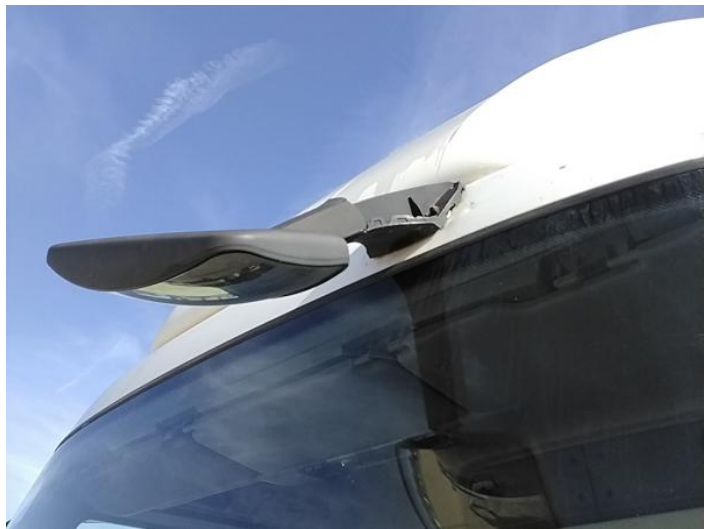
6: Door Mirror Assy nsf
Missing
Replace

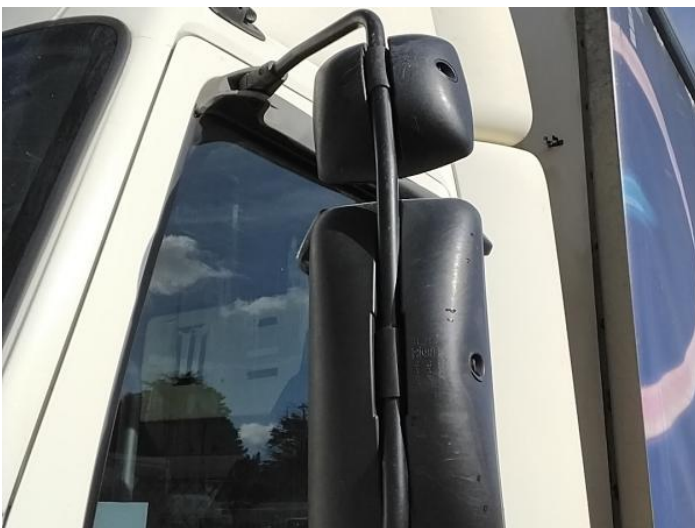
7: Door Mirror Assy nsf
Scuffed (Unpainted)
UpTo 100mm

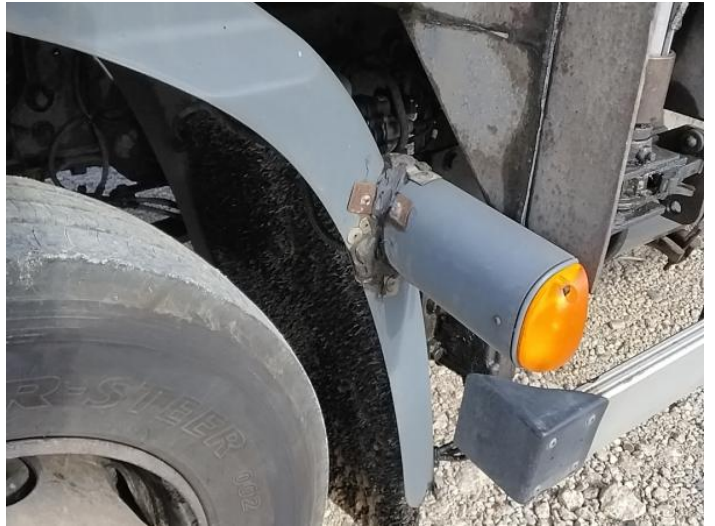
10: Flasher Side Repeater ns
Broken
Replace

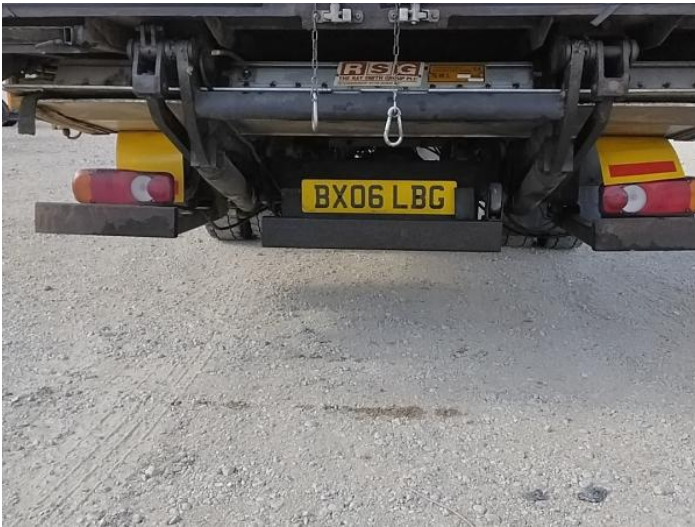
11: Bumper Rear
Rusted
Over 5mm

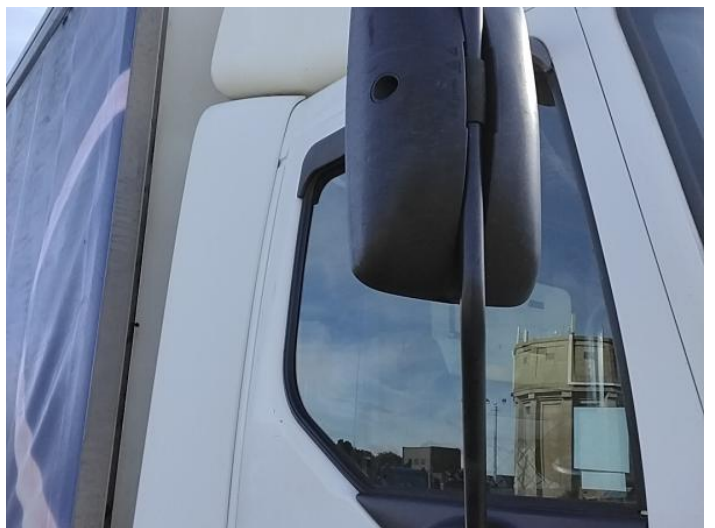
14: Door Mirror Assy osf
Scuffed (Unpainted)
UpTo 100mm

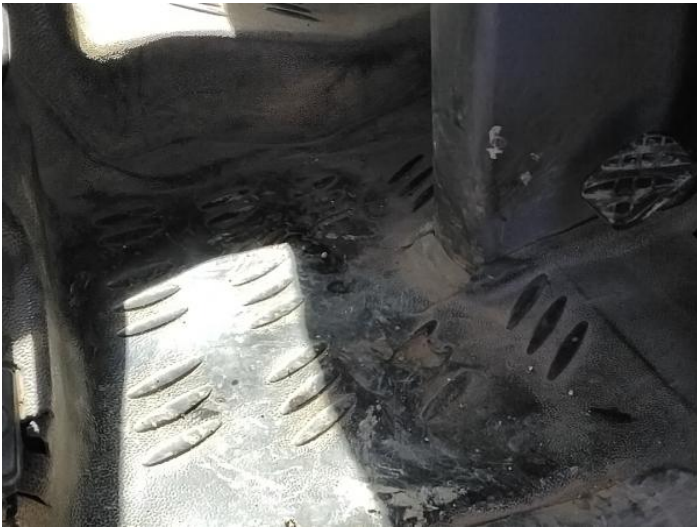
17: Carpets Front
Holed
Over 3mm
