# **VEHICLE INSPECTION REPORT**

**BE11MKM**

### **Iveco Stralis 310**

#### REAR LIFT, ATLAS 135.2VE-A12 REMOTE CRANE (YEAR 2018)

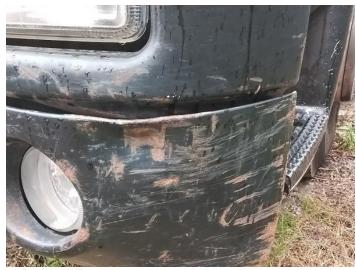
1: Bumper Front Dented With Paint Damage

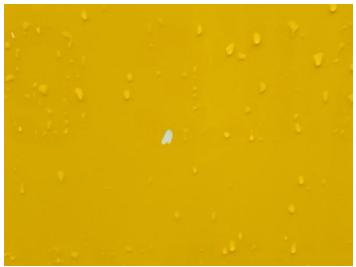
3: Door nsf Chipped Over 5mm

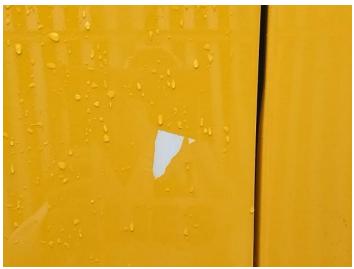
4: Door nsf Chipped Over 5mm

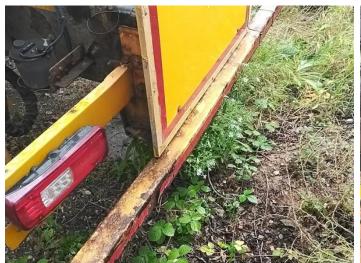
7: Bumper Rear Rusted Over 5mm

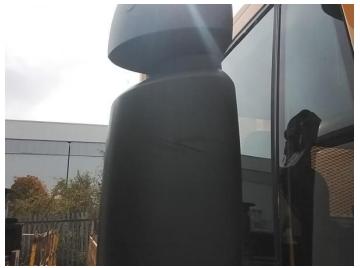
15: Door Mirror Assy osf Scuffed (Unpainted) Over 100mm

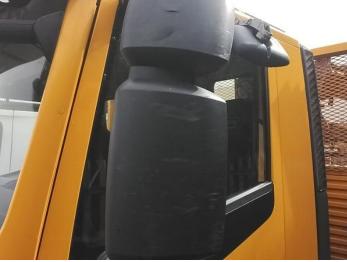
16: Door Mirror Assy nsf Scuffed (Unpainted) Over 100mm

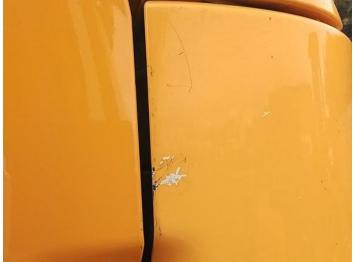
17: B Post os Scratched Over 25mm Thru Paint

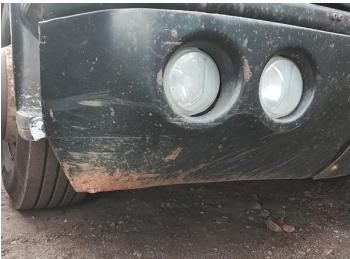
18: Bumper Front Rusted Over 5mm

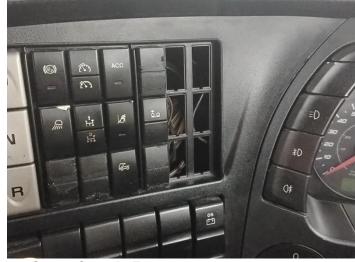
19: Centre Console Front Missing Replace
