# VEHICLE INSPECTION REPORT

**SH71GHV**

## Fiat Doblo CARGO 16V 1.6 MULTIJET

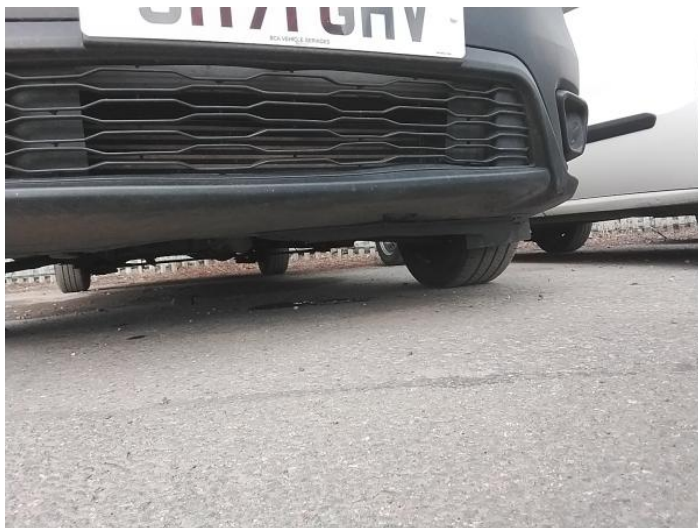
1: Bumper Front Moulding  
Broken  
Replace

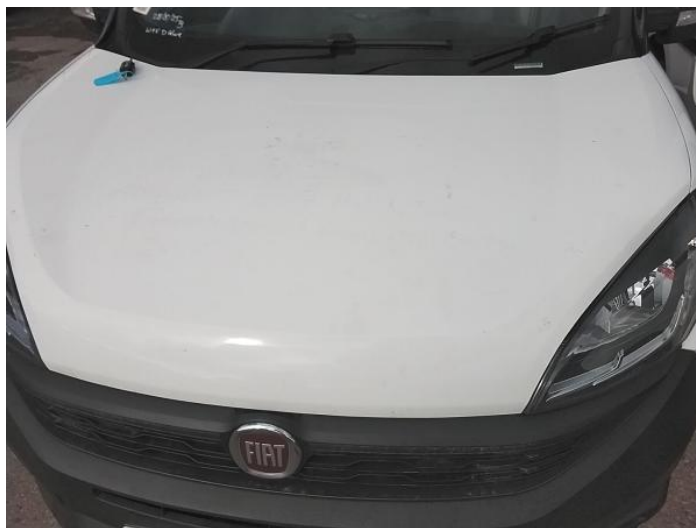
2: Bonnet  
Chipped  
Multiple Chips

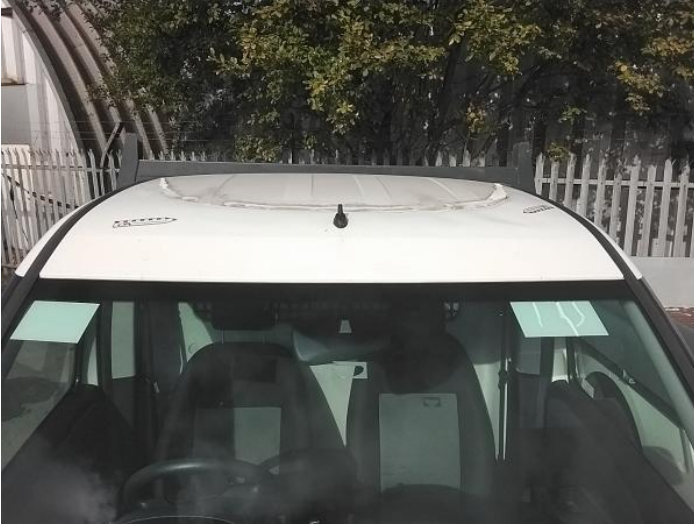
3: Roof  
Dented  
Over 30mm

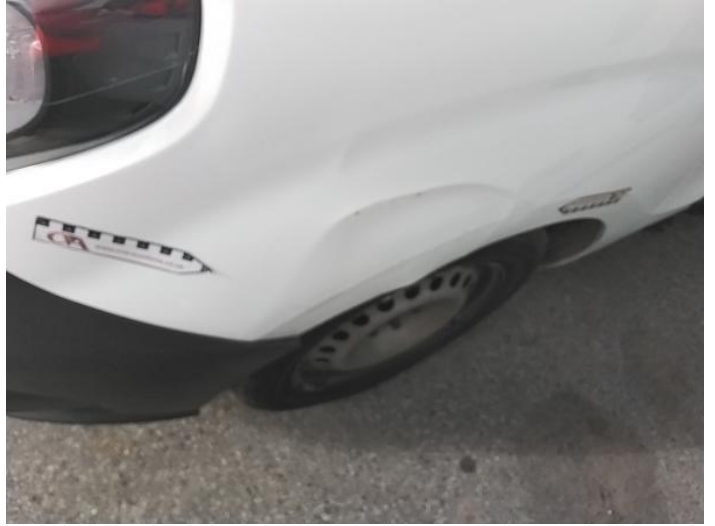
4: Wing nsf  
Dented  
With Paint Damage

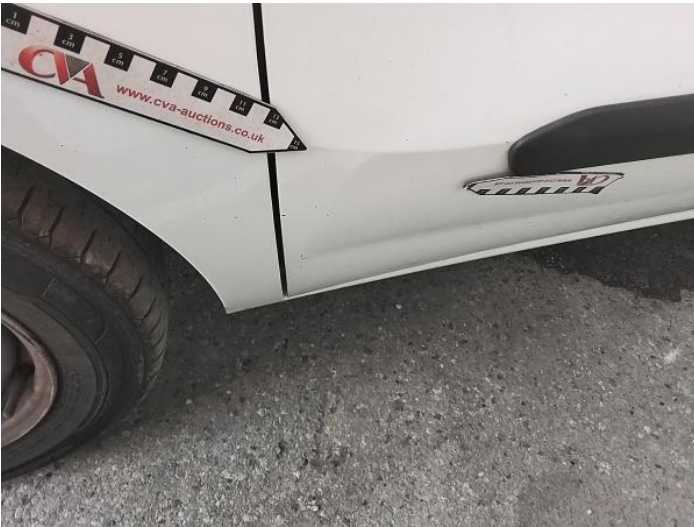
5: Door nsf  
Dented  
Over 30mm

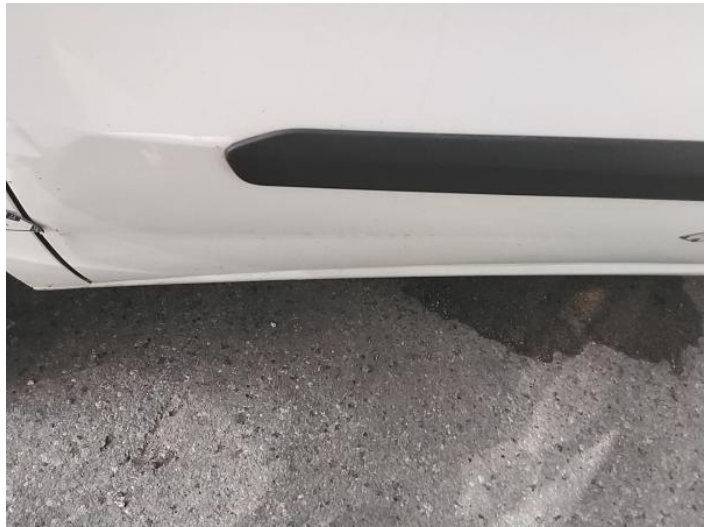
6: Door nsf  
Dented  
With Paint Damage

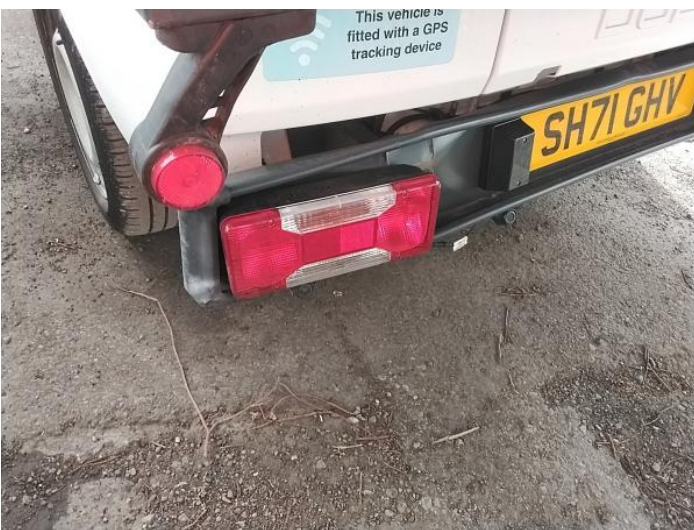
7: Bumper Rear  
Dented  
Over 30% Of Panel

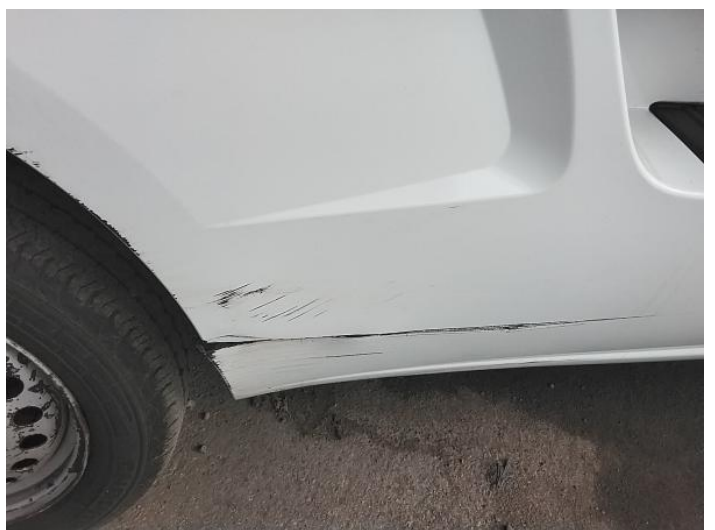
8: Qtr Panel osr  
Cracked  
Replace

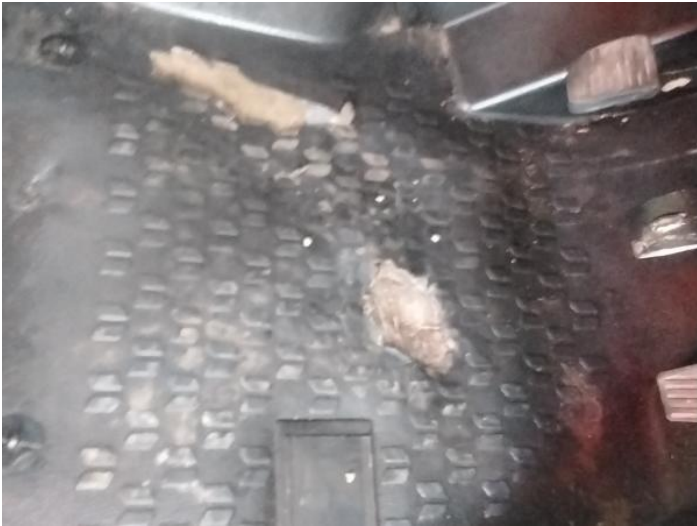
9: Carpets Front  
Holed  
Over 3mm

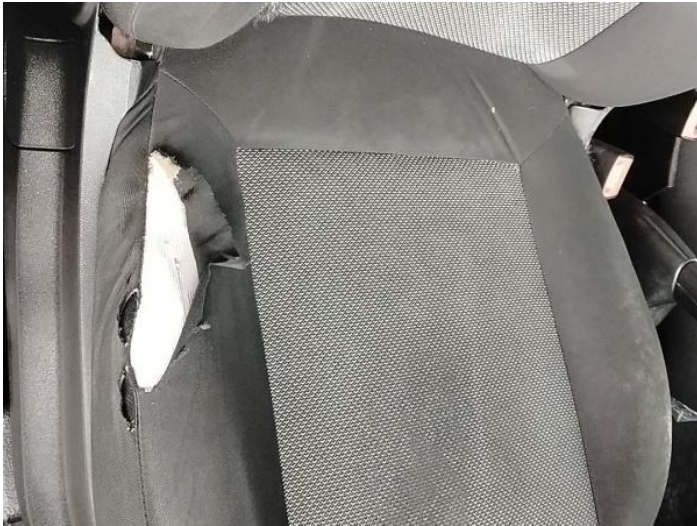
10: Seat Base Cover osf  
Torn  
Over 3mm

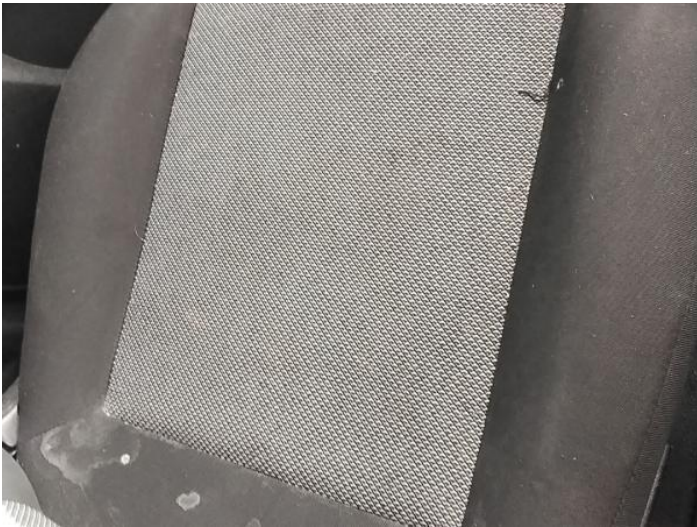
11: Seat Base Cover nsf  
Soiled  
Heavy

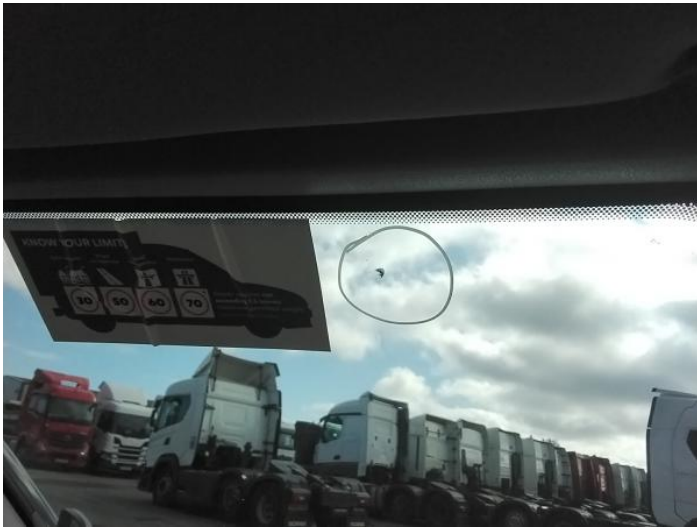
12: Screen Front  
Chipped  
Over 10mm
