VEHICLE INSPECTION REPORT

SF16CLL

Vauxhall Movano 35 2.3 CDTi BiTurbo ecoFLEX 136ps

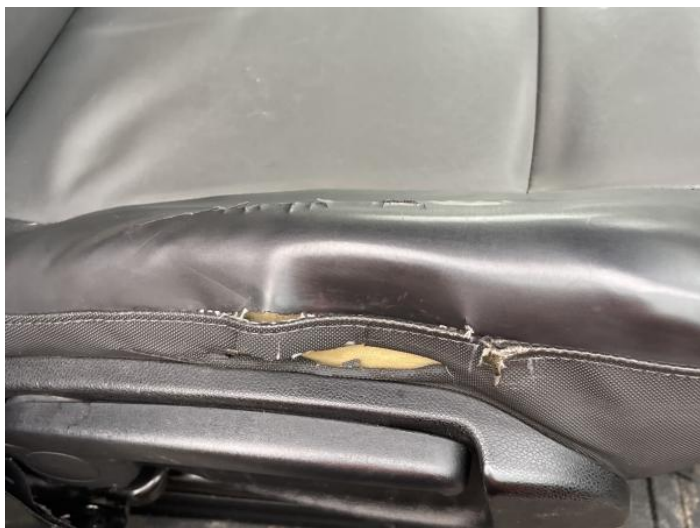
1: Seat Base Cover osf
Torn
Over 3mm

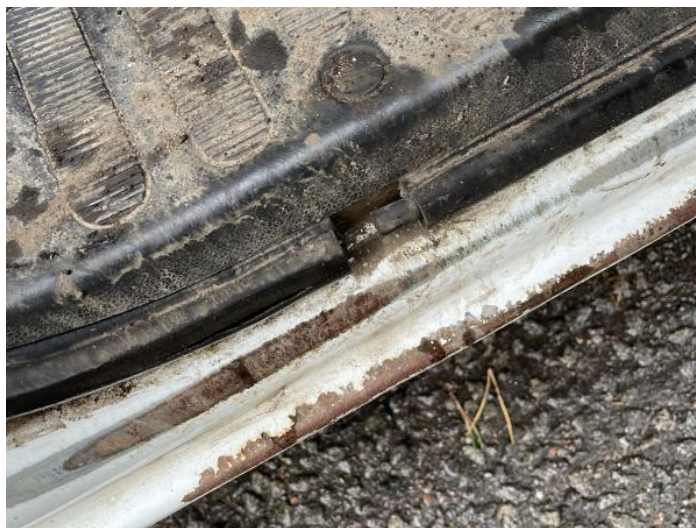
2: Sill os
Rusted
Over 5mm

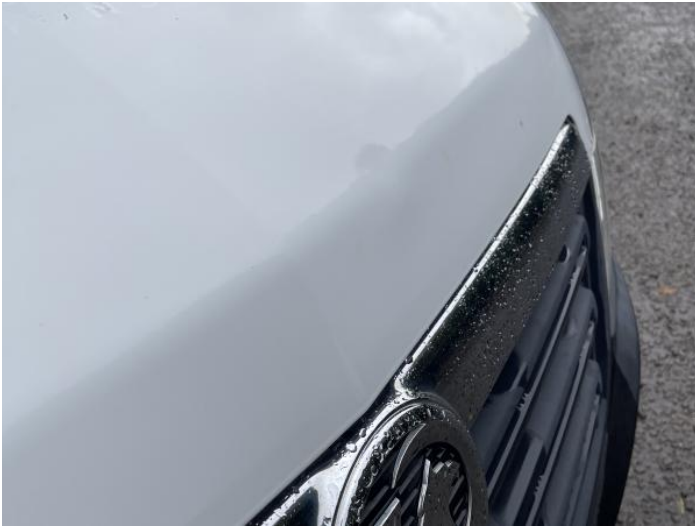
3: Bonnet
Dented
Over 30mm

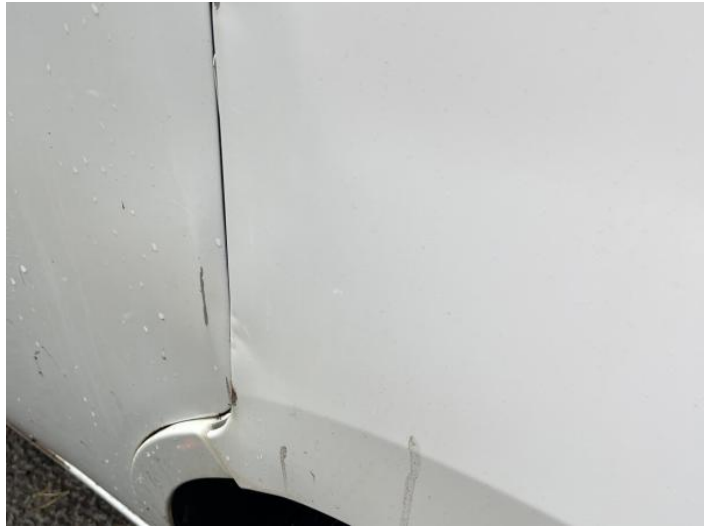
4: Wing osf
Dented
With Paint Damage

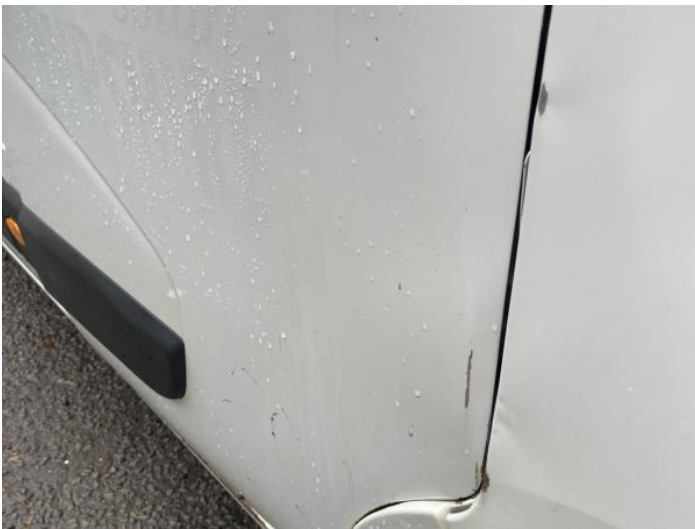
5: Door osf
Dented
With Paint Damage

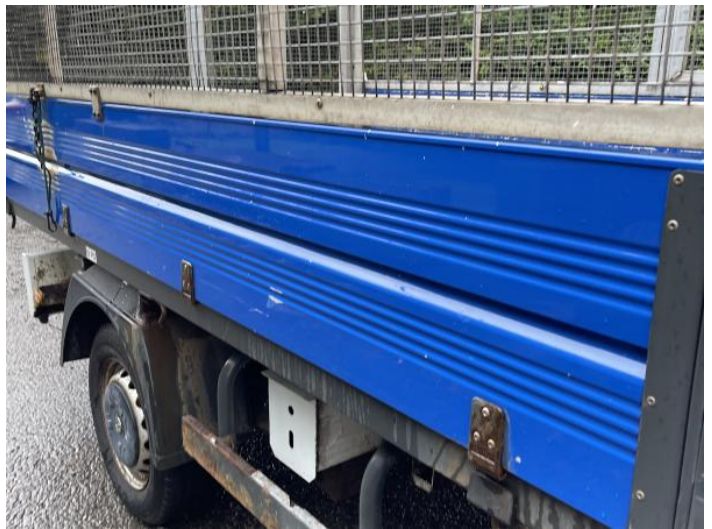
6: Qtr Panel osr
Dented
With Paint Damage

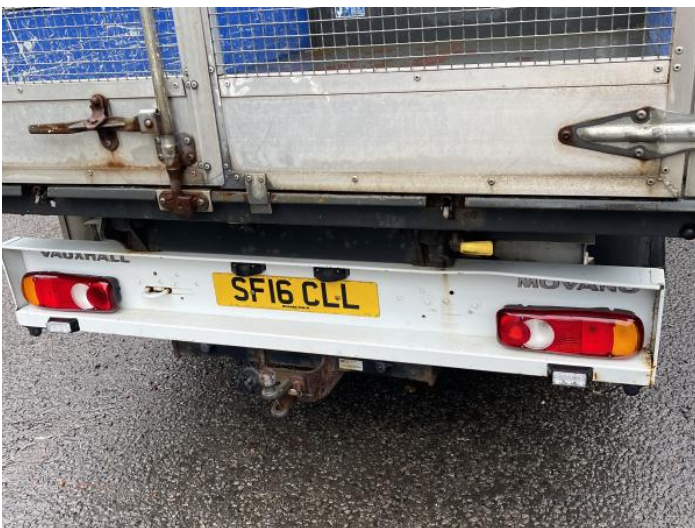
7: Tailgate
Dented
Over 30mm

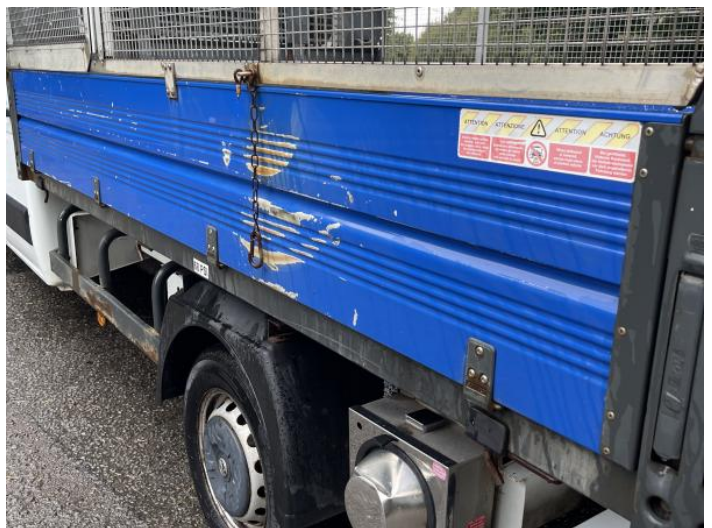
8: Qtr Panel nsr
Dented
With Paint Damage

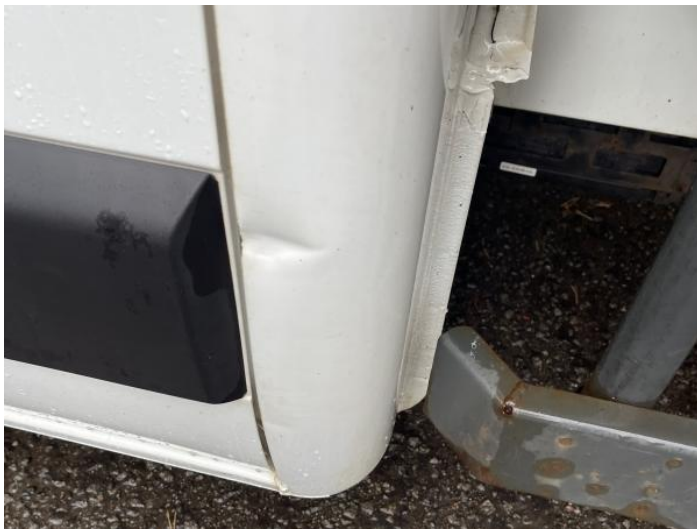
9: D Post ns
Dented
Over 30mm

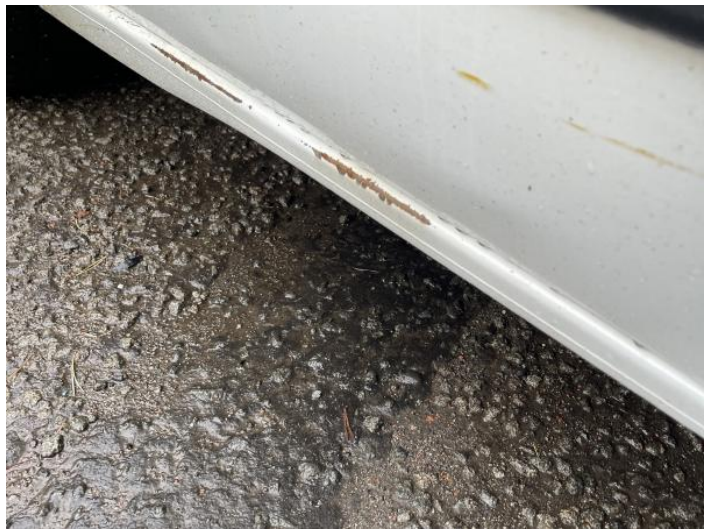
10: Sill ns
Dented
Over 30mm

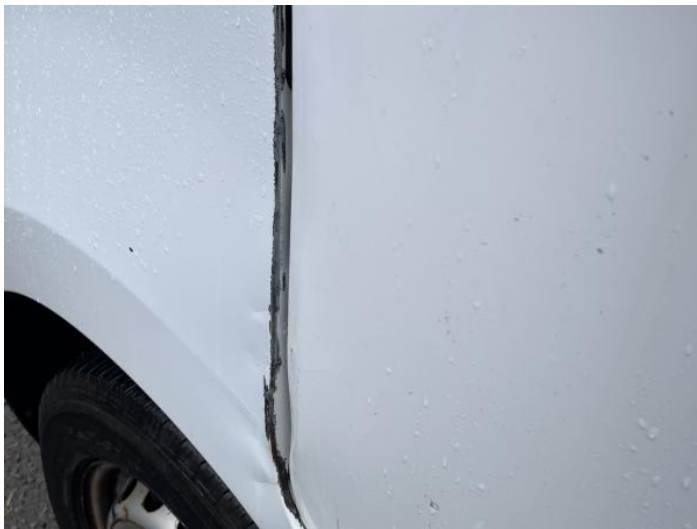
11: Door osf
Dented
With Paint Damage

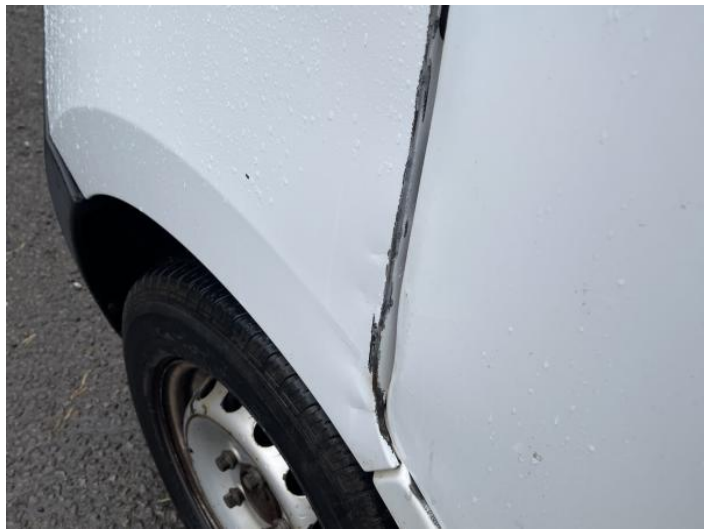
12: Wing nsf
Dented
With Paint Damage
