VEHICLE INSPECTION REPORT

SF16CLE

Vauxhall Movano F3500 2.3 CDTi BiTurbo ecoFLEX 136ps

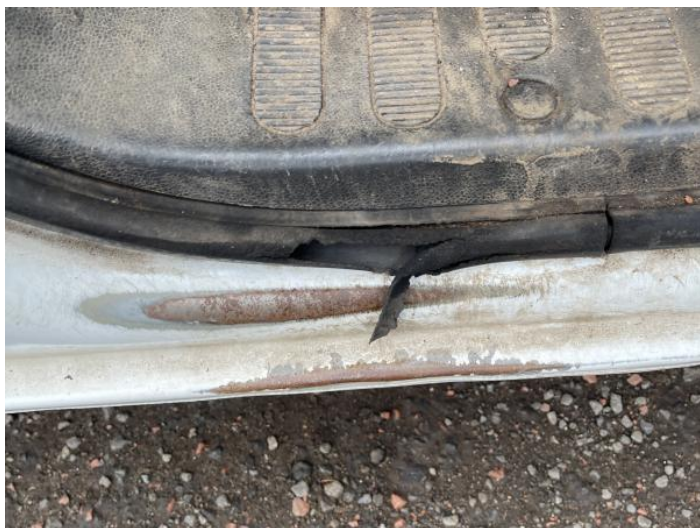
1: Sill os
Rusted
Over 5mm

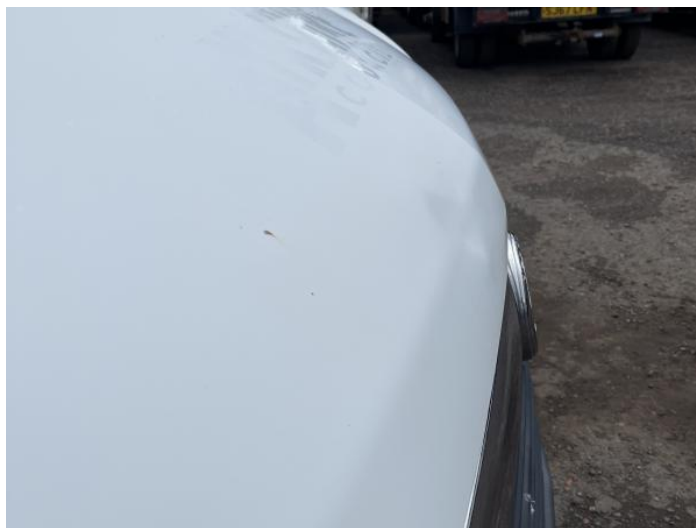
2: Bonnet
Dented
With Paint Damage

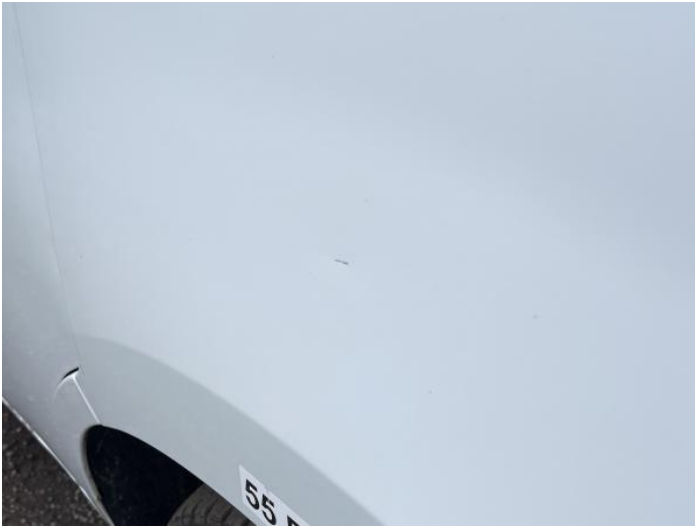
3: Wing osf
Dented
With Paint Damage

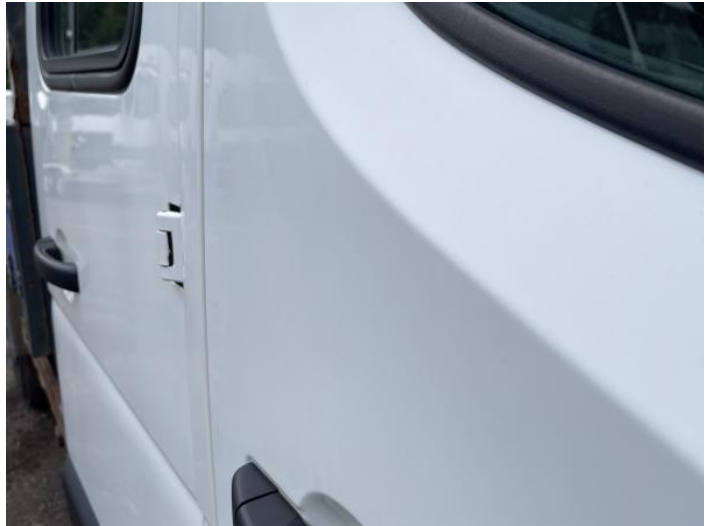
4: Door osf
Dented
Over 30mm

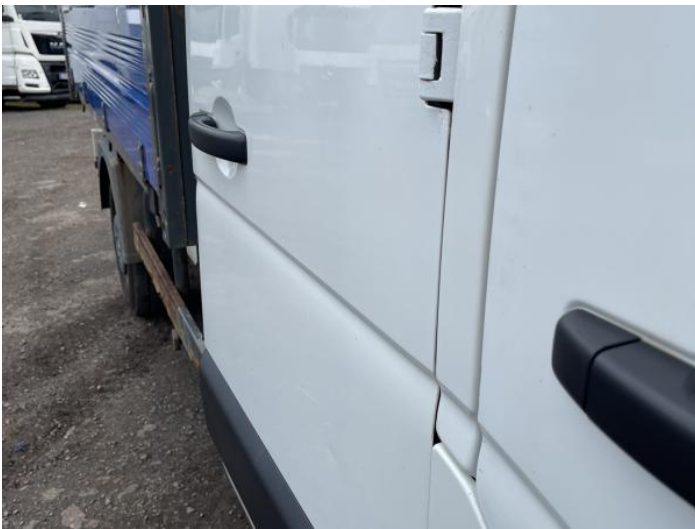
5: Door osr
Dented
Over 30mm

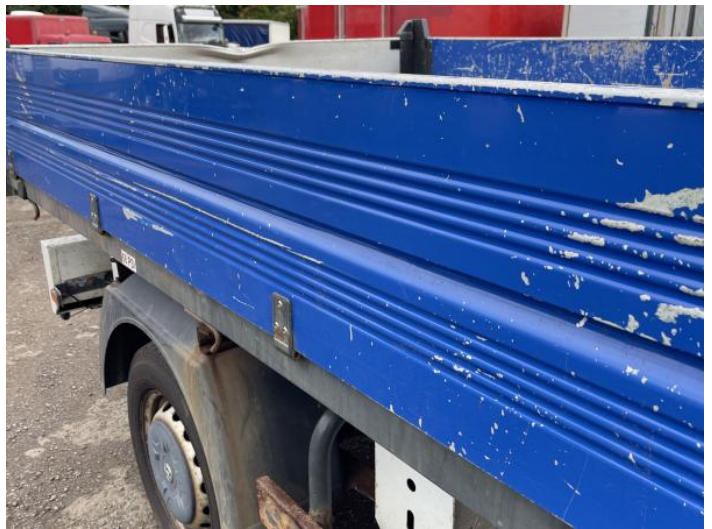
6: Qtr Panel osr
Dented
With Paint Damage

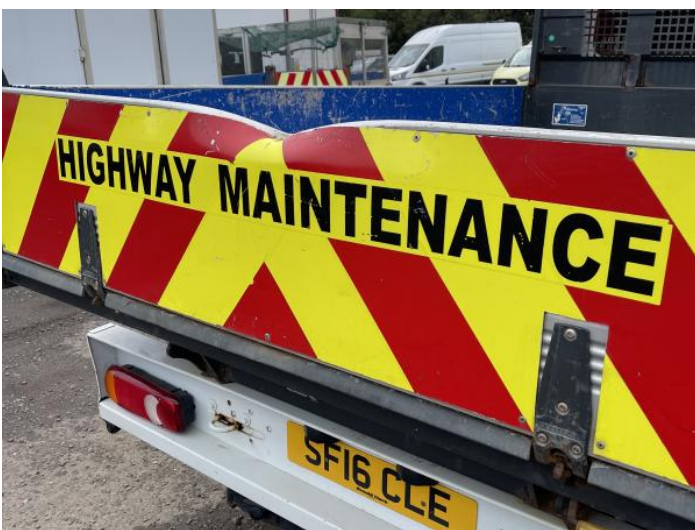
7: Tailgate
Dented
Over 30mm

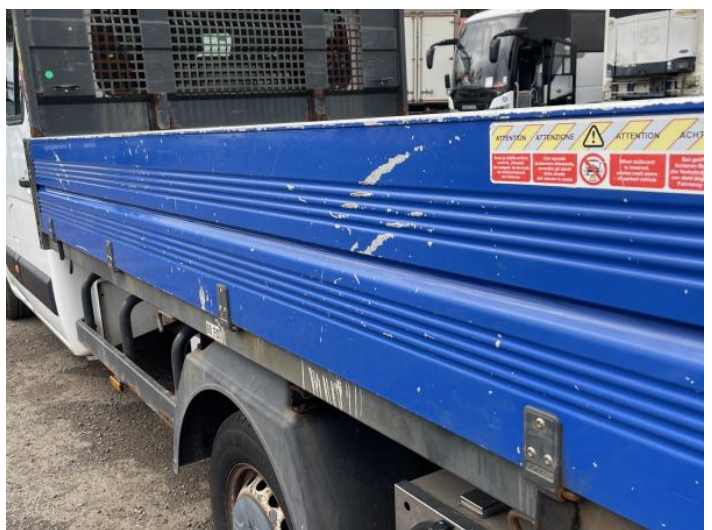
8: Qtr Panel nsr
Dented
Over 30mm

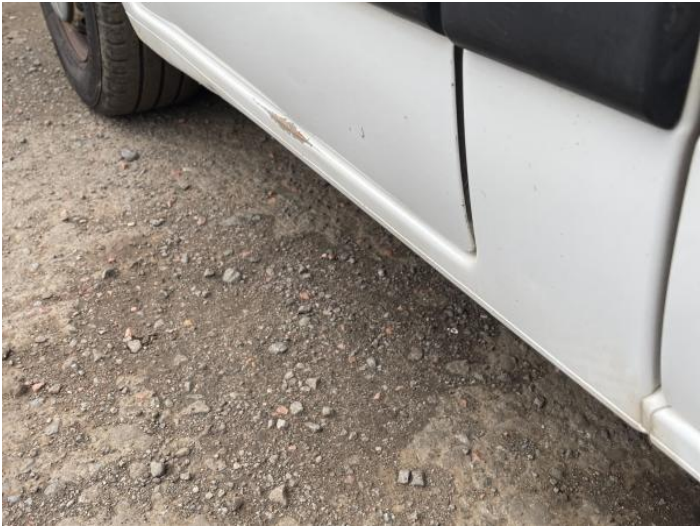
9: Sill ns
Dented
Over 30mm

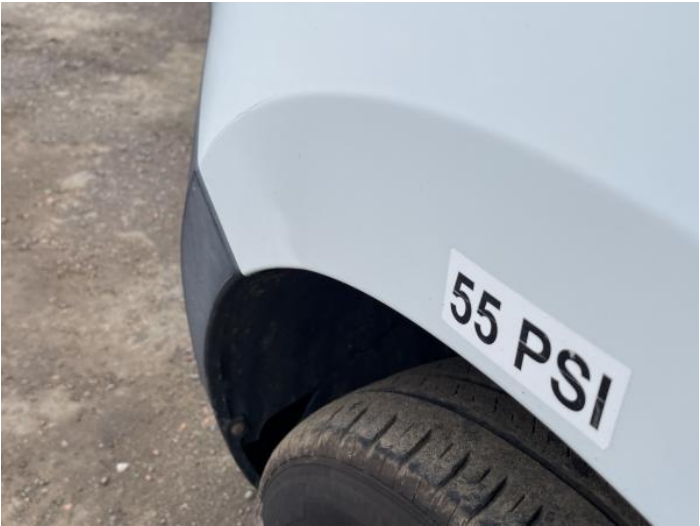
10: Wing nsf
Dented
Over 30mm
