VEHICLE INSPECTION REPORT

SF16CLP

Vauxhall Movano 2.3 CDTi BiTurbo ecoFLEX 136ps

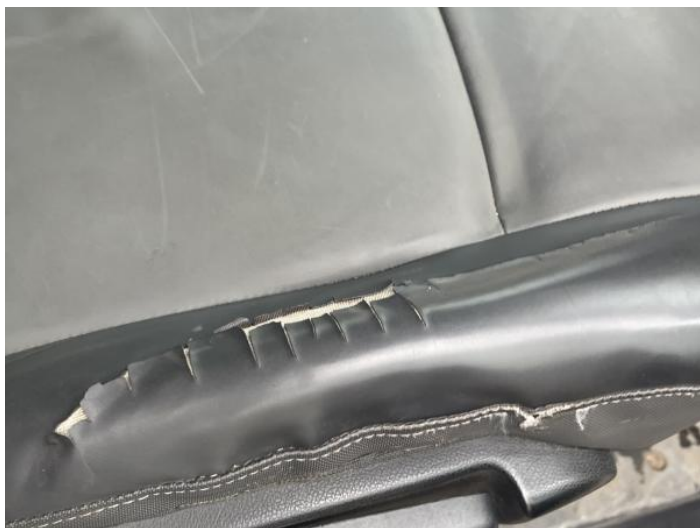
1: Seat Base Cover osf
Torn
Over 3mm

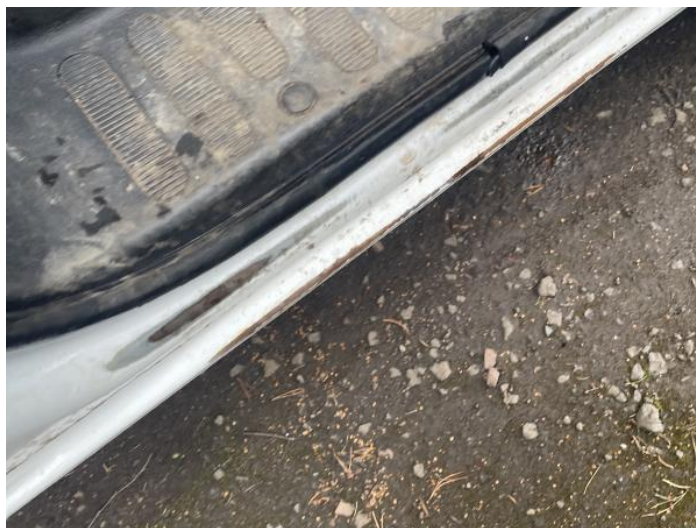
2: Sill os
Rusted
Over 5mm

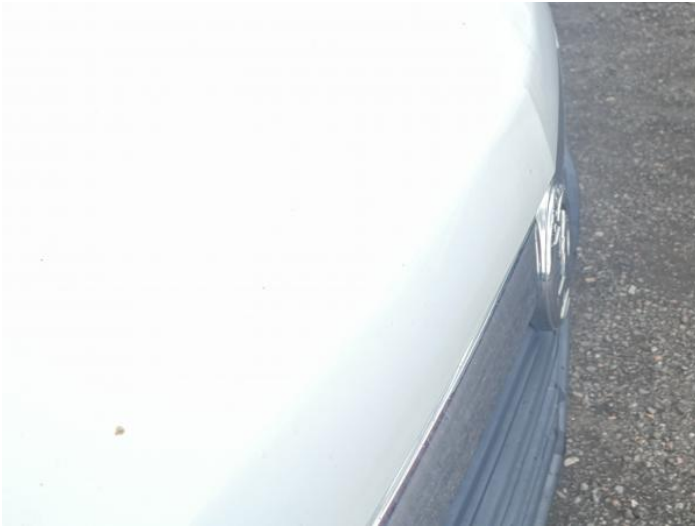
3: Bonnet
Dented
With Paint Damage

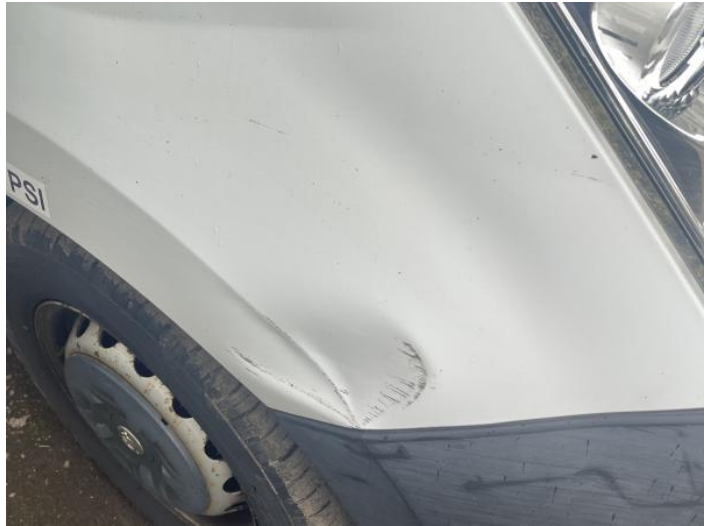
4: Wing osf
Dented
With Paint Damage

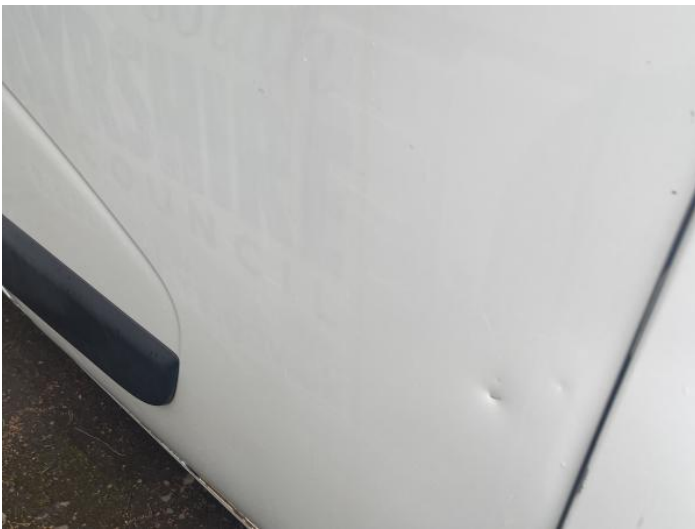
5: Door osf
Dented
With Paint Damage

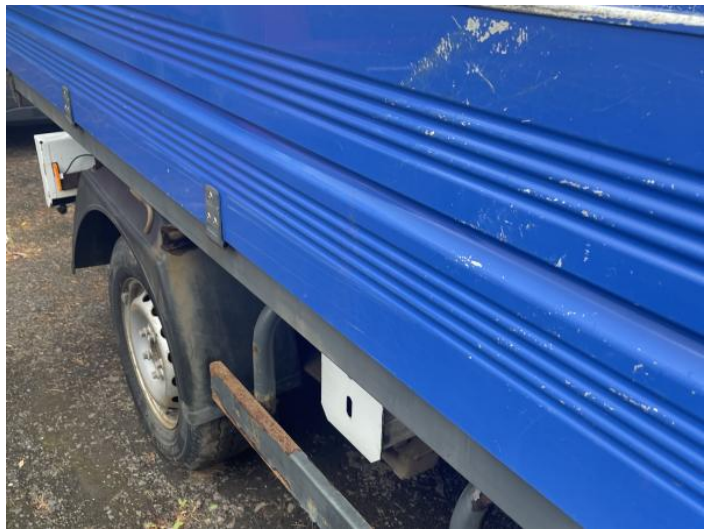
6: Qtr Panel osr
Dented
With Paint Damage

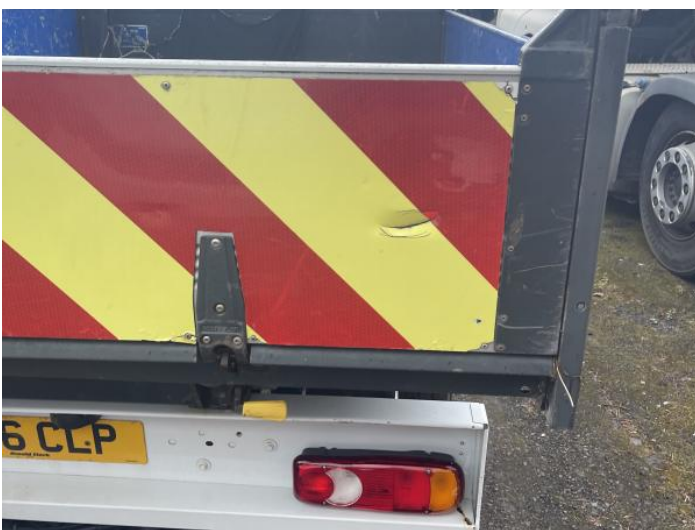
7: Tailgate
Dented
With Paint Damage

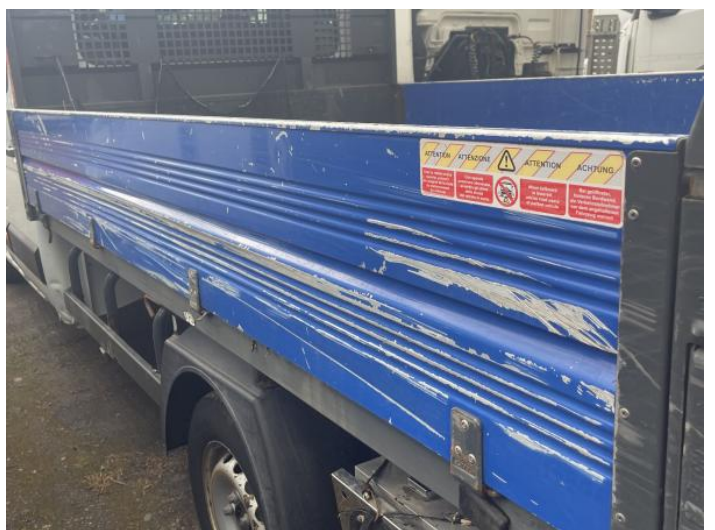
8: Qtr Panel nsr
Dented
With Paint Damage

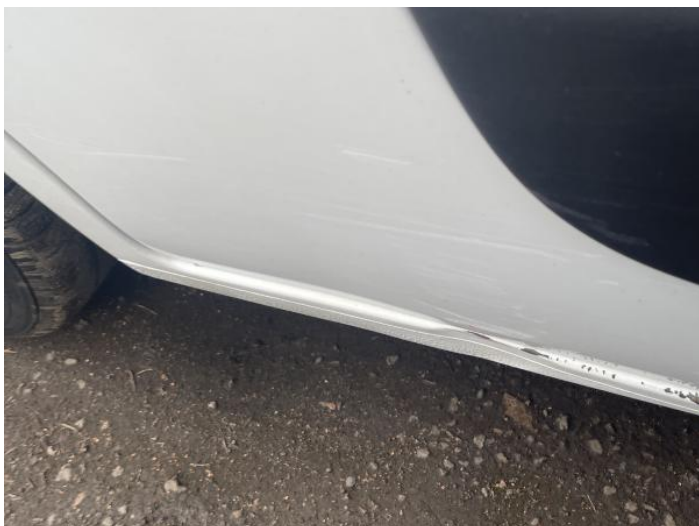
9: Door nsf
Dented
With Paint Damage

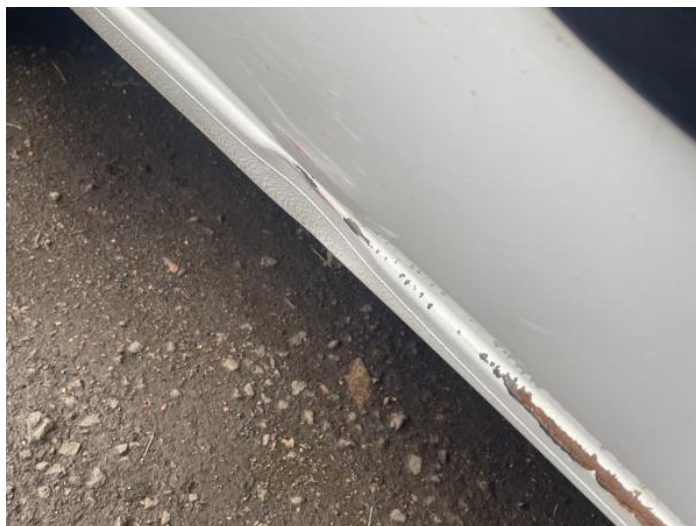
10: Sill ns
Dented
With Paint Damage

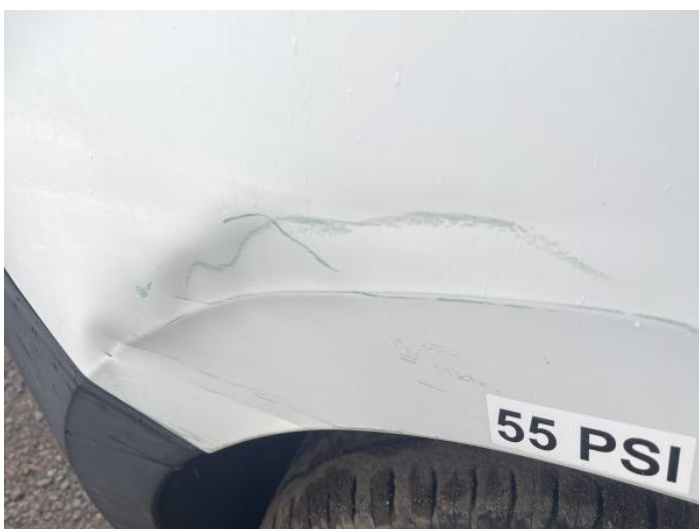
11: Wing nsf
Dented
With Paint Damage
