VEHICLE INSPECTION REPORT

SF16CMT

Vauxhall Movano 35 2.3 CDTi BiTurbo ecoFLEX 136ps

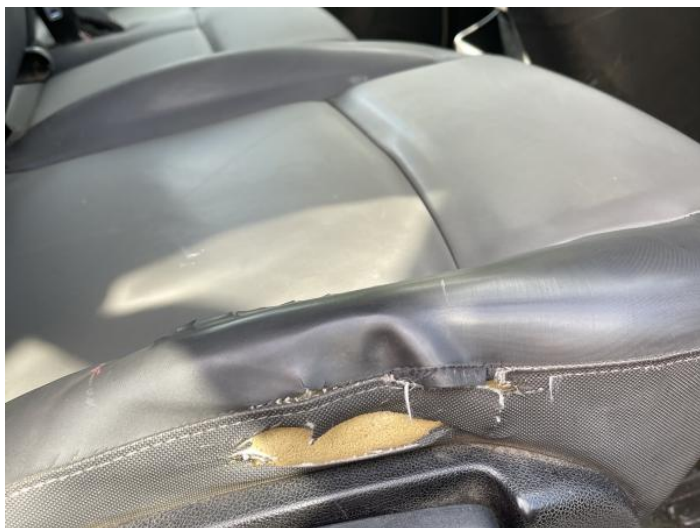
1: Seat Base Cover osf
Torn
Over 3mm

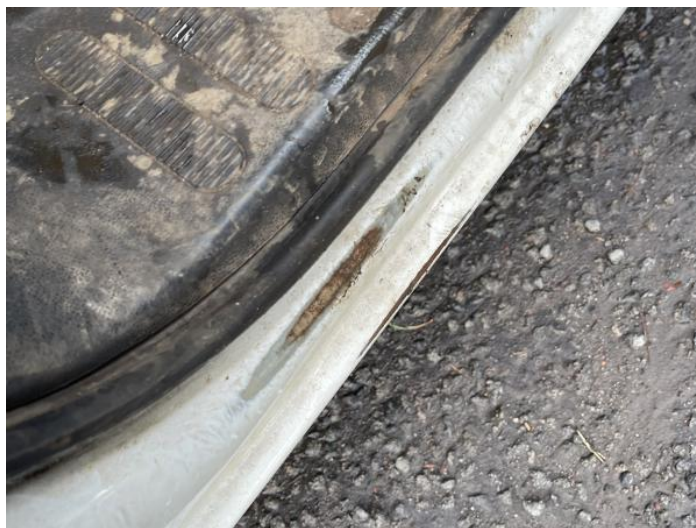
2: Sill os
Dented
Over 30mm

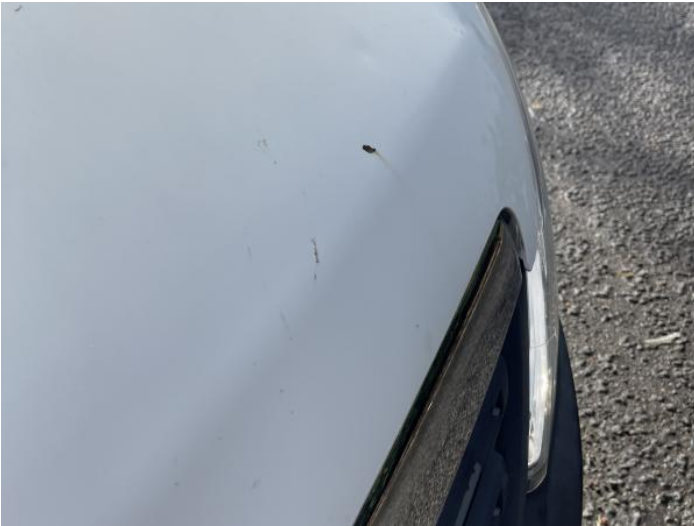
3: Bonnet
Dented
With Paint Damage

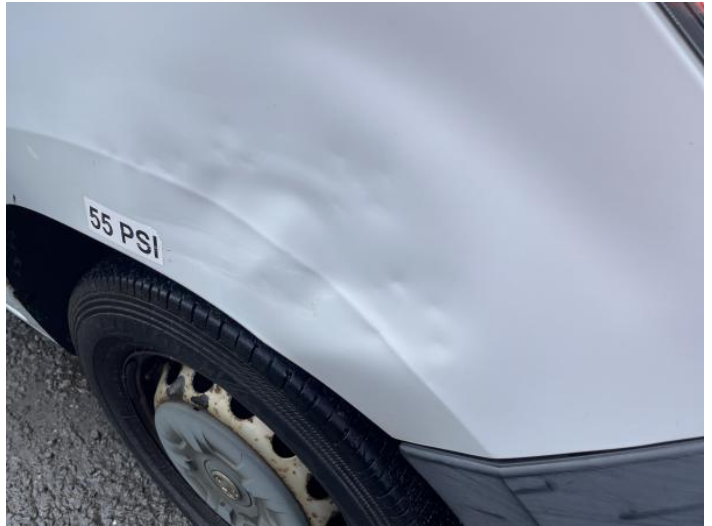
4: Wing osf
Dented
With Paint Damage

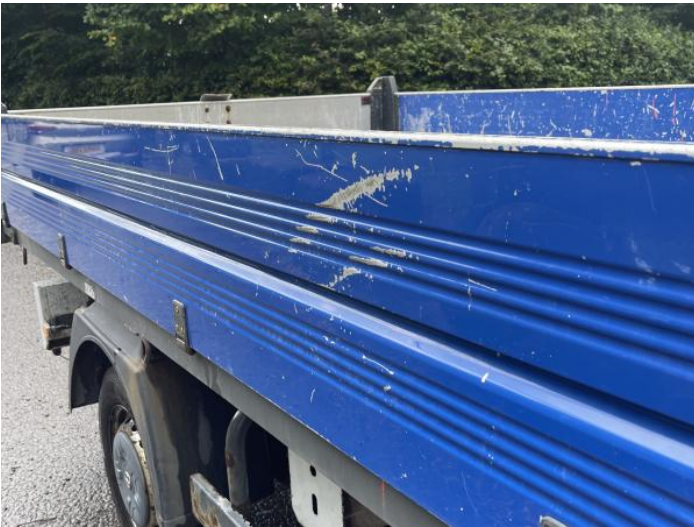
5: Qtr Panel osr
Dented
With Paint Damage

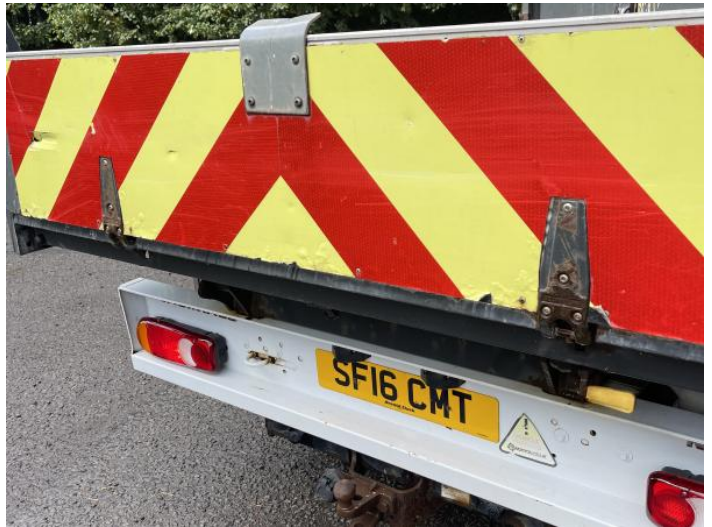
6: Tailgate
Dented
With Paint Damage

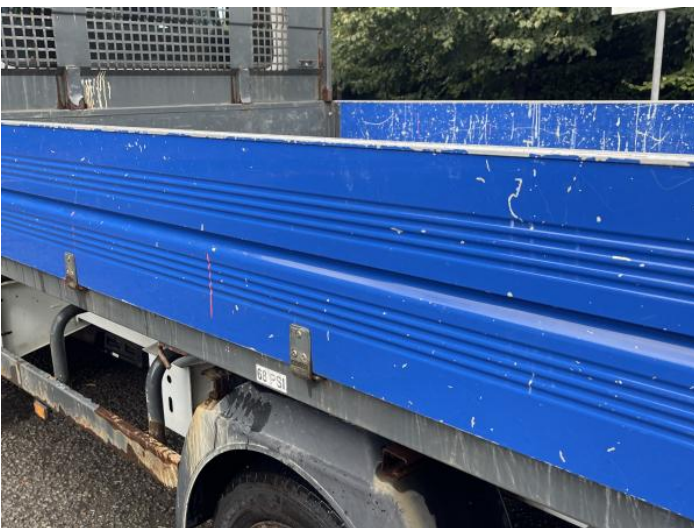
7: Qtr Panel nsr
Dented
With Paint Damage

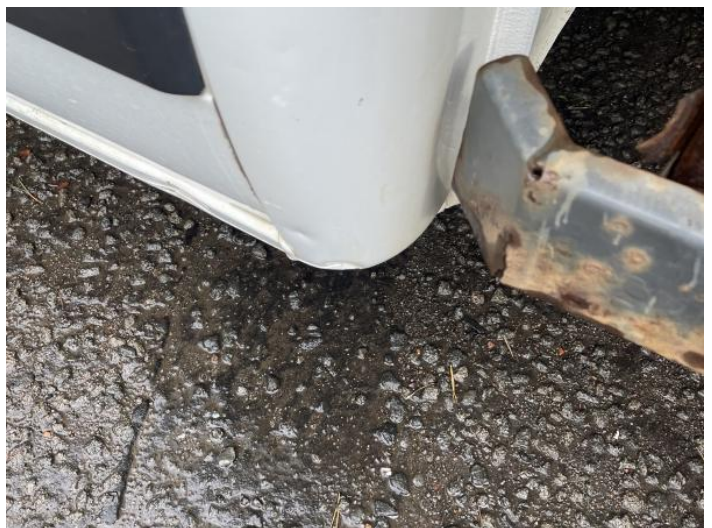
8: D Post ns
Dented
Over 30mm

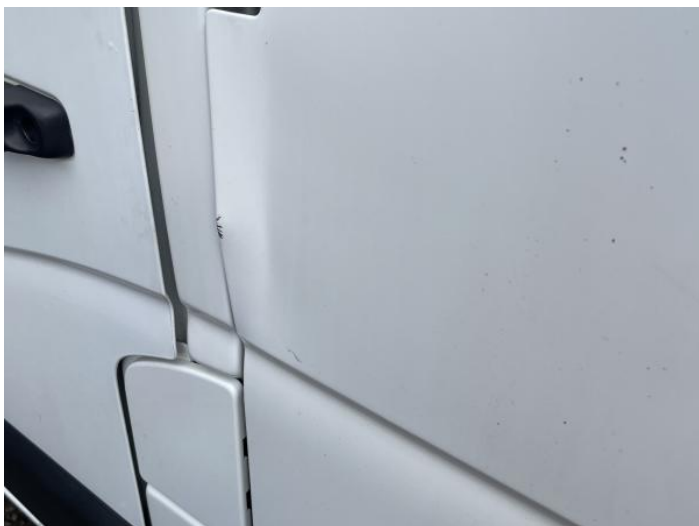
9: Door nsr
Dented
With Paint Damage

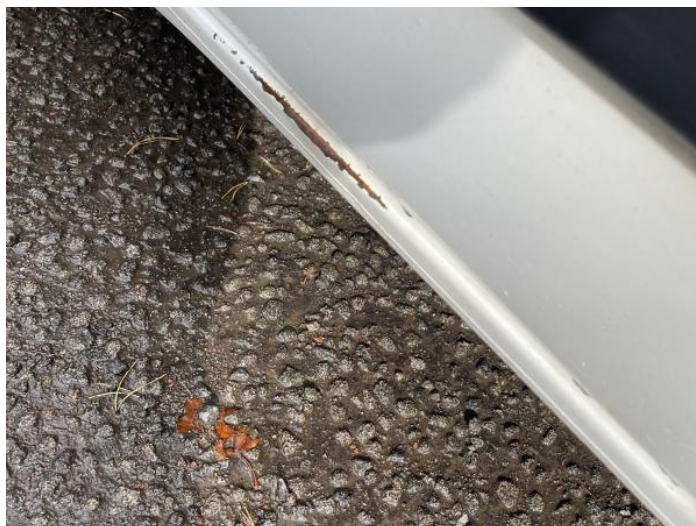
10: Sill ns
Rusted
Over 5mm

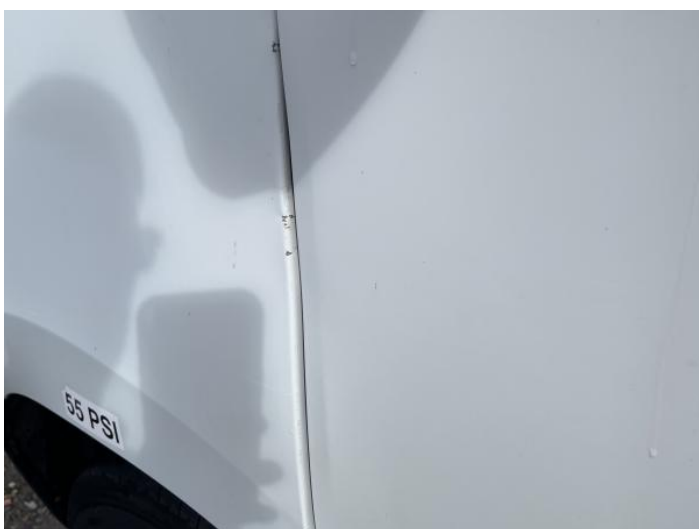
11: Door nsf
Dented
With Paint Damage

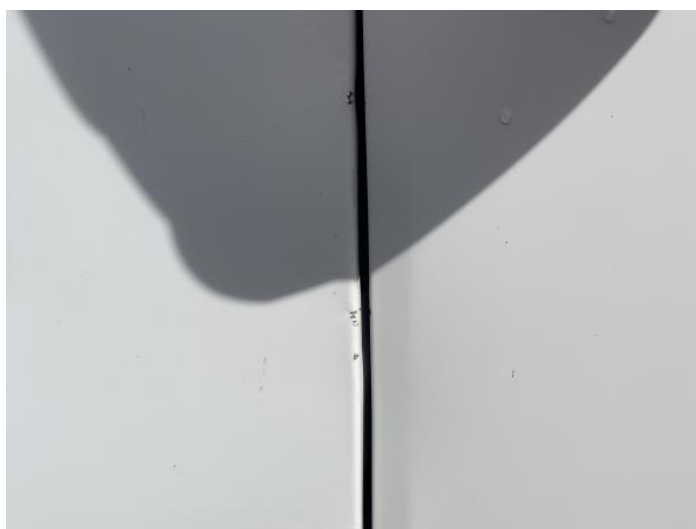
12: Wing nsf
Dented
Over 30mm
