VEHICLE INSPECTION REPORT

SF16CND

Vauxhall Movano 35 2.3 CDTI BiTurbo ecoFLEX H1 136ps

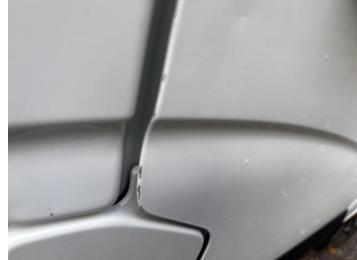
1: Door osf Chipped Edge Chip

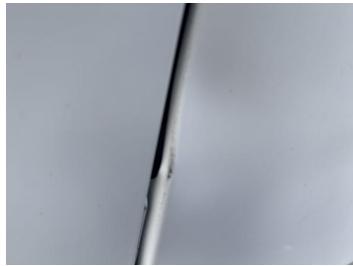
2: Wing osf Dented With Paint Damage

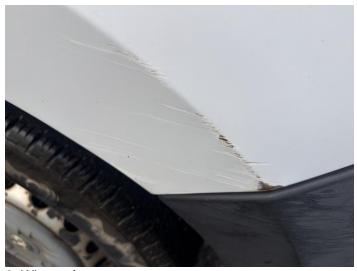
3: Wing osf Scratched Over 25mm Thru Paint

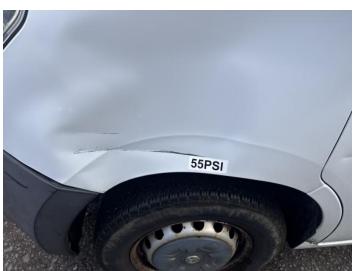
4: Wing nsf Dented With Paint Damage

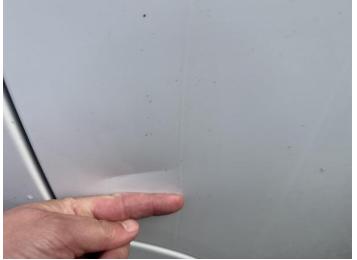
5: Door nsf Dented With Paint Damage

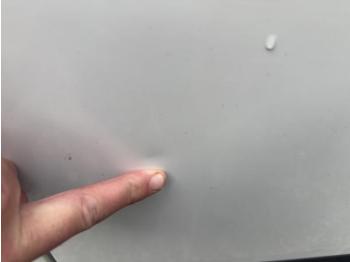
6: Door osr Dented Between 10mm + 30mm
