# VEHICLE INSPECTION REPORT

**PJ70DJK**

## Daf CF 370

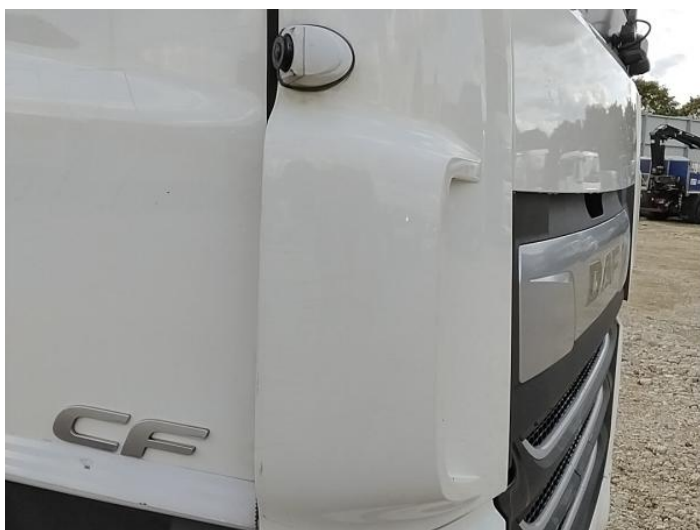
1: Wing osf  
Scratched  
UpTo 25mm Not Thru Paint

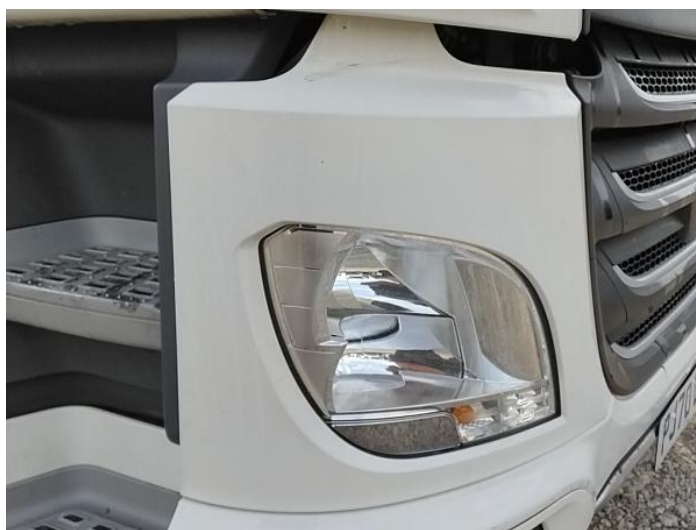
2: Fog Lamp Surround os  
Scratched (Painted)  
UpTo 25mm Not Thru Paint

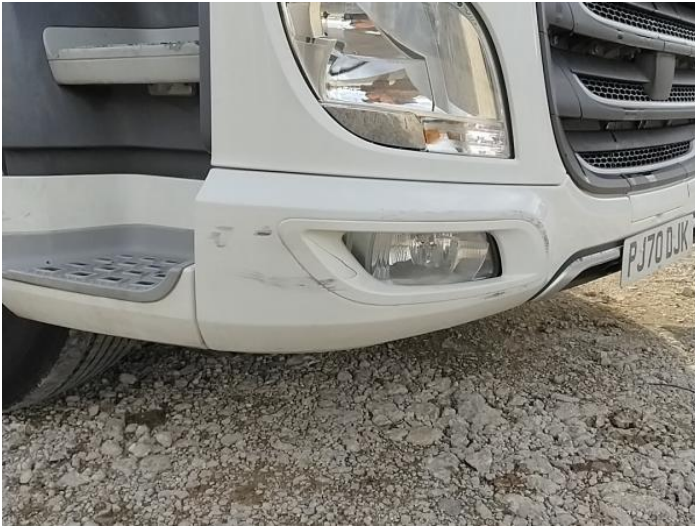
3: Bumper Front Moulding  
Scratched (Painted)  
Over 25mm Thru Paint

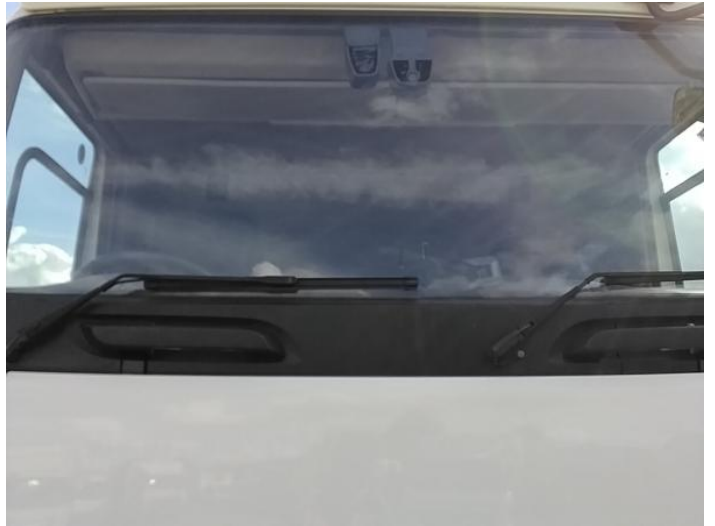
4: Screen Front  
Chipped  
Over 10mm

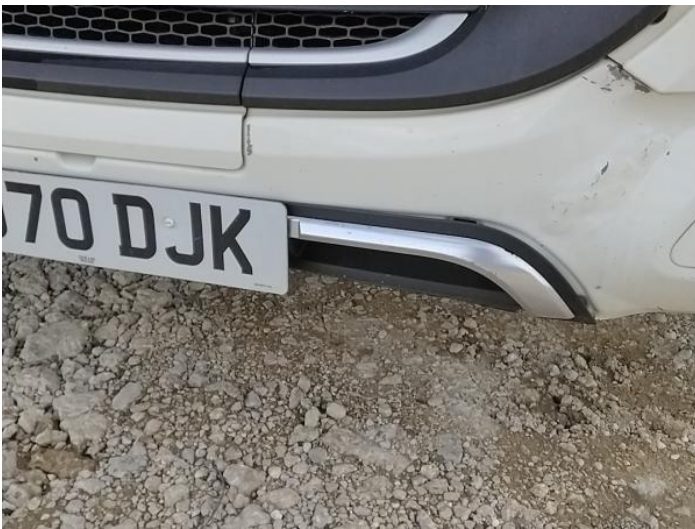
5: Grille Front  
Broken  
Replace

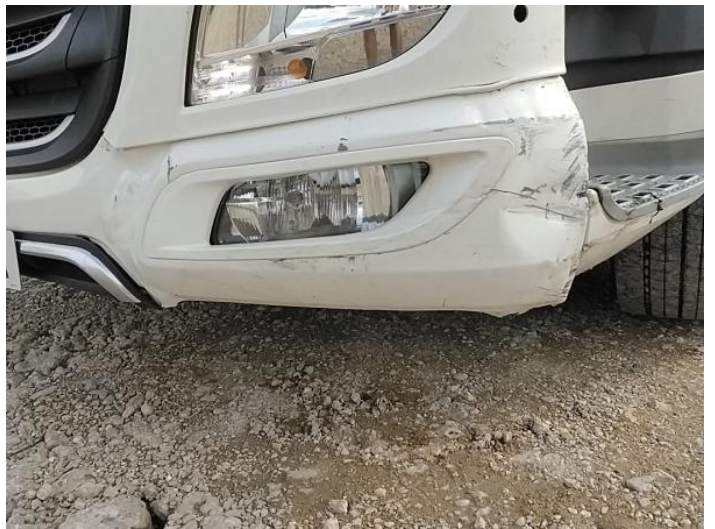
6: Bumper Front Moulding  
Broken  
Replace

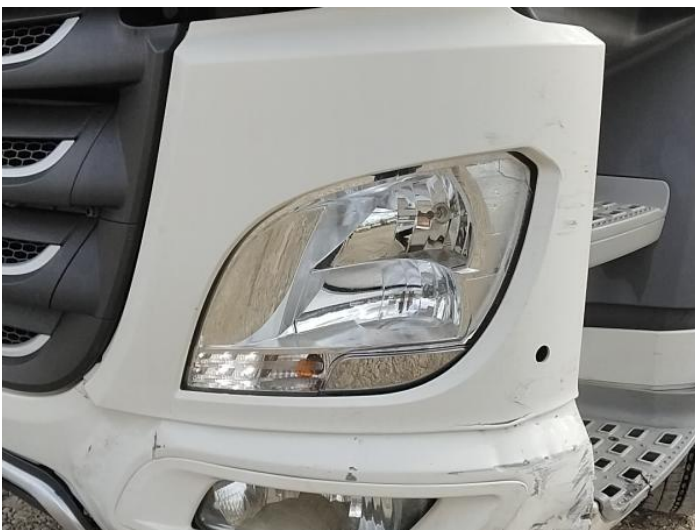
7: Fog Lamp Surrounds  
Scratched (Painted)  
UpTo 25mm Not Thru Paint

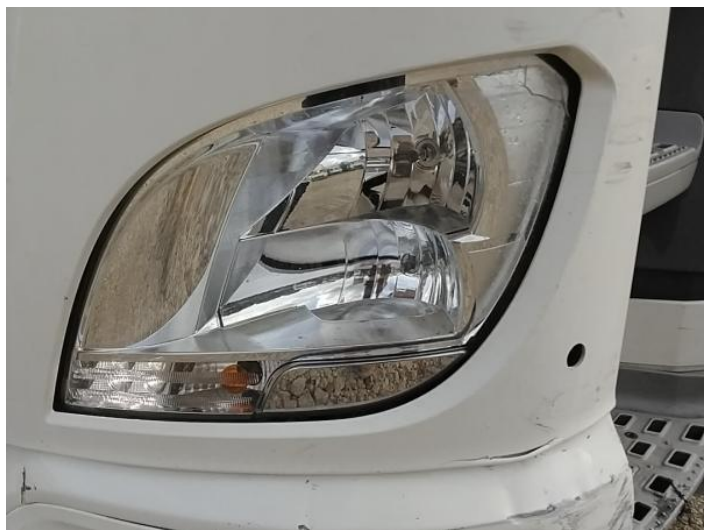
8: Headlamp  
Broken  
Replace

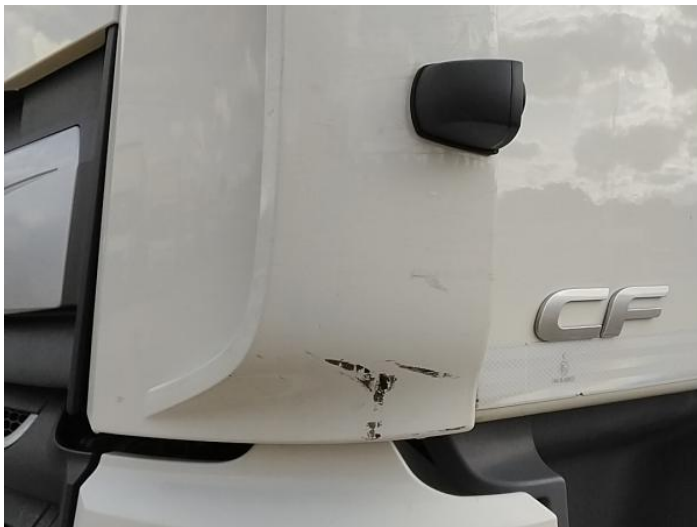
9: Wing nsf  
Scratched  
UpTo 25mm Not Thru Paint

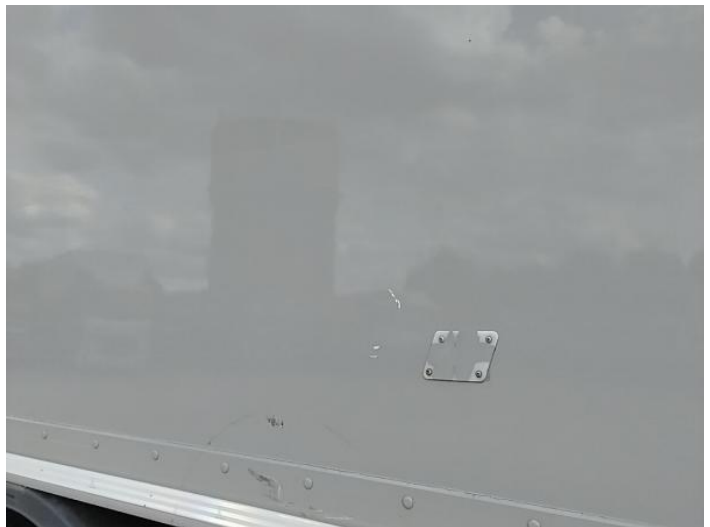
10: Qtr Panel nsr  
Scratched  
Over 25mm Thru Paint

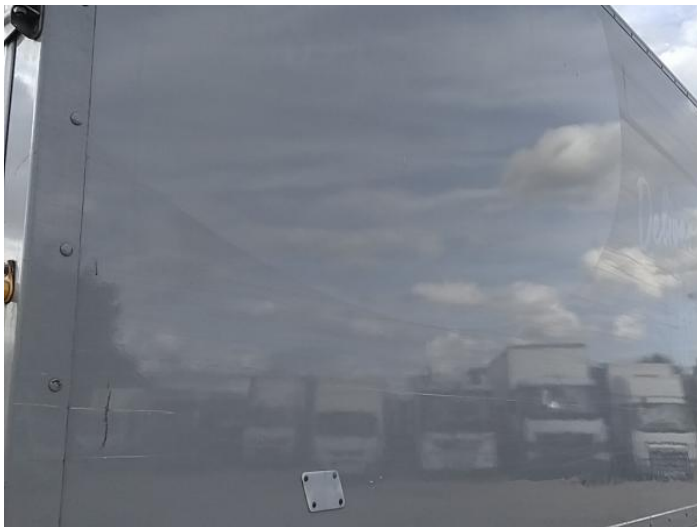
11: Qtr Panel osr  
Scratched  
Over 25mm Thru Paint

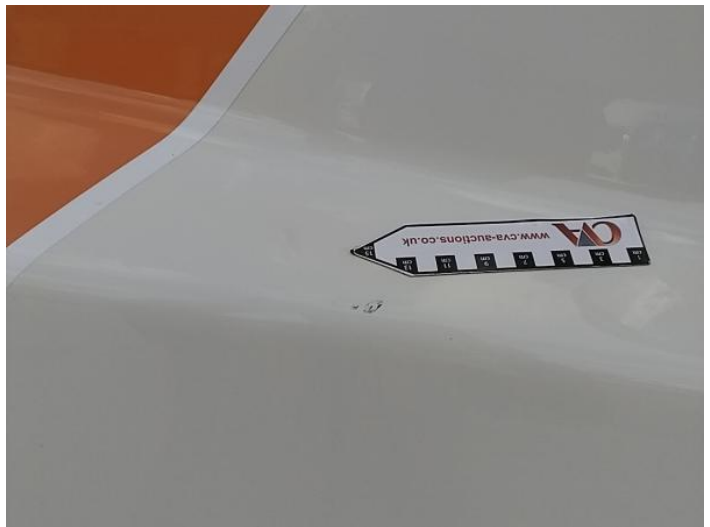
12: Door osf  
Dented  
Over 2 UpTo 10mm

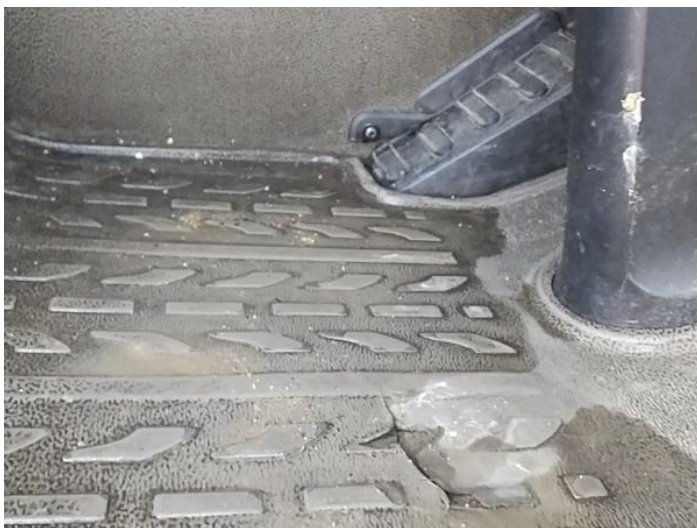
13: Carpets Front  
Holed  
Over 3mm

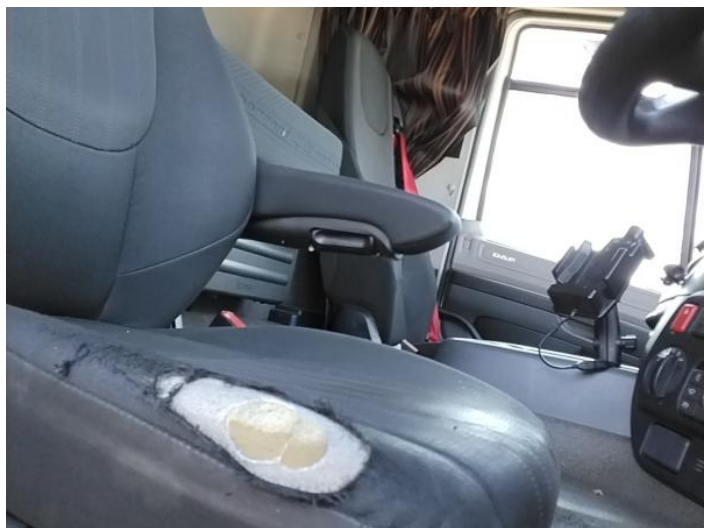
14: Seat Base Cover osf  
Holed  
Over 3mm
