# VEHICLE INSPECTION REPORT

**DW19UGK**

## Daf LF 180

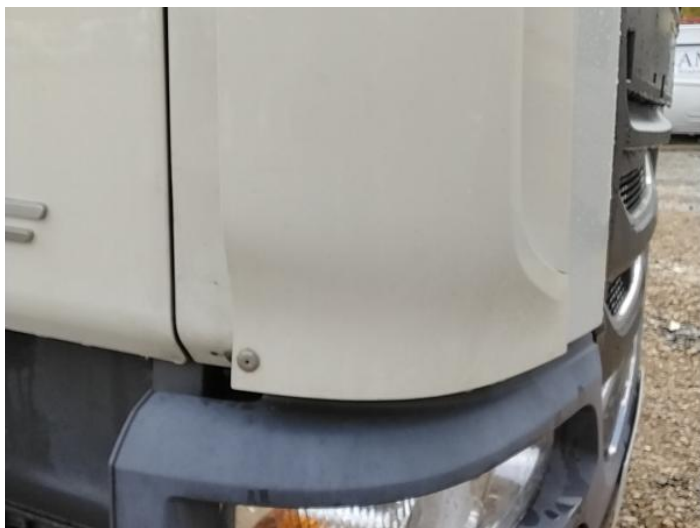
1: Wing osf  
Poor Previous Repair  
Poor Colour

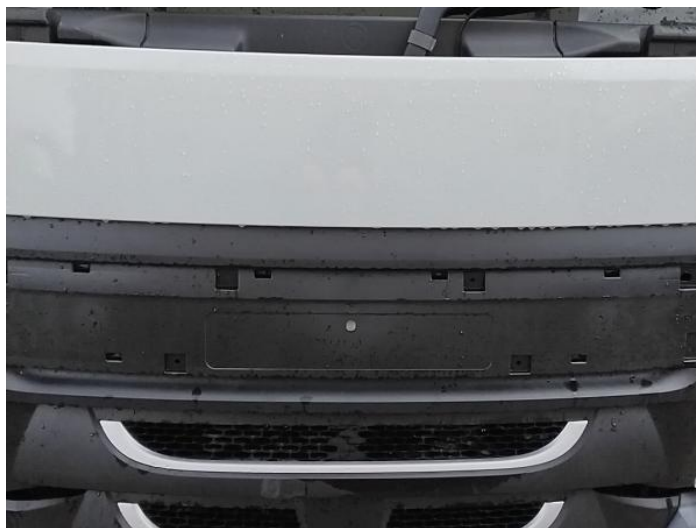
2: Badgedecal Front  
Missing  
Replace

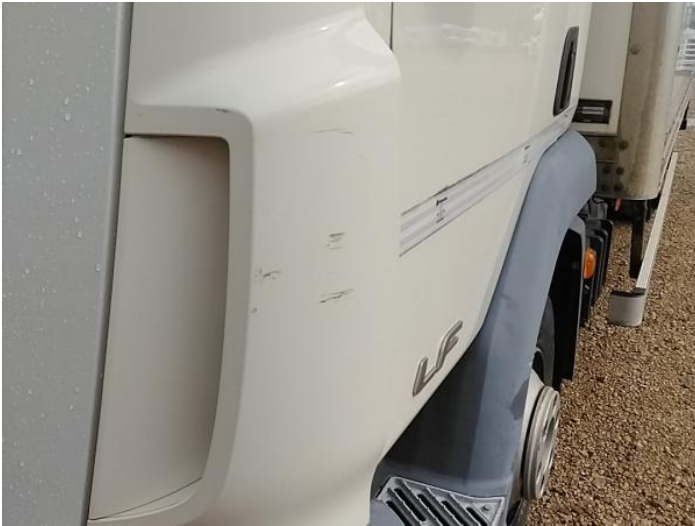
3: Wing nsf  
 Scratched  
 Over 25mm Thru Paint

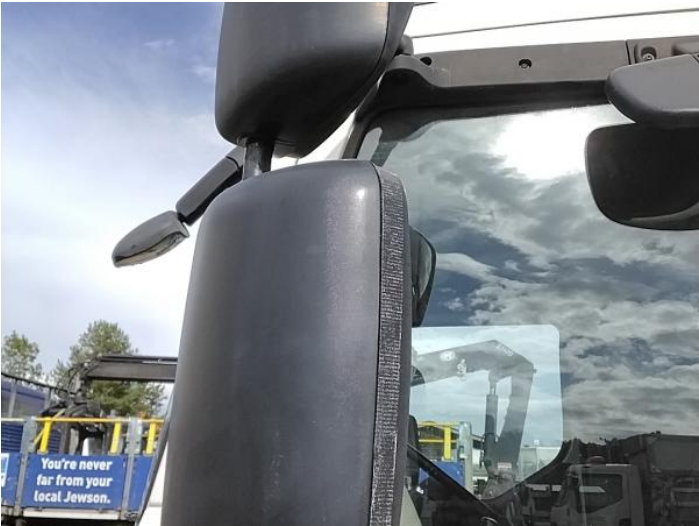
4: Door Mirror Assy nsf  
 Scuffed (Unpainted)  
 UpTo 100mm

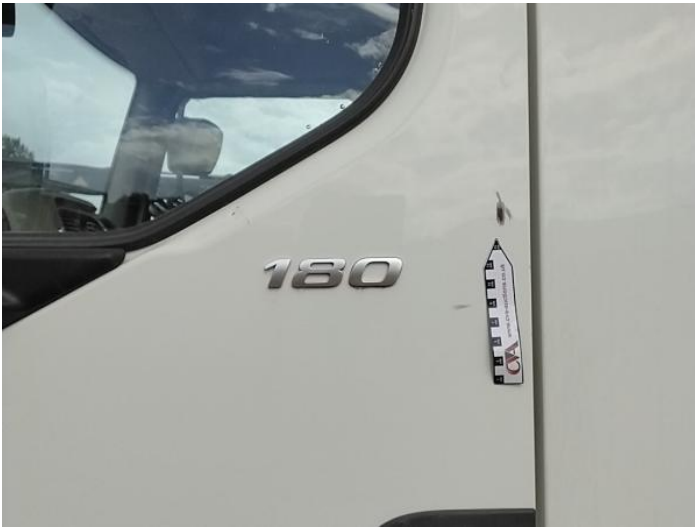
5: Door nsf  
 Scratched  
 UpTo 25mm Thru Paint

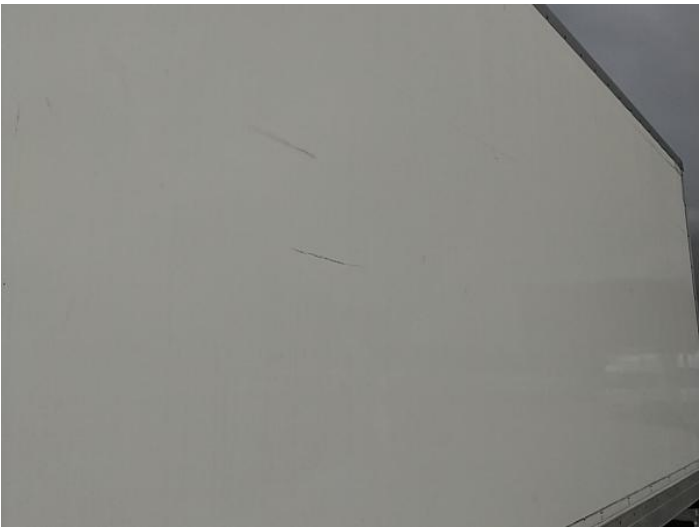
8: Qtr Panel nsr  
 Scratched  
 Over 25mm Not Thru Paint

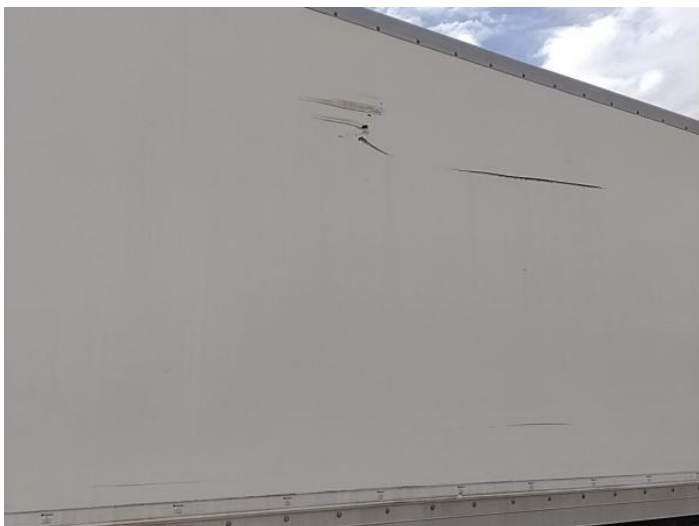
9: Qtr Panel osr  
 Scratched  
 Over 25mm Not Thru Paint

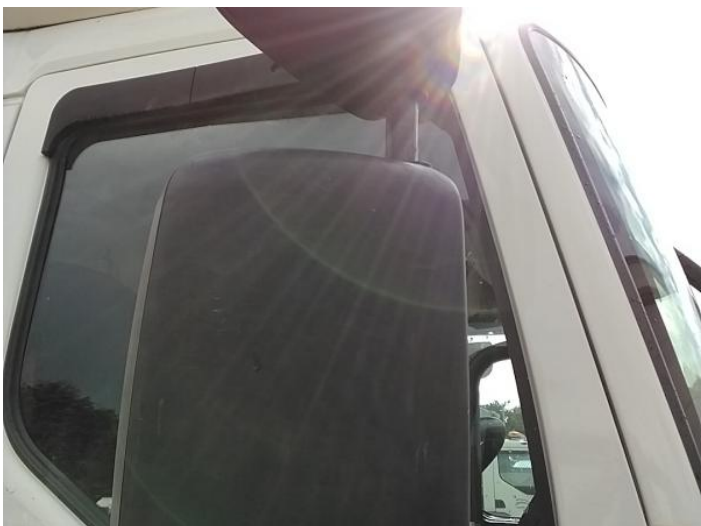
10: Door Mirror Assy osf  
 Scuffed (Unpainted)  
 UpTo 100mm

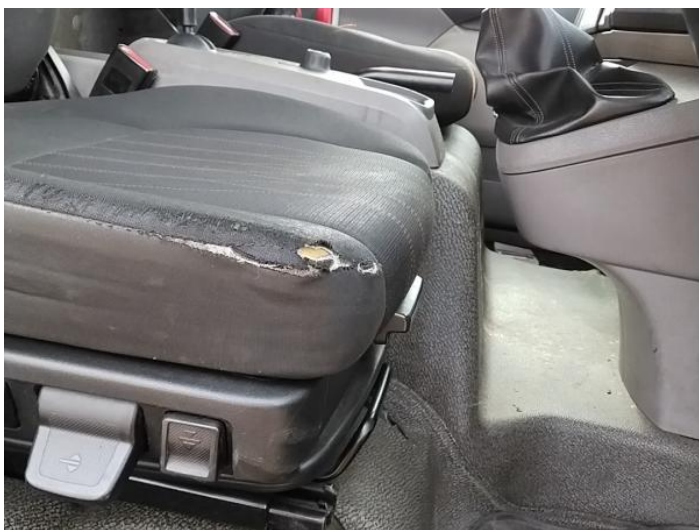
11: Seat Base Cover osf  
 Holed  
 Over 3mm
