VEHICLE INSPECTION REPORT

SH71GHX

Fiat Doblo CARGO 16V 1.6 MULTIJET

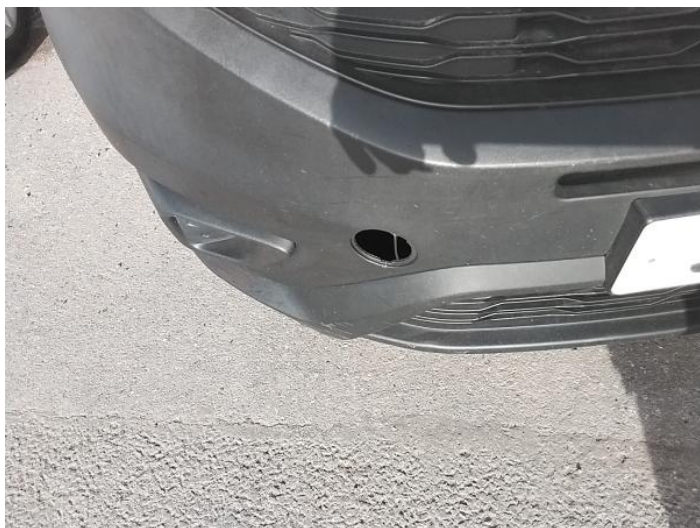
1: Bumper Front Moulding
Missing
Replace

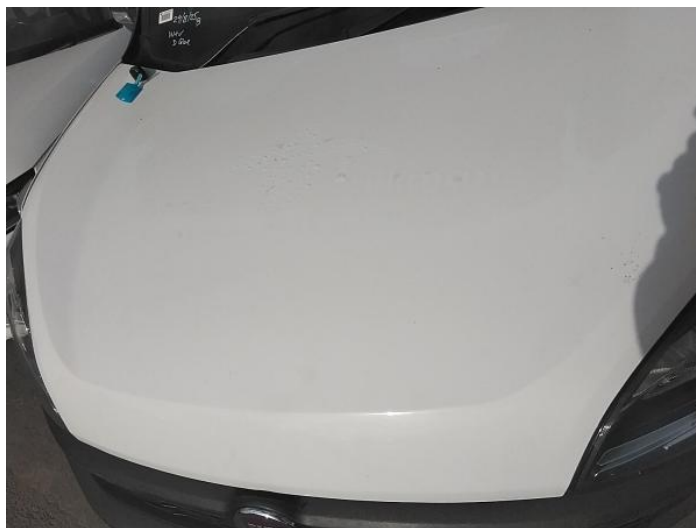
2: Bonnet
Chipped
Multiple Chips

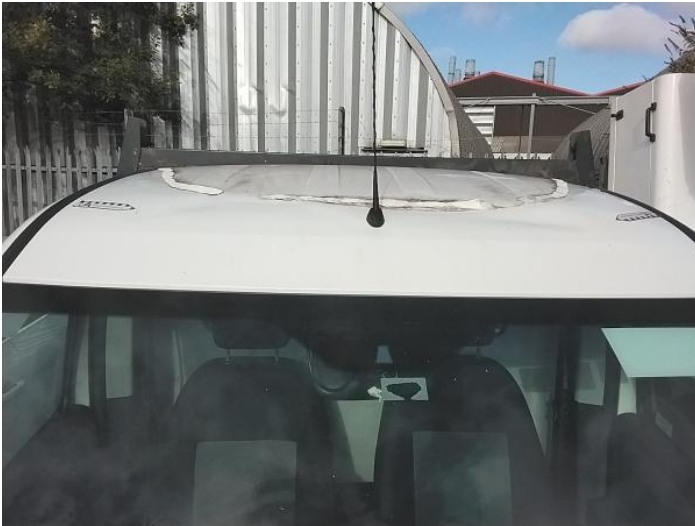
3: Roof
Dented
Over 30mm

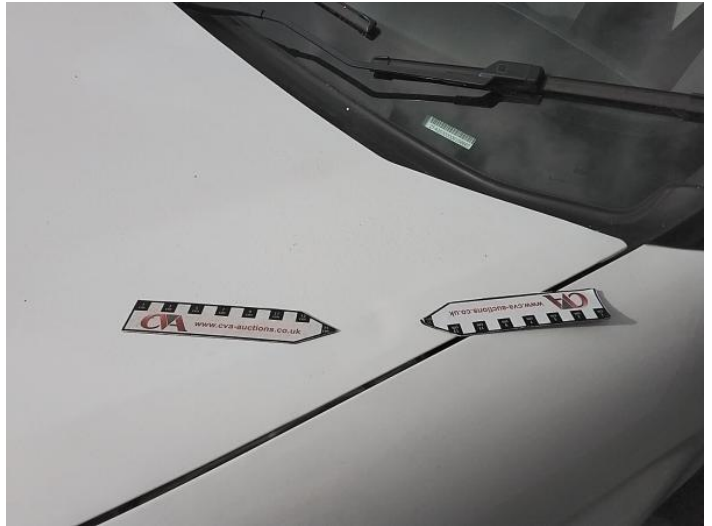
4: Bonnet
Dented
Over 30mm

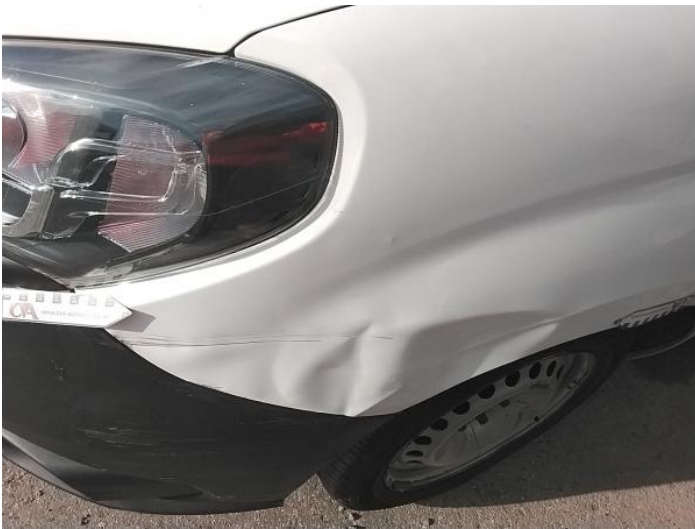
5: Wing nsf
Dented
With Paint Damage

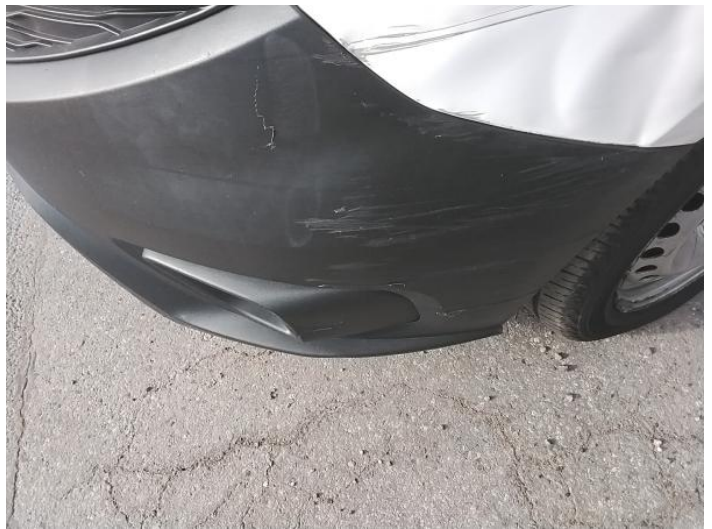
6: Bumper Front
Scratched
Over 100mm Thru Paint

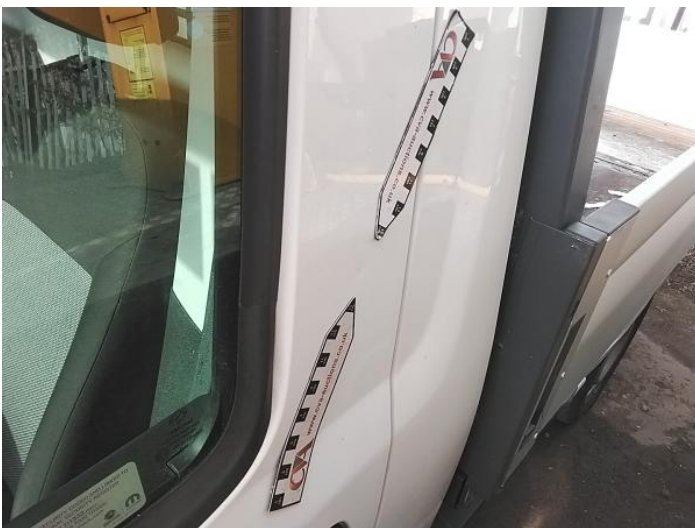
7: Door nsf
Dented
Over 30mm

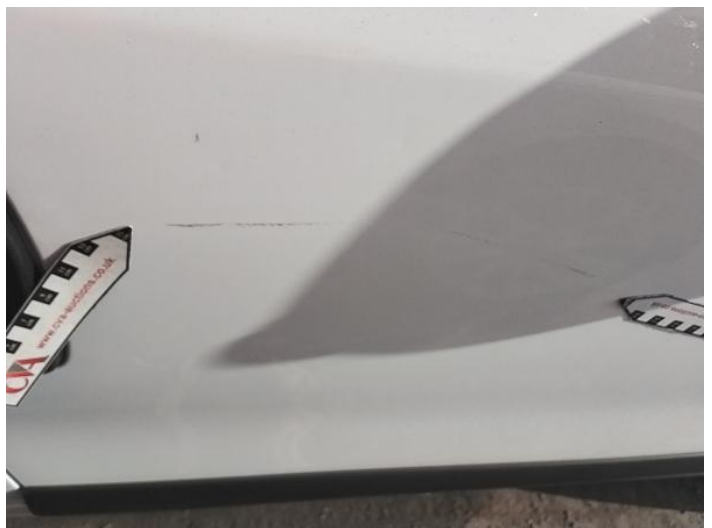
8: Door osf
Scratched
Over 25mm Thru Paint

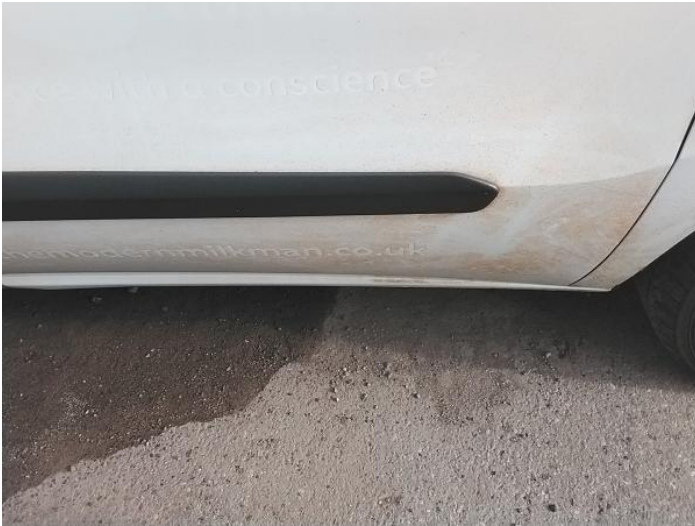
9: Door osf
Chipped
Multiple Chips

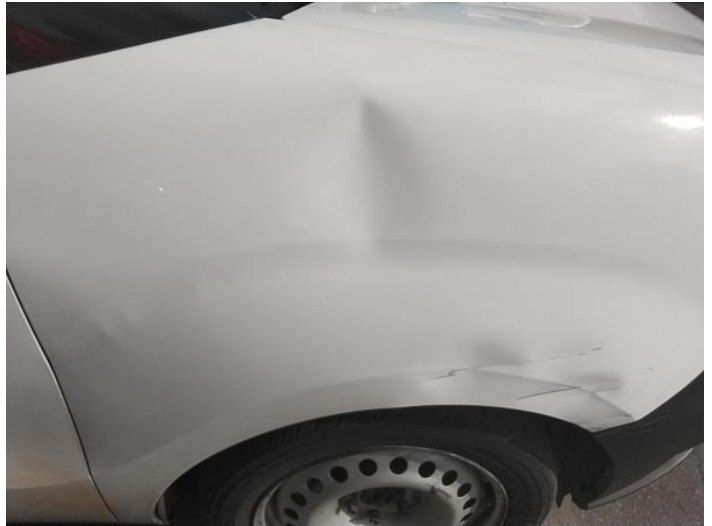
10: Wing osf
Dented
Over 30% Of Panel

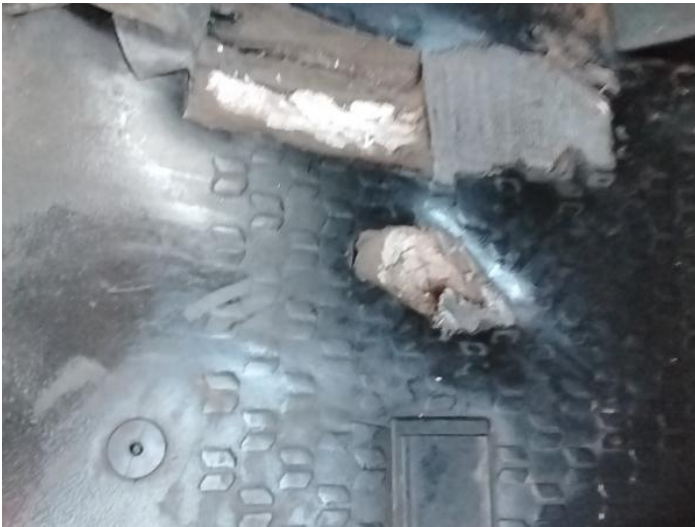
11: Carpets Front
Holed
Over 3mm

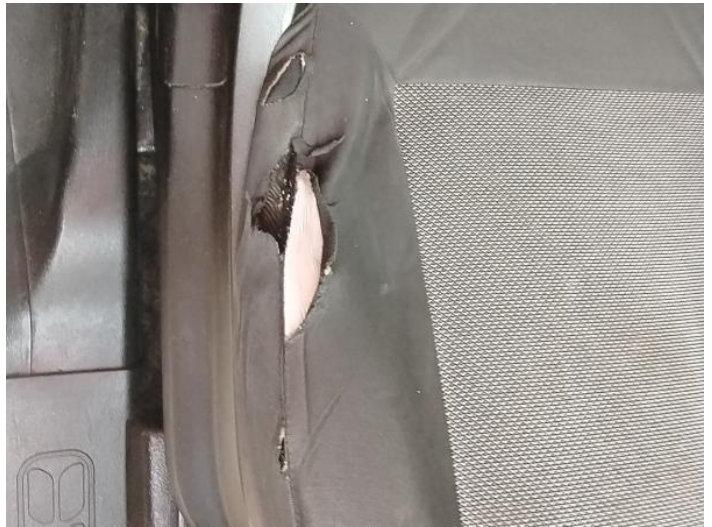
12: Seat Base Cover osf
Torn
Over 3mm

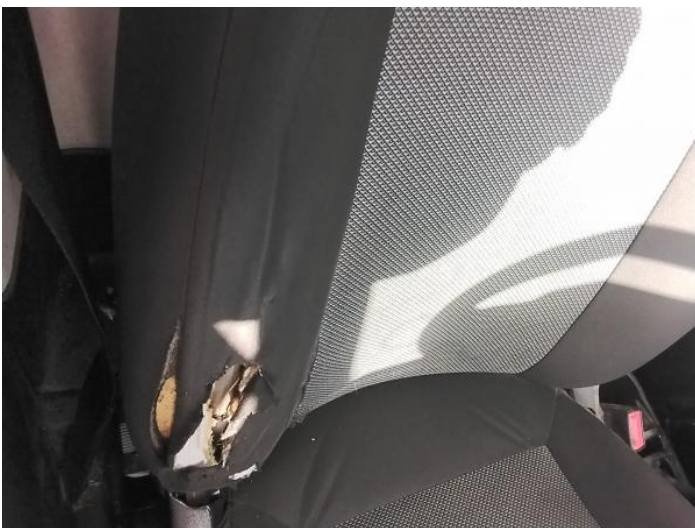
13: Seat Back Cover osf
Holed
Over 3mm

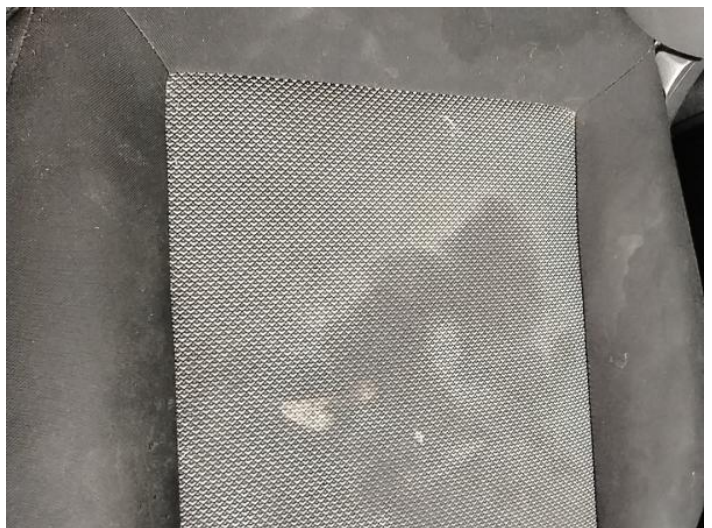
14: Seat Base Cover nsf
Soiled
Heavy

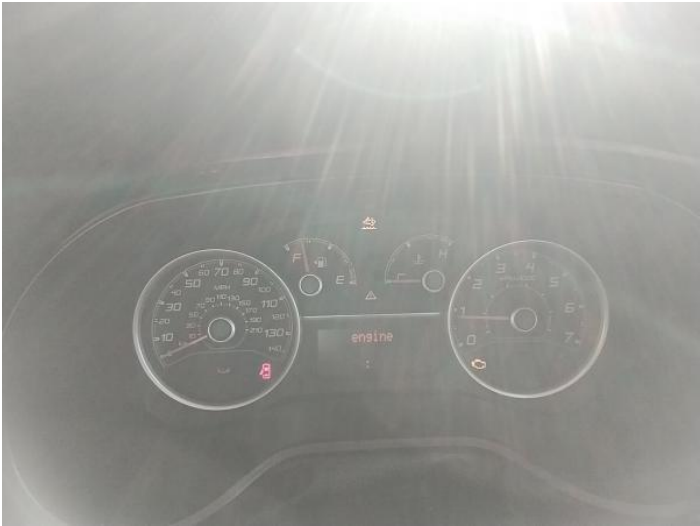
WARNING LIGHT ON DASH AD-BLUE

15: Dash Warning Lights
Displayed
No Action

Carpet Condition		Poor	Upholstery Condition		OK
Seat Condition		Poor	Odour		No
Engine Runs		OK	No Excessive Smoking		OK
EML light illuminated		Fault	DPF light illuminated		Fault
ABS light illuminated		OK

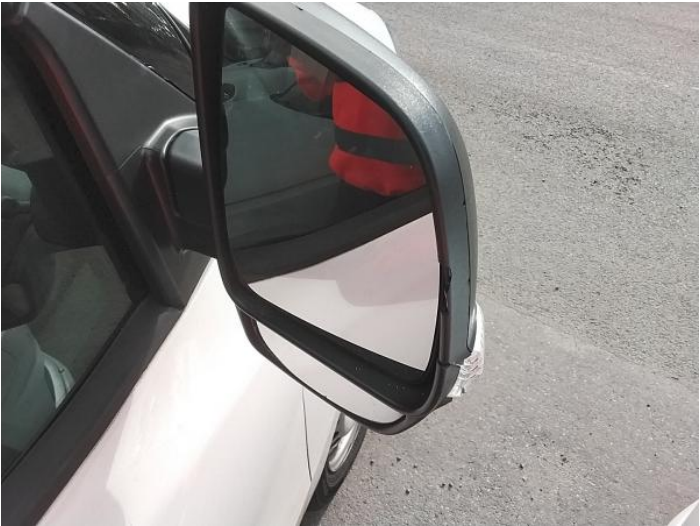
16: Door Mirror Assy osf
Broken
Replace
