# VEHICLE INSPECTION REPORT

**SH71GHB**

## FIAT DOBLO CARGO 16V 1.6 Multijet

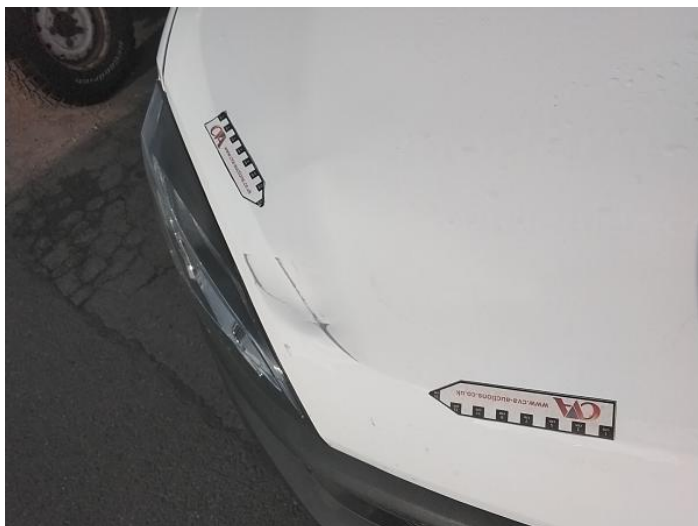
1: Bonnet  
Dented  
With Paint Damage

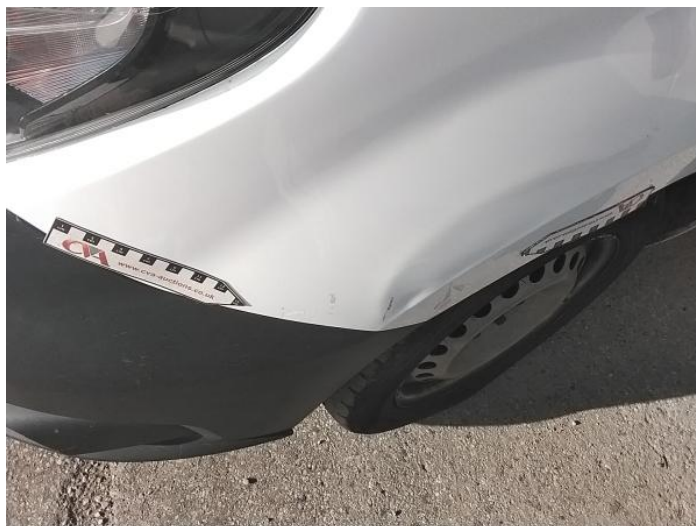
2: Wing nsf  
Dented  
With Paint Damage

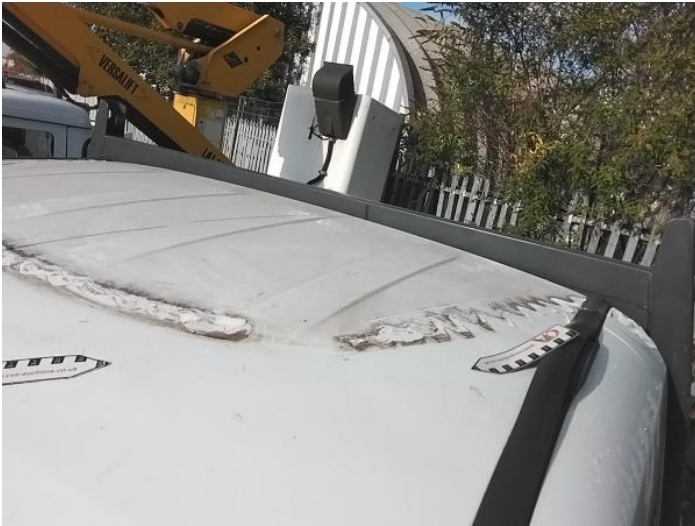
3: Roof  
Dented  
Over 30mm

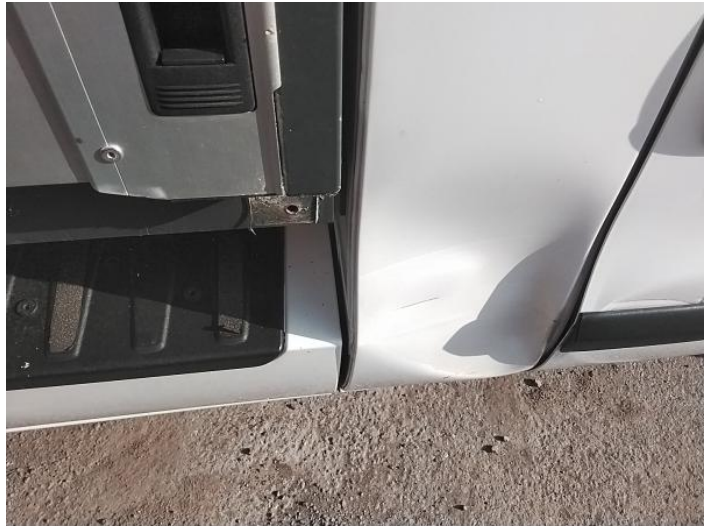
4: B Post os  
Dented  
Over 30% Of Panel

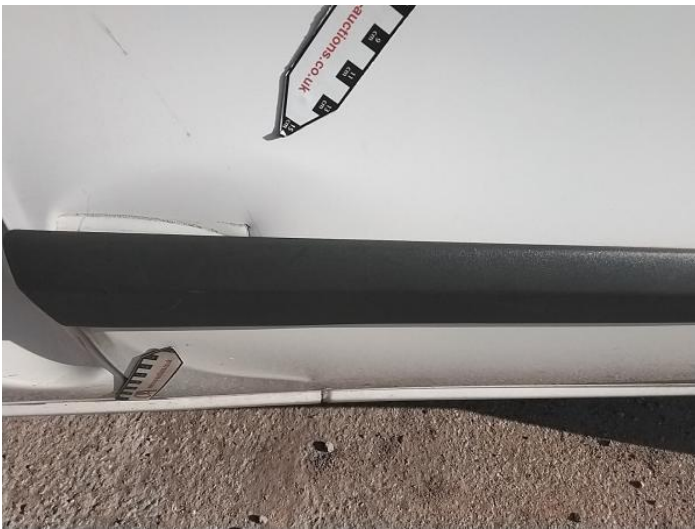
5: Door osf  
Dented  
With Paint Damage

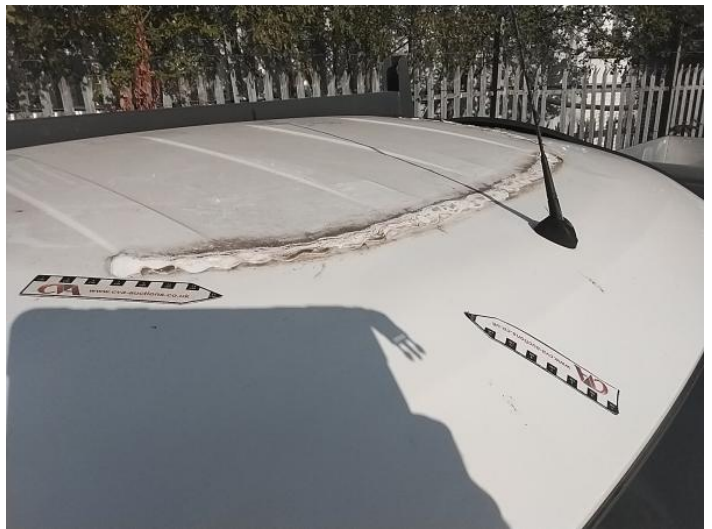
6: Roof  
Dented  
Over 30mm

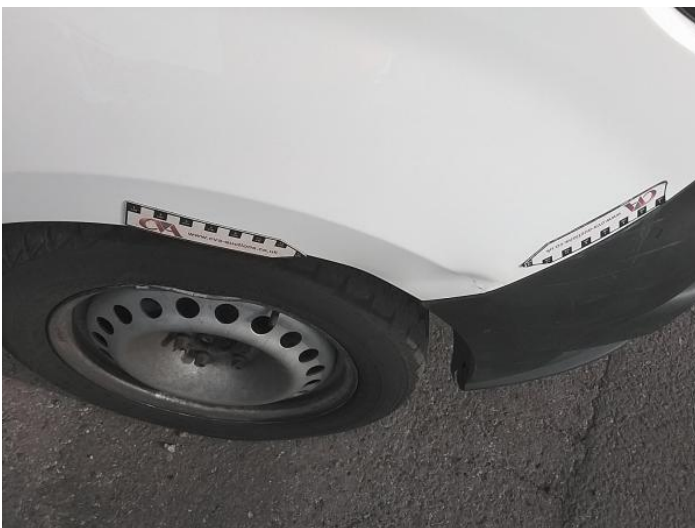
7: Wing osf  
Dented  
Over 30mm

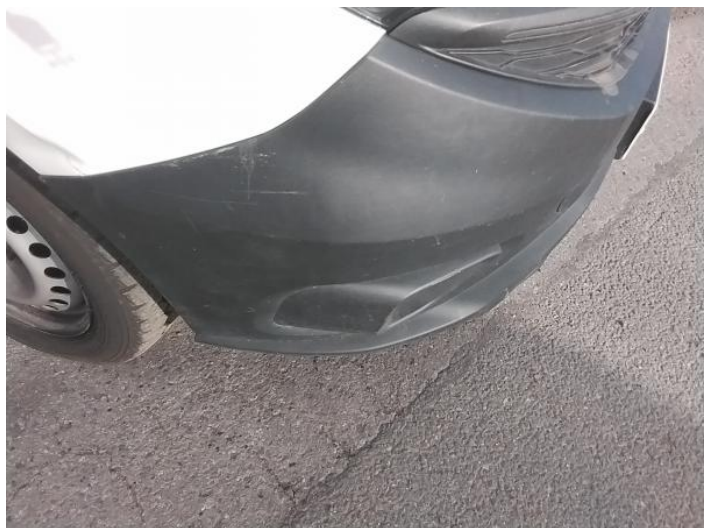
8: Bumper Front  
Scratched  
Over 100mm Thru Paint

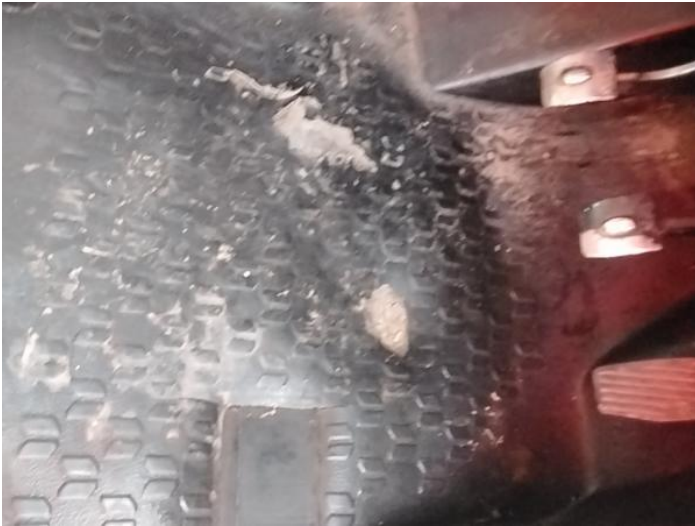
9: Carpets Front  
Holed  
Over 3mm

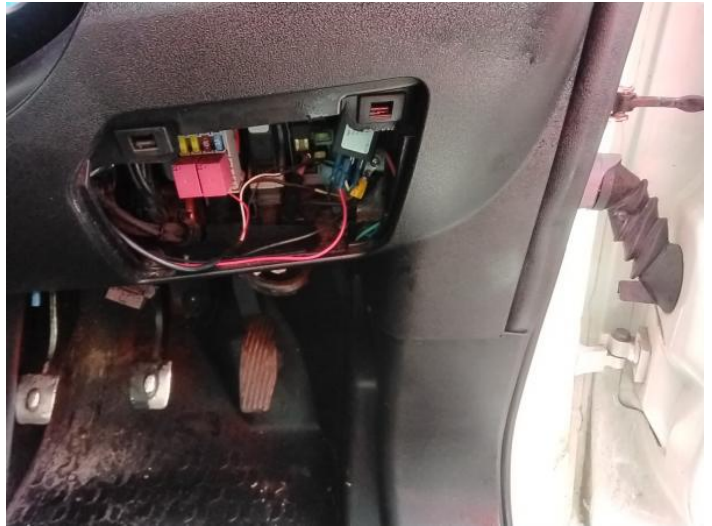
10: Fascia Panel  
Missing  
Replace

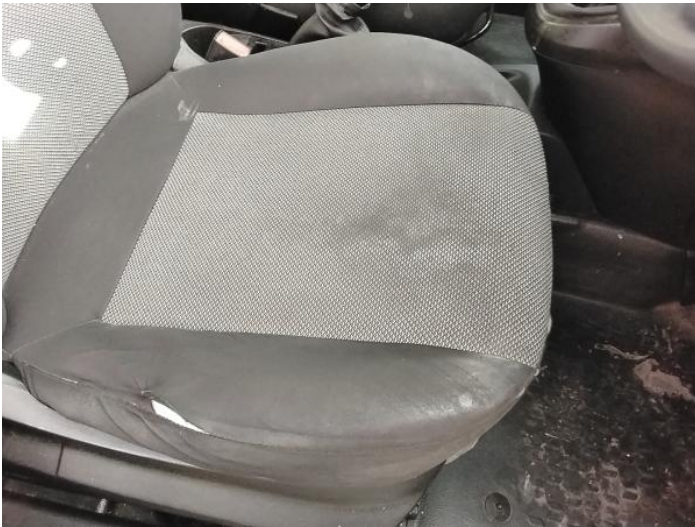
11: Seat Base Cover osf  
Torn  
Over 3mm

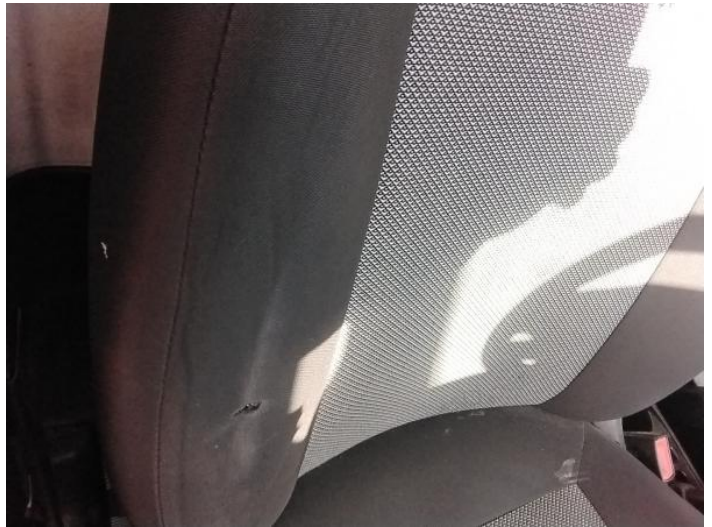
12: Seat Back Cover osf  
Holed  
Over 3mm

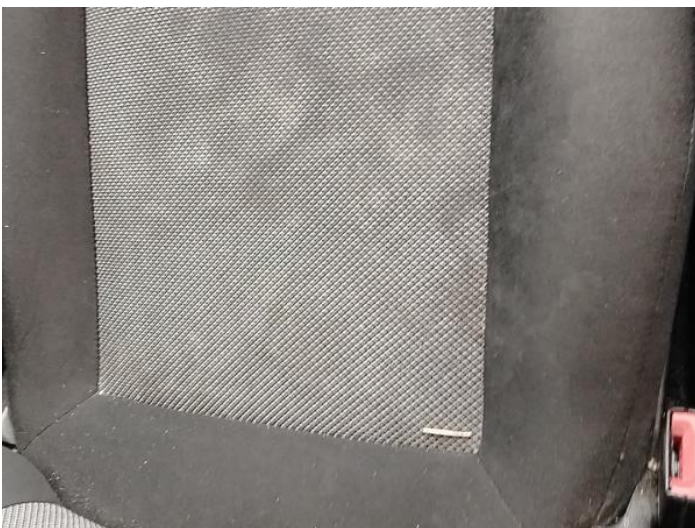
13: Seat Base Cover nsf  
Soiled  
Heavy

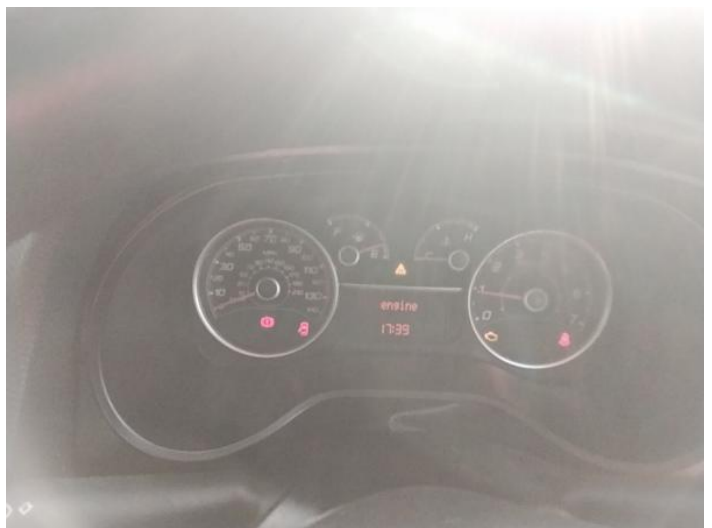
14: Dash Warning Lights  
Displayed  
No Action

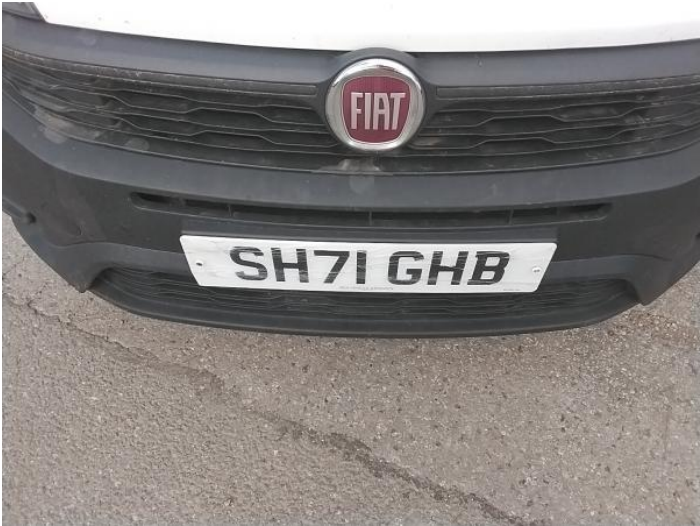
15: Number Plate Front  
Broken  
Replace
