VEHICLE INSPECTION REPORT

PO13DZK

Daf LF 45.140

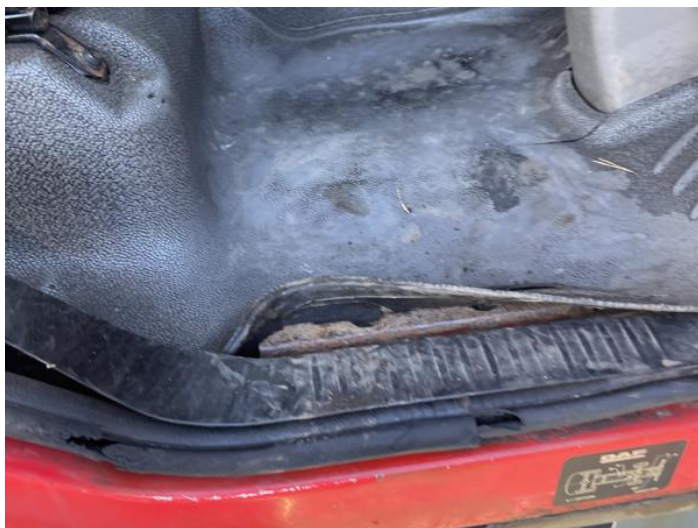
1: Carpets Front
Holed
Over 3mm

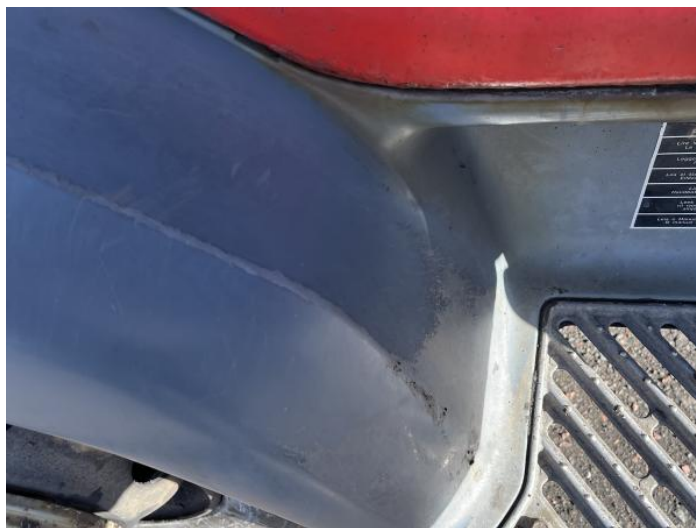
2: Door Moulding osf
Scuffed (Unpainted)
Over 100mm

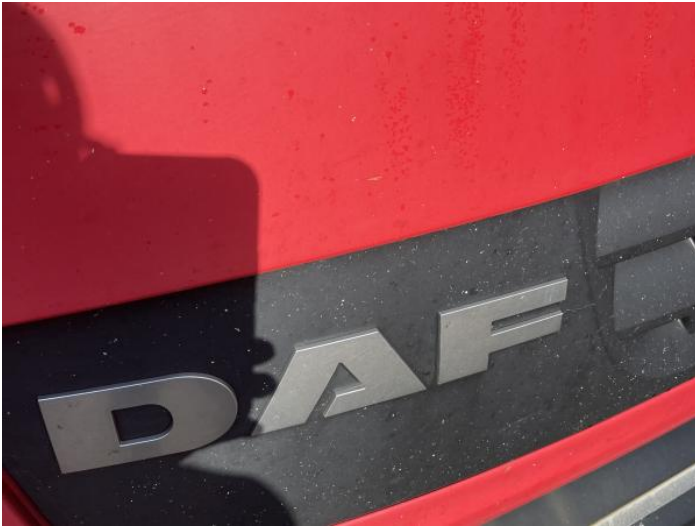
3: Bonnet
Chipped
Multiple Chips

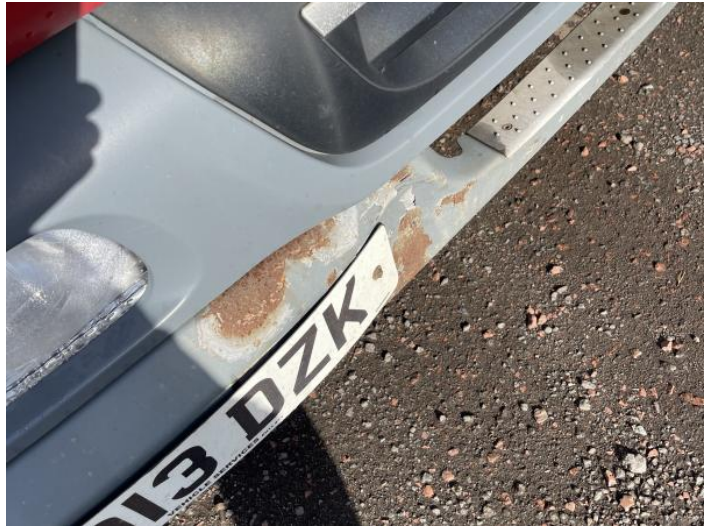
4: Bumper Front
Rusted
Over 5mm

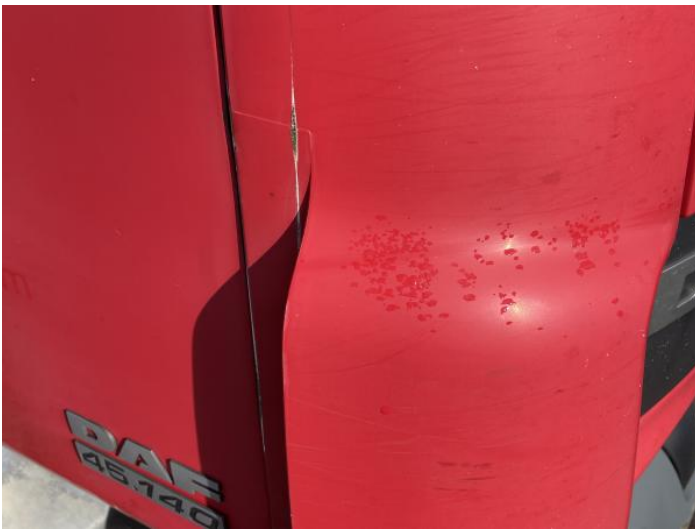
5: Wing osf
Dented
With Paint Damage

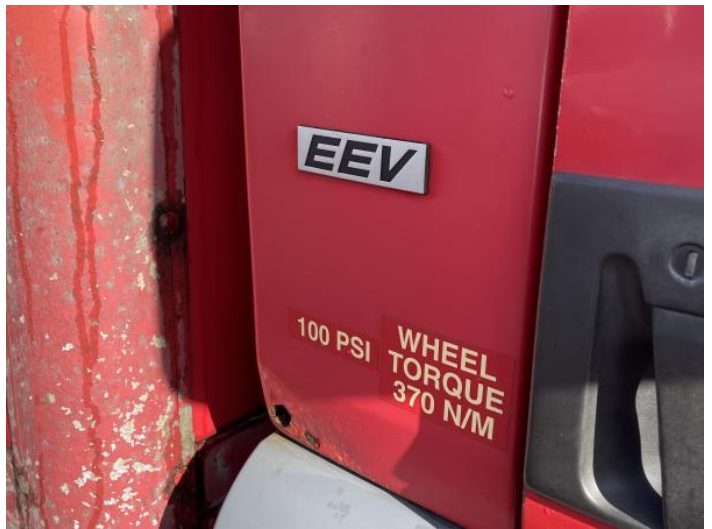
6: B Post os
Hole
UpTo 10mm

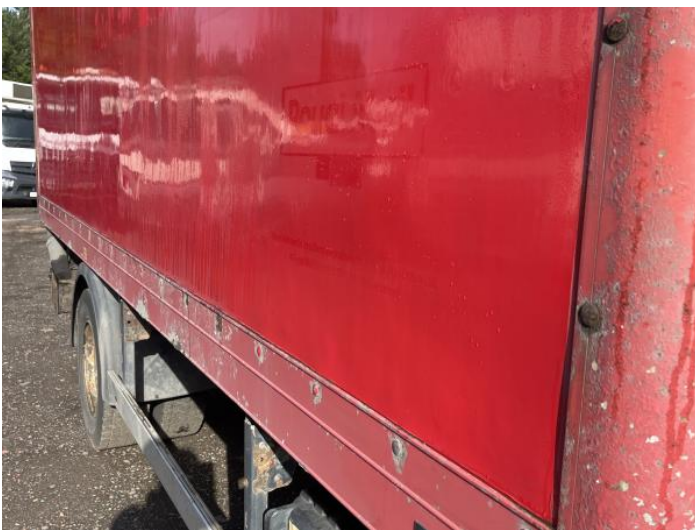
7: Qtr Panel osr
Rusted
Over 5mm

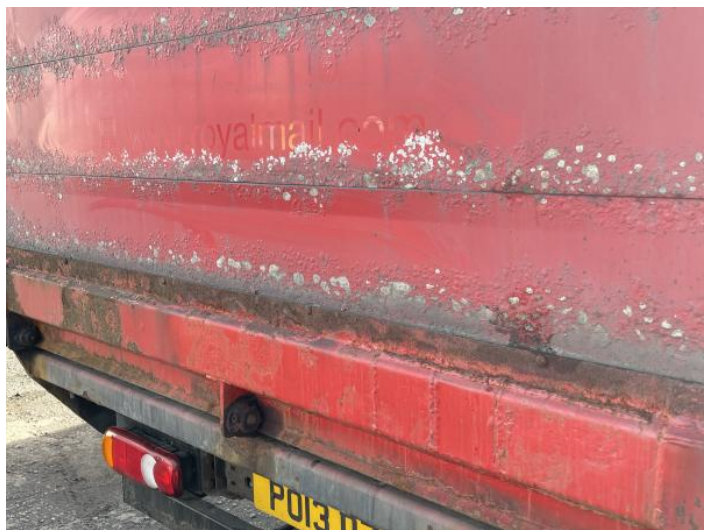
8: Tailgate
Rusted
Over 5mm

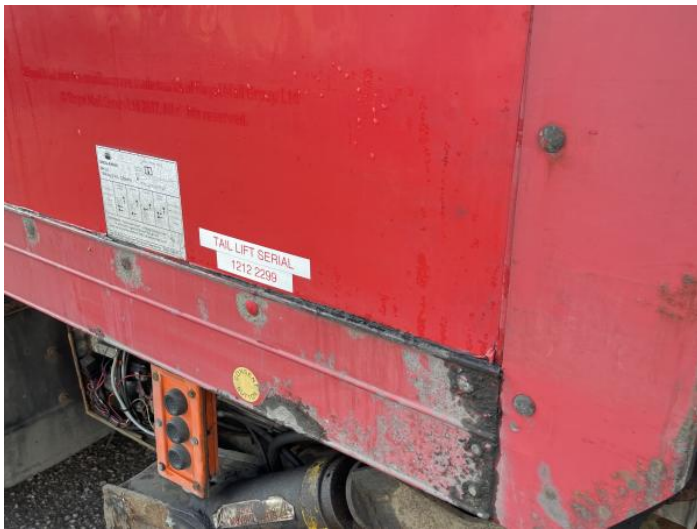
9: Qtr Panel nsr
Rusted
Over 5mm

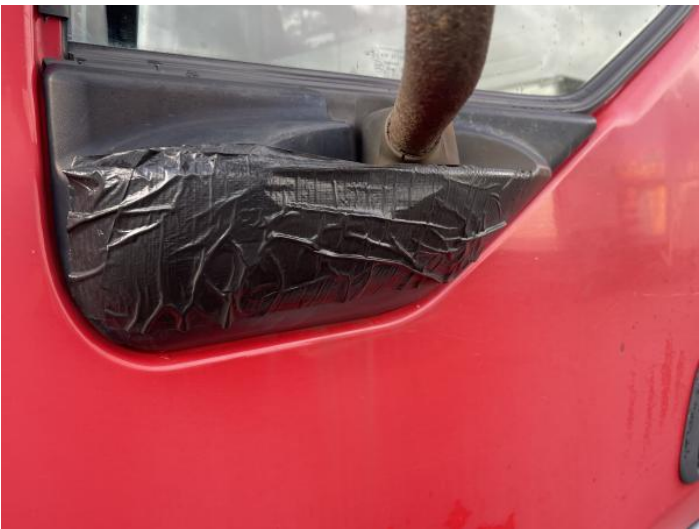
10: Door Mirror Assy nsf
Broken
Replace
