VEHICLE INSPECTION REPORT

A162357

Volvo B9R PLAXTON PANTHER

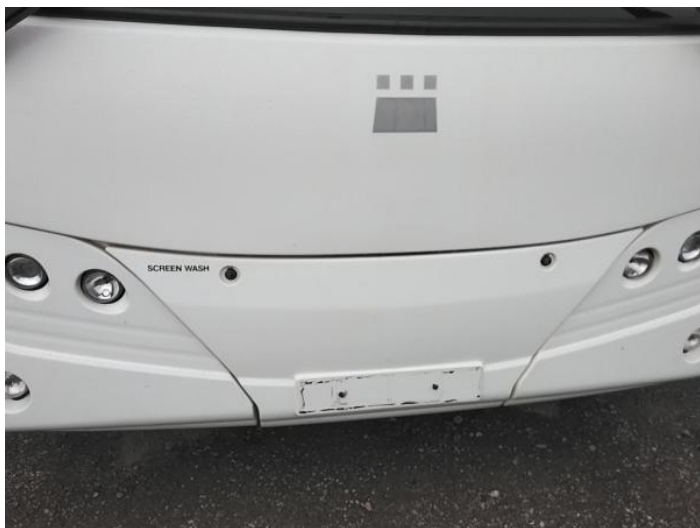
1: Bonnet
Chipped
Multiple Chips

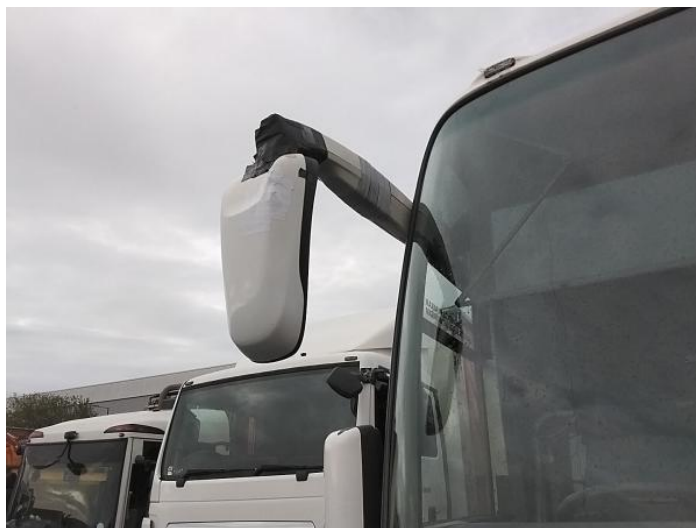
2: Door Mirror Assy osf
Broken
Replace

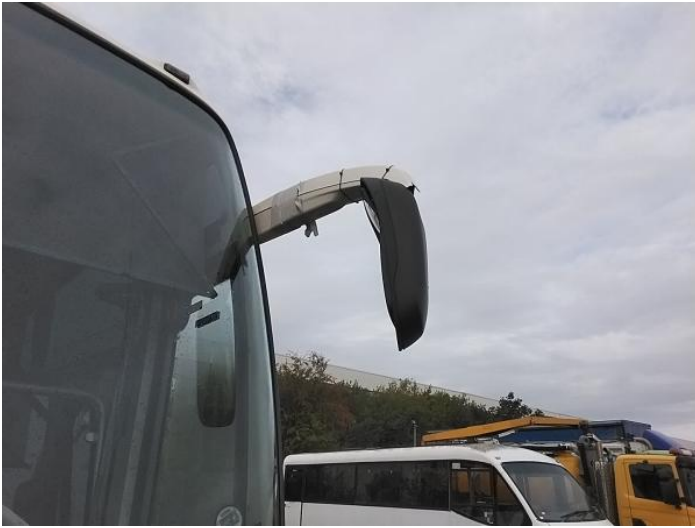
3: Door Mirror Assy nsf
Broken
Replace

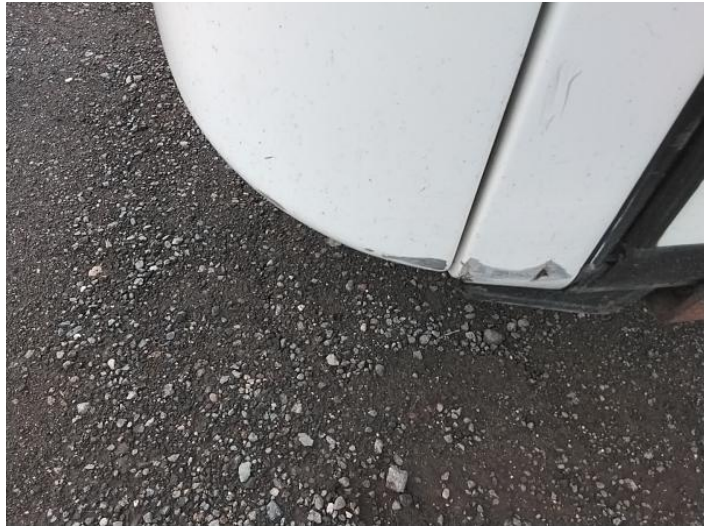
4: A Post ns
Scratched
Over 25mm Thru Paint

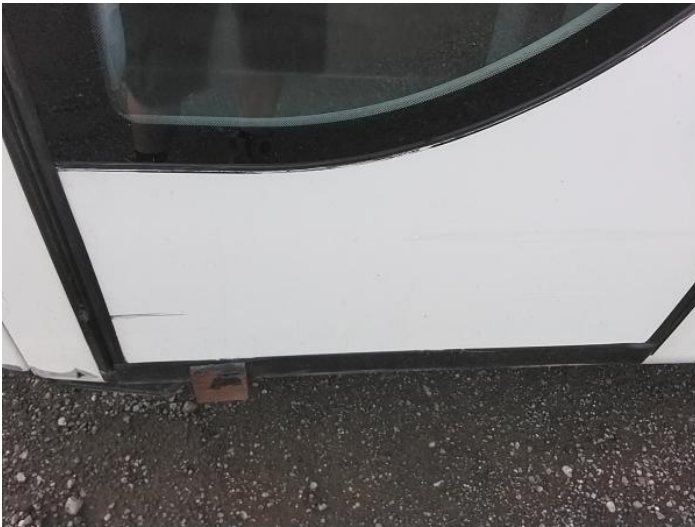
5: Door nsf
Scratched
Over 25mm Thru Paint

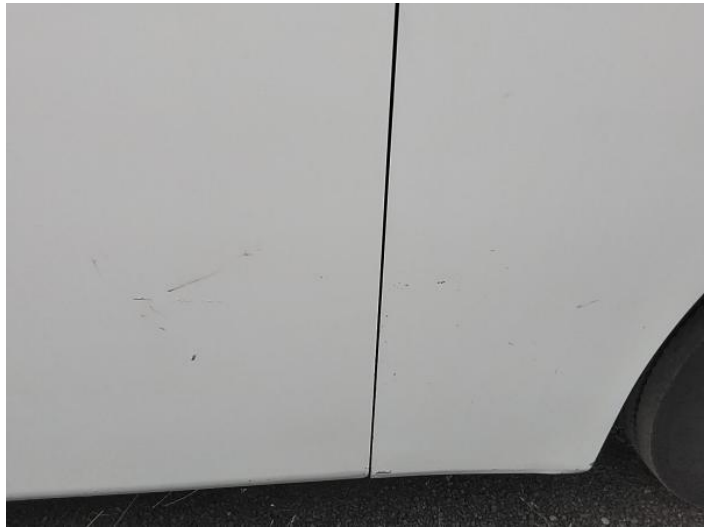
6: Qtr Panel nsr
Chipped
Multiple Chips

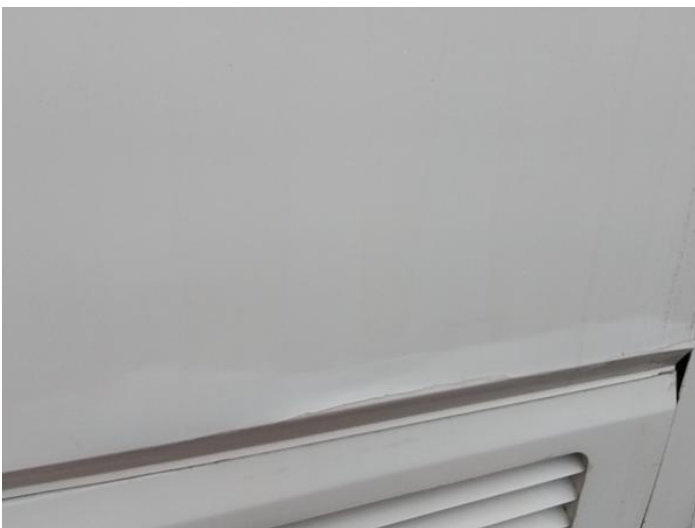
7: Qtr Panel nsr
Dented
With Paint Damage

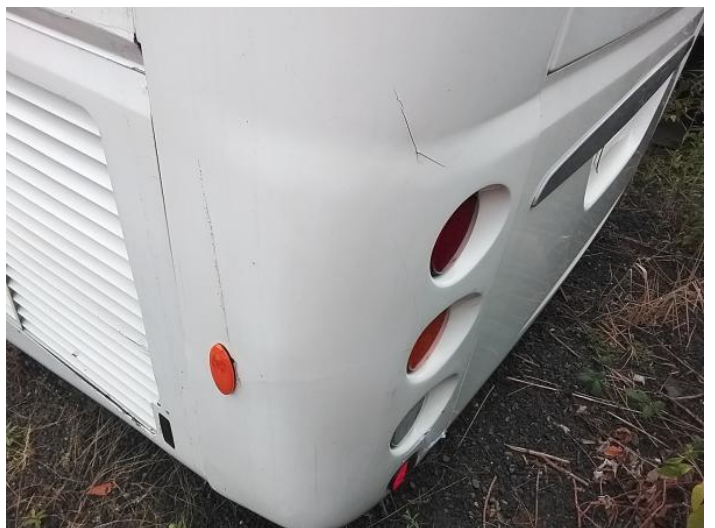
8: B Post ns
Cracked
Replace

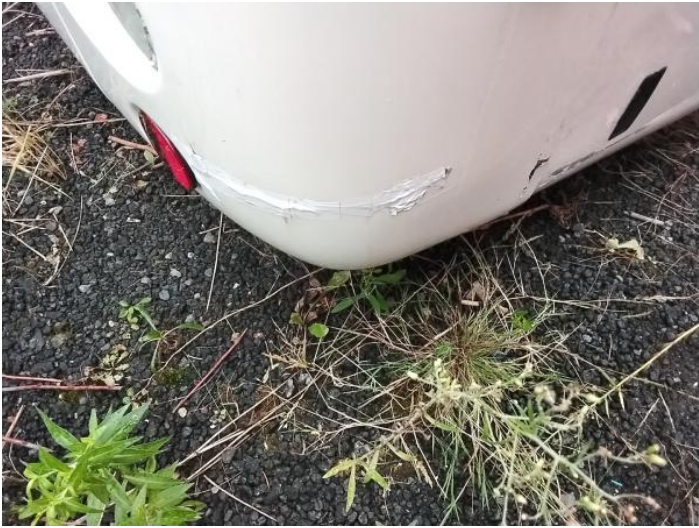
9: B Post os
Cracked
Replace

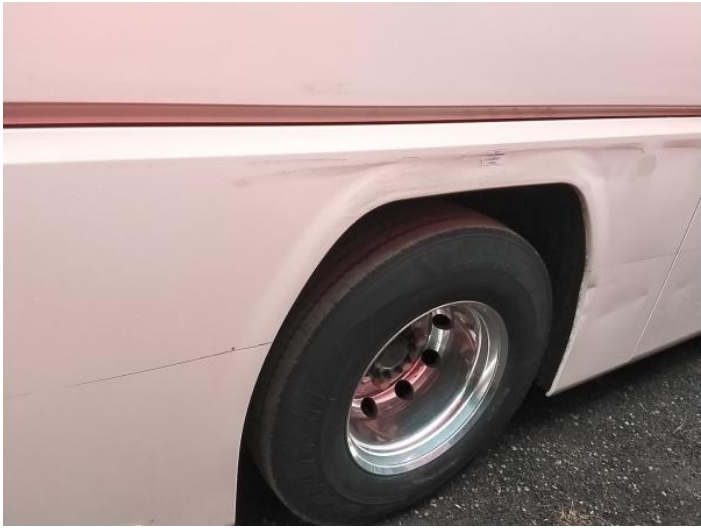
10: Qtr Panel osr
Dented
Over 30% Of Panel

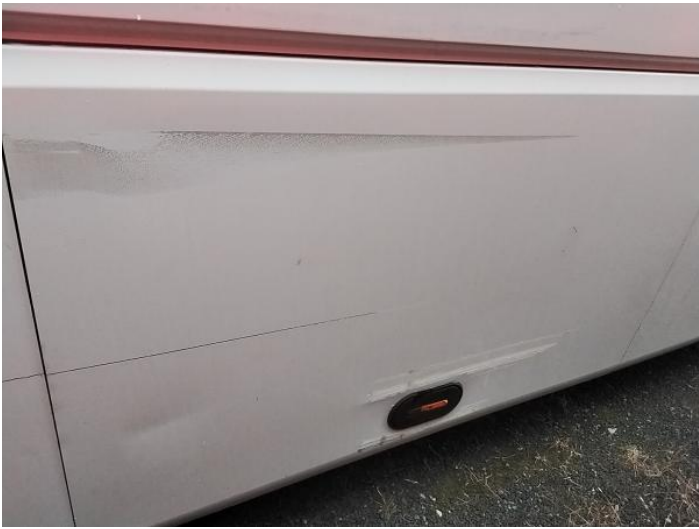
11: Qtr Panel osr
Dented
Over 30% Of Panel
