VEHICLE INSPECTION REPORT

FN17BPO

Daf LF 260

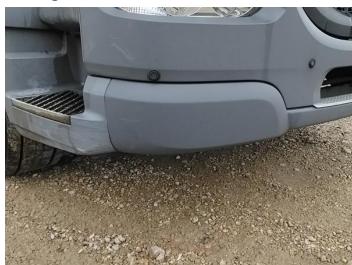
1: Bumper Front Moulding Scuffed (Unpainted) UpTo 100mm

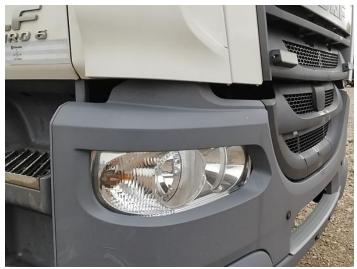
2: Fog Lamp Surround os Scuffed (Unpainted) UpTo 100mm

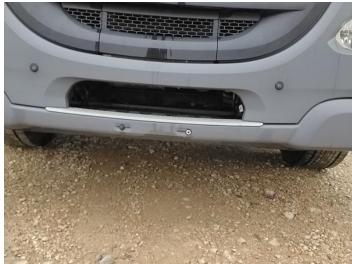
3: Number Plate Front Broken Replace

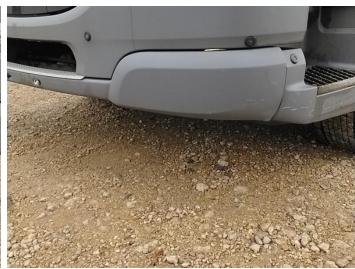
4: Bumper Front Moulding Scuffed (Unpainted) UpTo 100mm

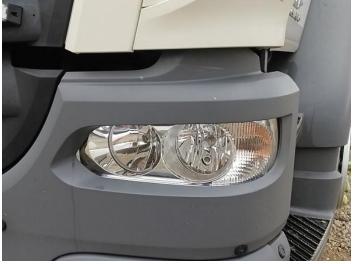
5: Fog Lamp Surround ns Scuffed (Unpainted) UpTo 100mm

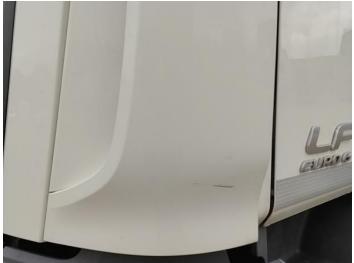
6: Wing nsf Scratched UpTo 25mm Thru Paint

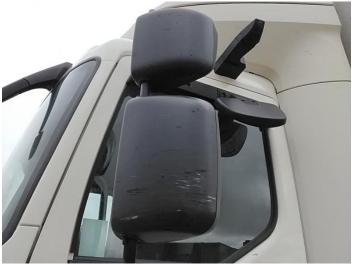
8: Door Mirror Assy nsf Scuffed (Unpainted) UpTo 100mm

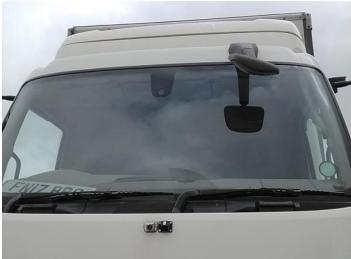
10: Screen Front Chipped UpTo 10mm

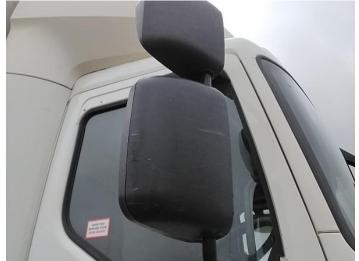
13: Door Mirror Assy osf Scuffed (Unpainted) UpTo 100mm
