VEHICLE INSPECTION REPORT

PJ67LZX

Daf CF 450

Non Runner

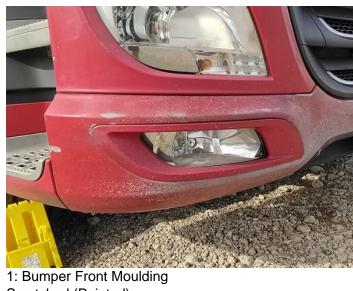
1: Bumper Front Moulding Scratched (Painted)
Over 25mm Thru Paint

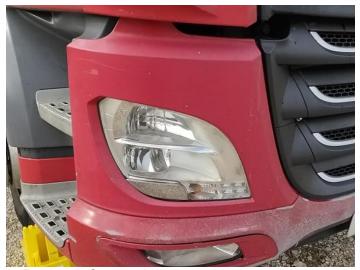
2: Fog Lamp Surround os Scratched (Painted) UpTo 25mm Thru Paint

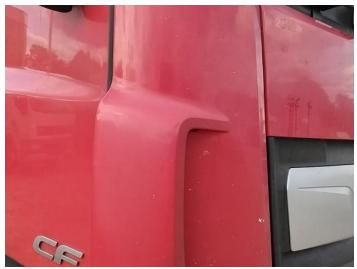
3: Wing osf Chipped Multiple Chips

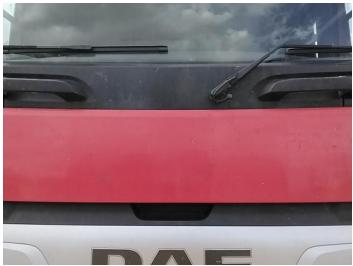
4: Bonnet Chipped Multiple Chips

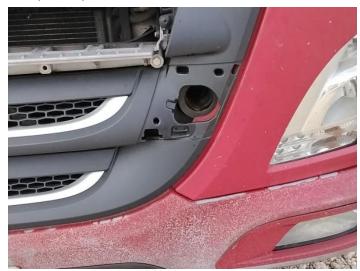
5: Front TowEye Cvr Missing Replace

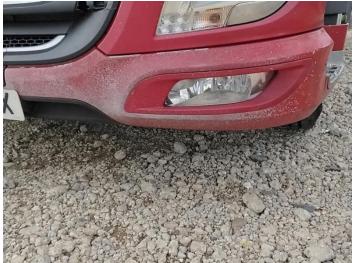
6: Bumper Front Moulding Scratched (Painted) Over 25mm Thru Paint

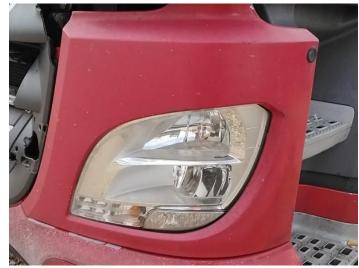
7: Fog Lamp Surround ns Scratched (Painted) UpTo 25mm Thru Paint

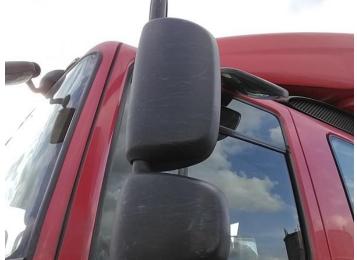
8: Door Mirror Assy nsf Scuffed (Unpainted) UpTo 100mm

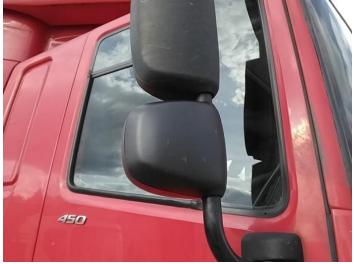
10: Door Mirror Assy osf Scuffed (Unpainted) UpTo 100mm

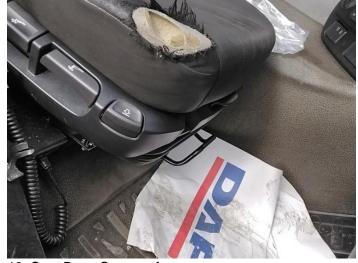
13: Seat Base Cover osf Holed Over 3mm
