VEHICLE INSPECTION REPORT

FG17NMU

Daf CF 260

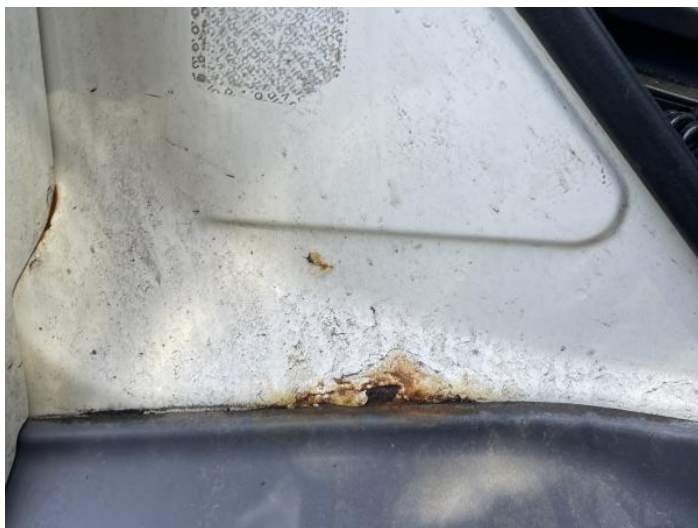
1: Sill os
Rusted
Over 5mm

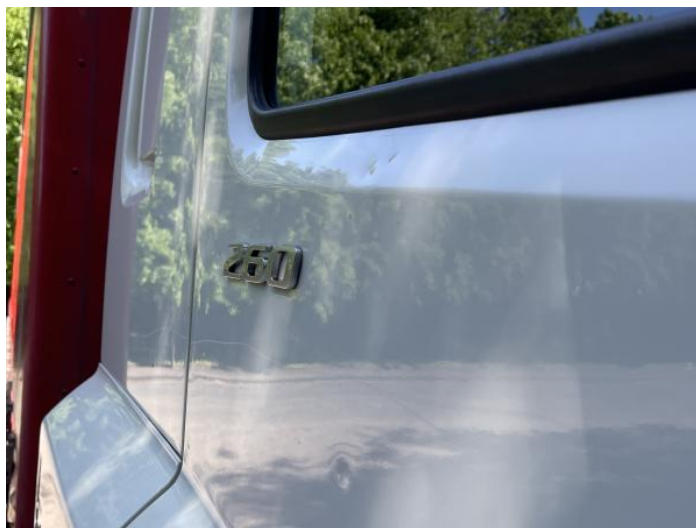
2: Door osf
Dented
Over 30mm

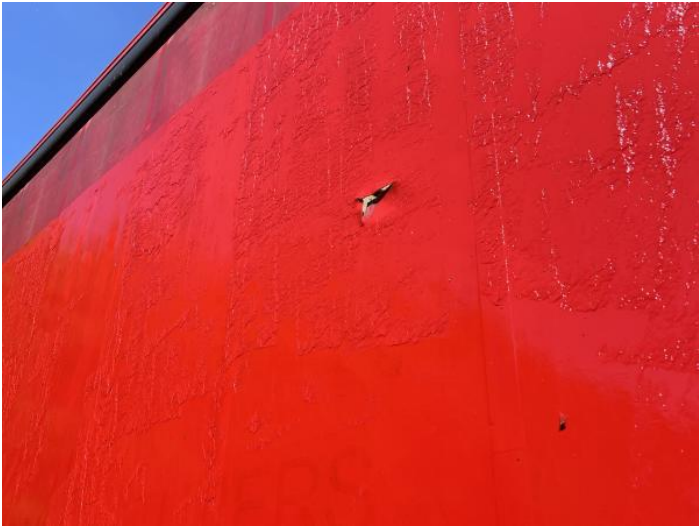
3: Qtr Panel osr
Dented
Over 30mm

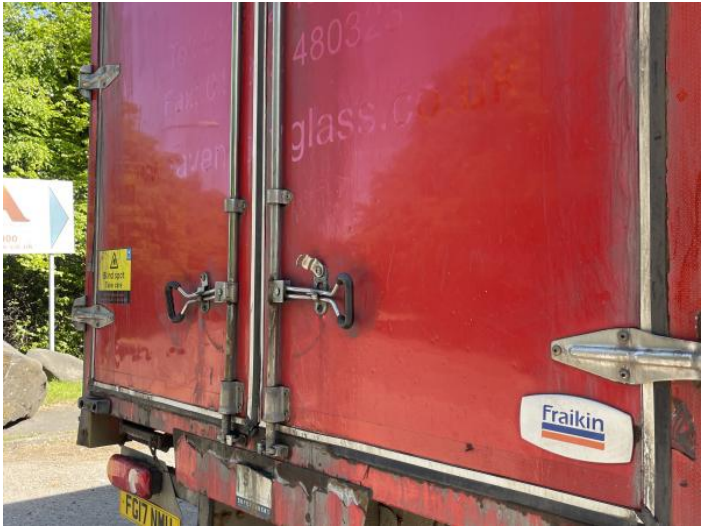
4: Tailgate
Dented
Over 30mm

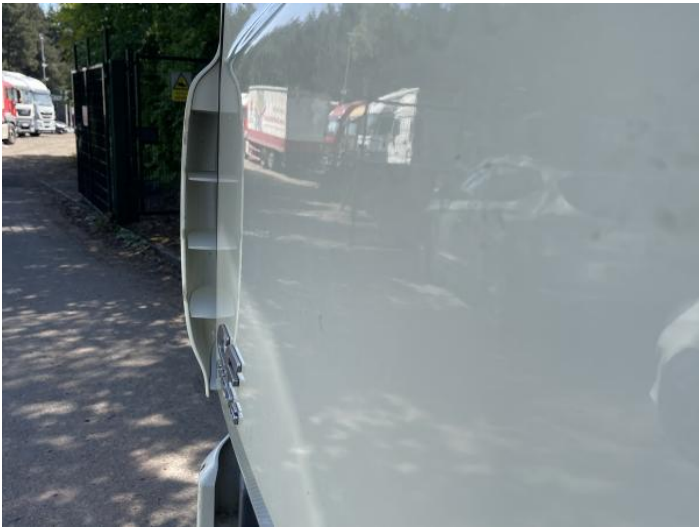
5: Door nsf
Dented
Over 30mm

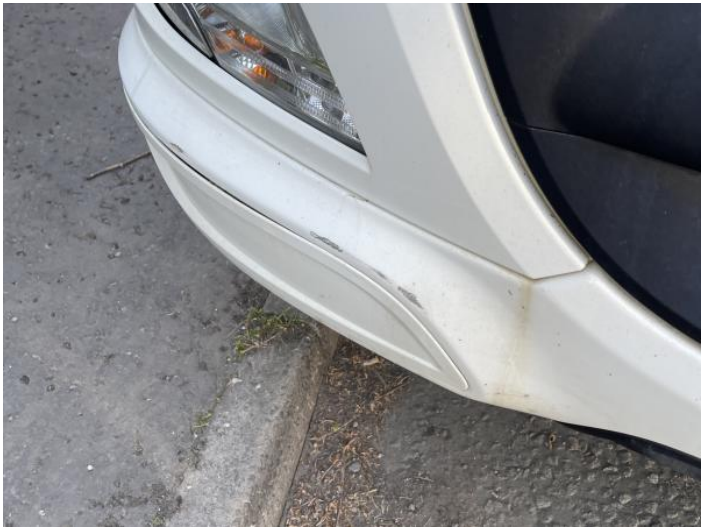
6: Bumper Front
Scratched
25 to 100mm Thru Paint
