# VEHICLE INSPECTION REPORT

**MF16XRD**

## Vauxhall Vivaro 2900 1.6 CDTI BITURBO 120PS ECOFLEX

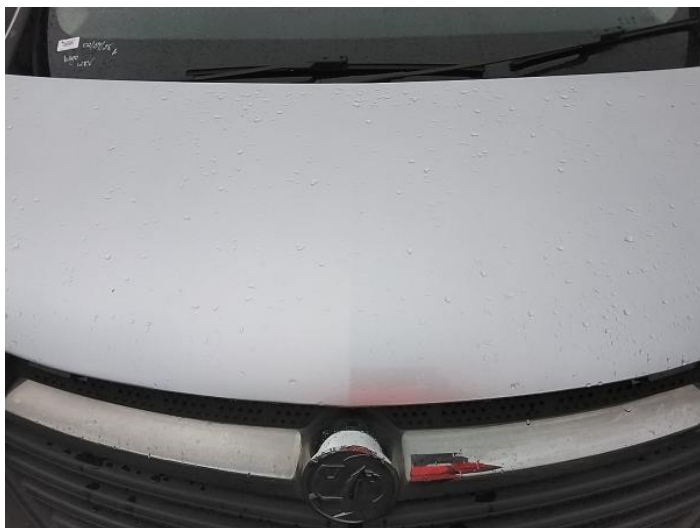
1: Bonnet  
Chipped  
Multiple Chips

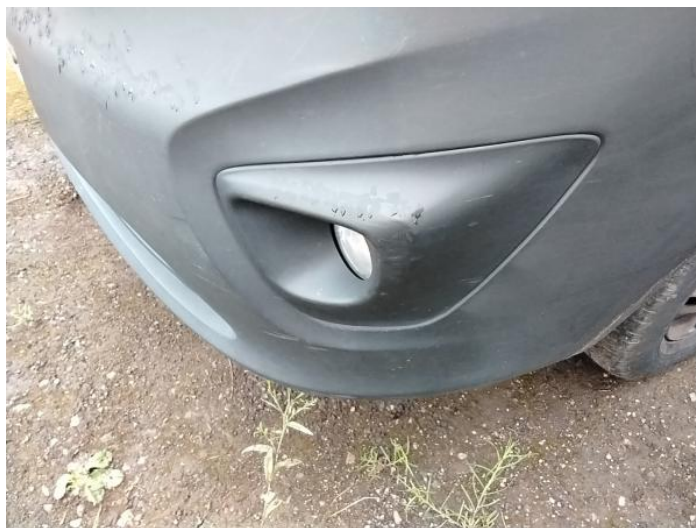
2: Bumper Front  
Scratched  
Over 100mm Thru Paint

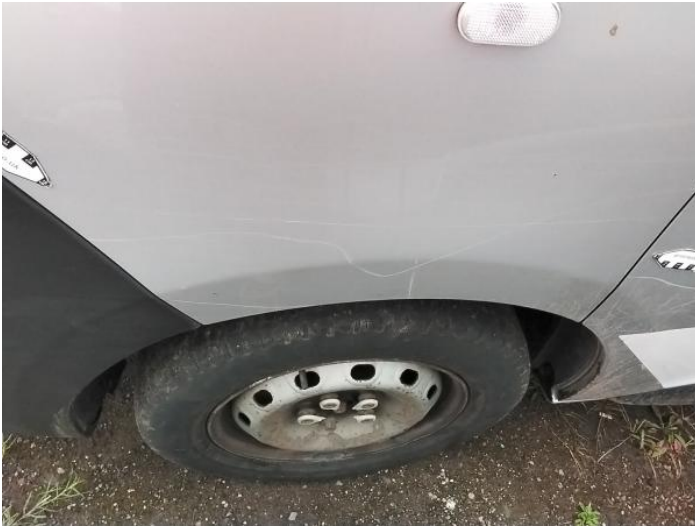
3: Wing nsf  
Scratched  
Over 25mm Thru Paint

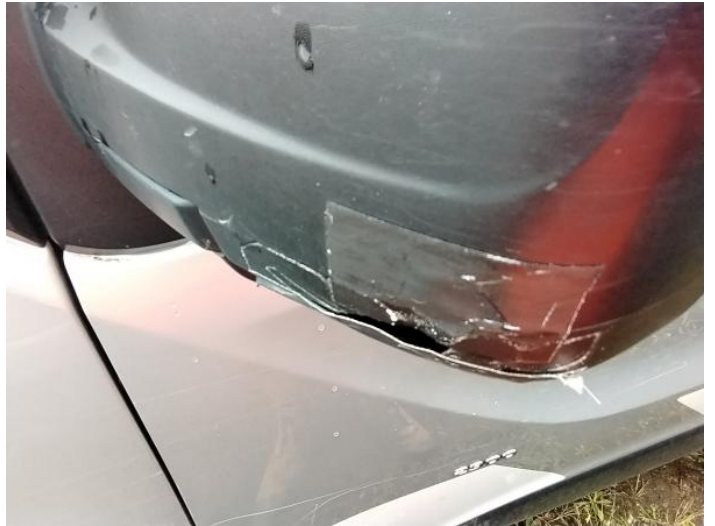
4: Door Mirror Assy nsf  
Broken  
Replace

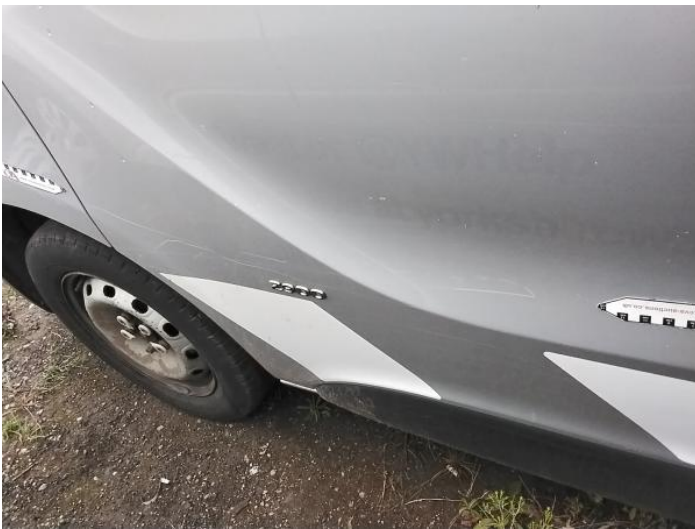
5: Door nsf  
Scratched  
Over 25mm Thru Paint

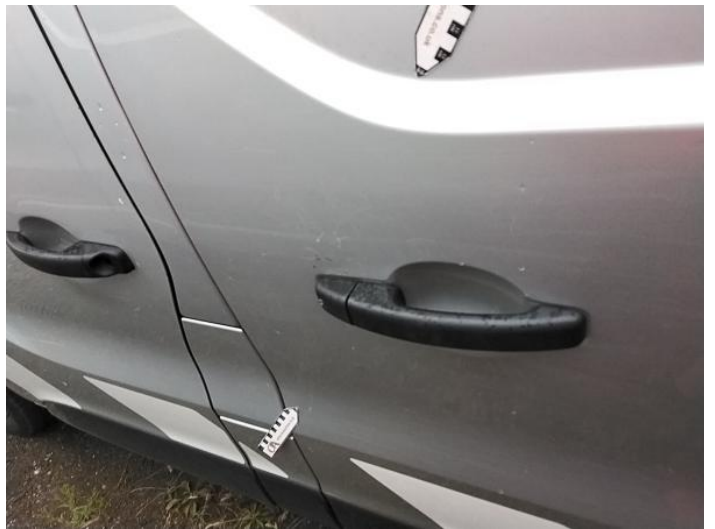
6: Qtr Panel nsr  
Scratched  
Over 25mm Thru Paint

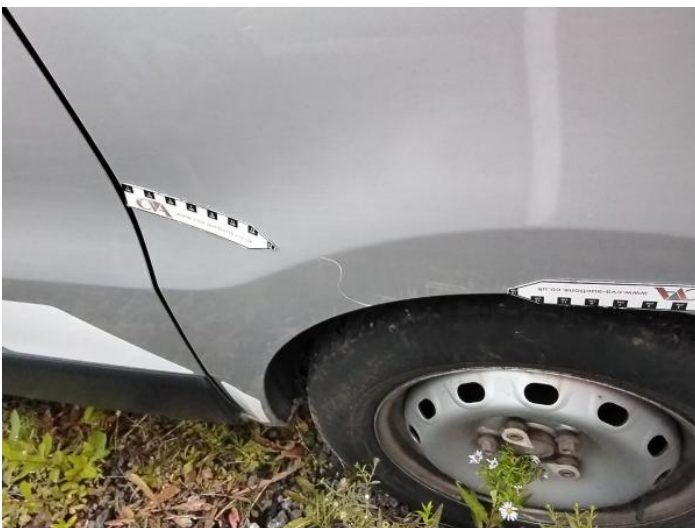
7: Qtr Panel nsr  
Scratched  
Over 25mm Thru Paint

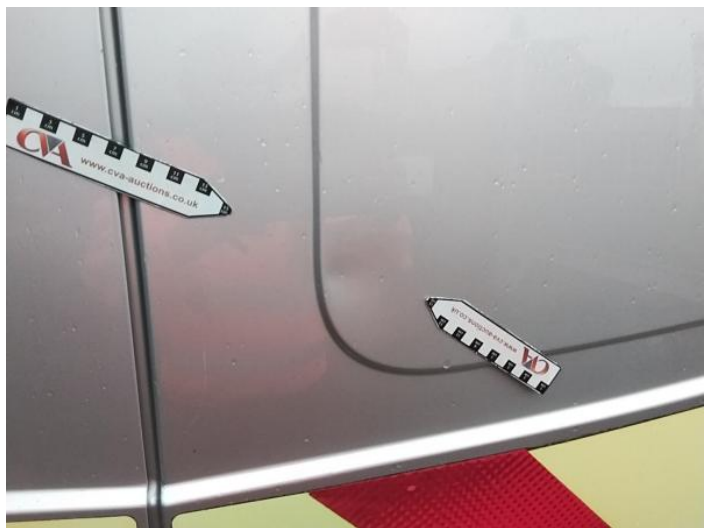
8: Door osr  
Dented  
Over 30mm

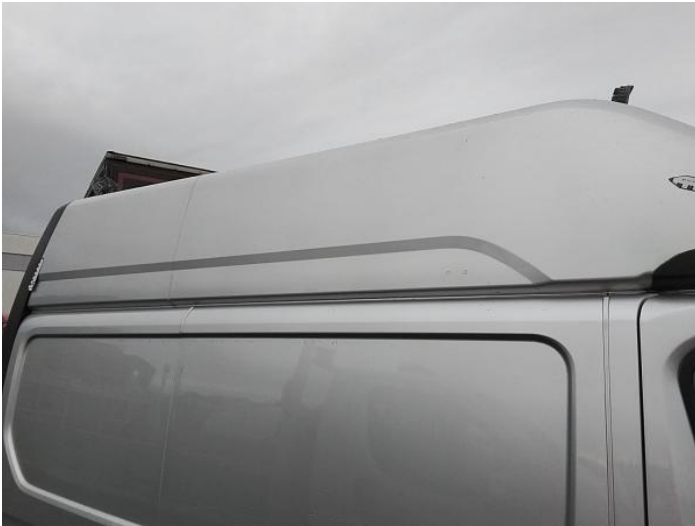
9: Roof  
Scratched  
Over 25mm Thru Paint

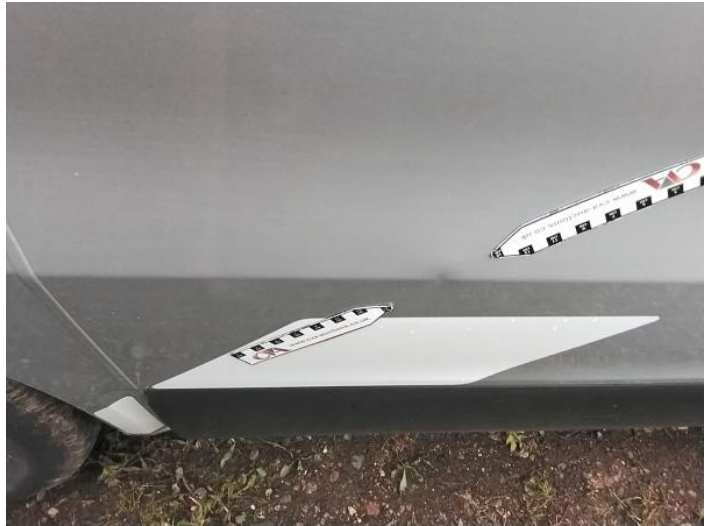
10: Qtr Panel osr  
Dented  
Over 30mm

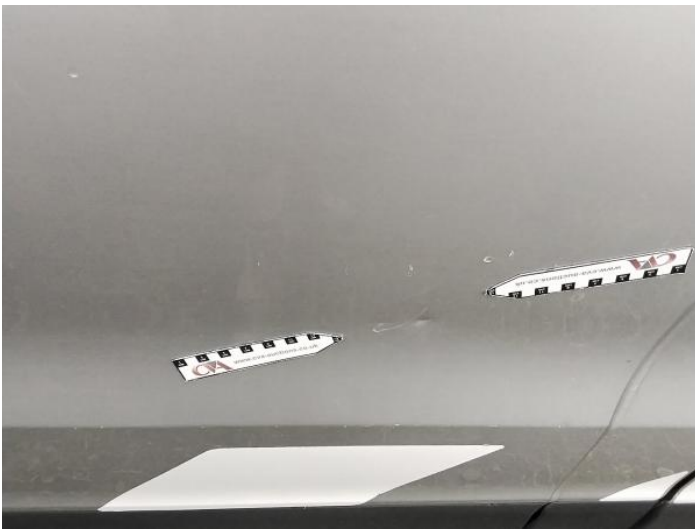
11: Qtr Panel osr  
Dented  
With Paint Damage

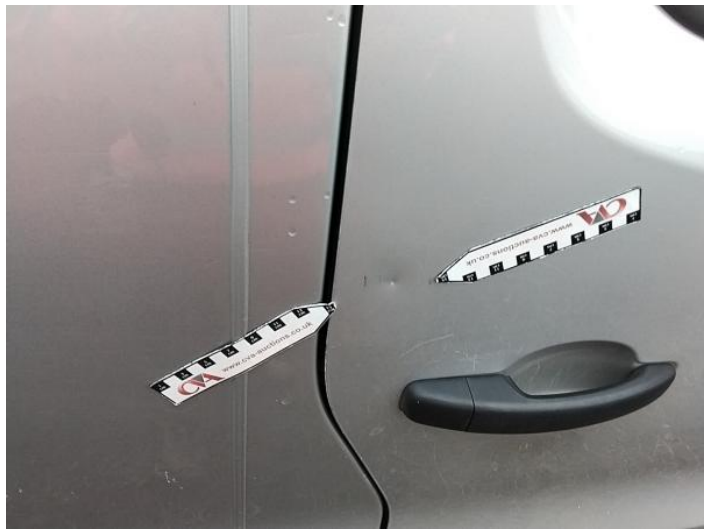
12: Door osf  
Dented  
With Paint Damage

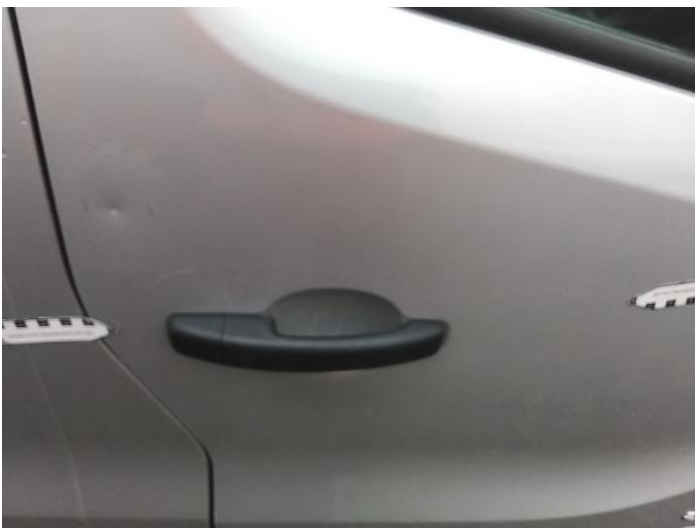
13: Door osf  
Scratched  
Over 25mm Thru Paint

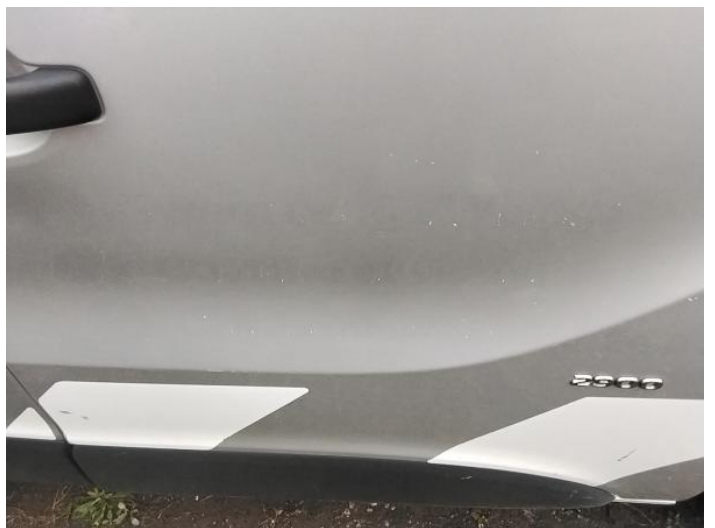
14: Door osf  
Chipped  
Multiple Chips

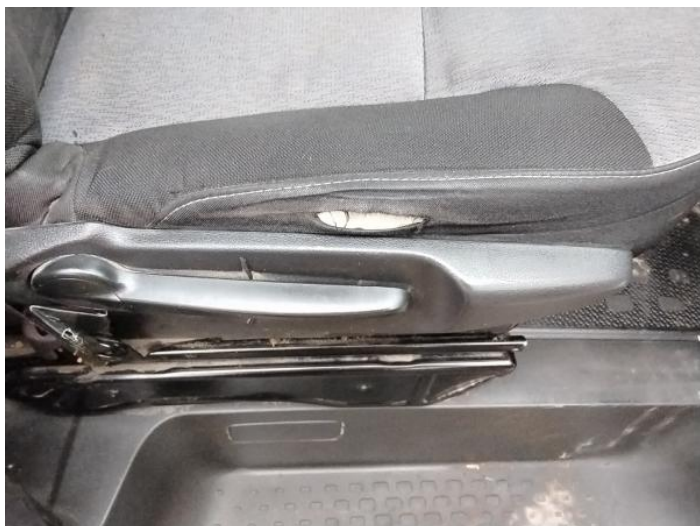
15: Seat Base Cover osf  
Torn  
Over 3mm

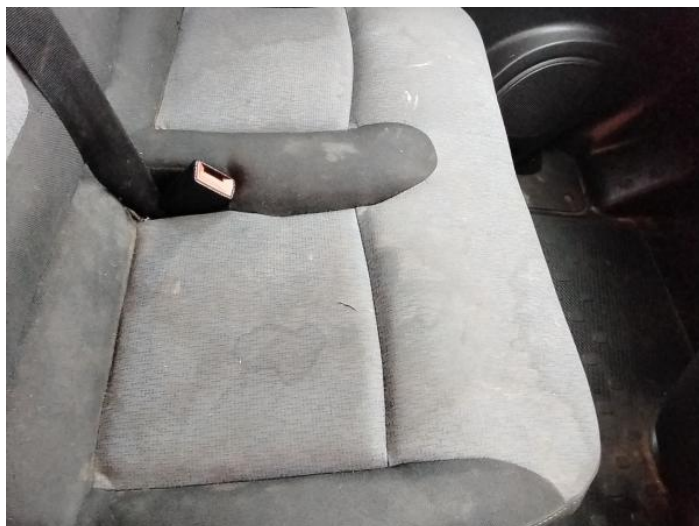
16: Seat Base Cover nsf  
Soiled  
Heavy
