VEHICLE INSPECTION REPORT

BK14AOL

Iveco Eurocargo 75E16

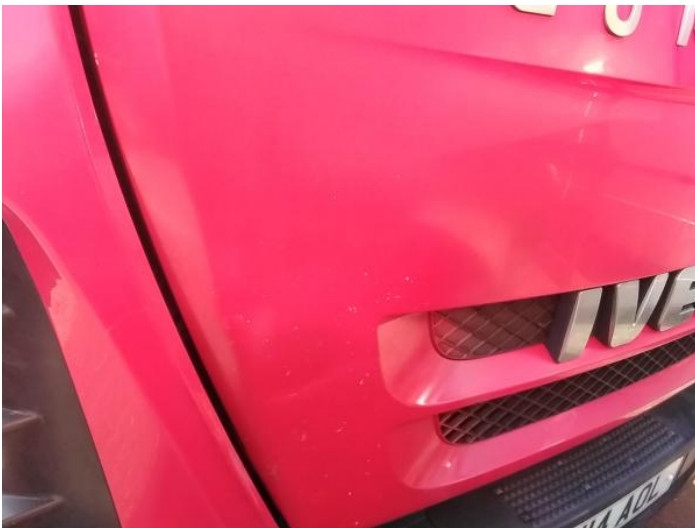
1: Bonnet
Poor Previous Repair
Rippled UpTo 30%

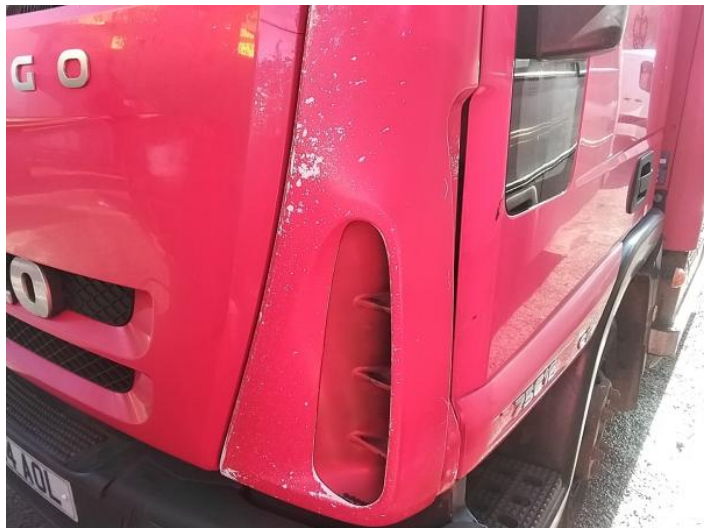
2: Panel Front
Chipped
Multiple Chips

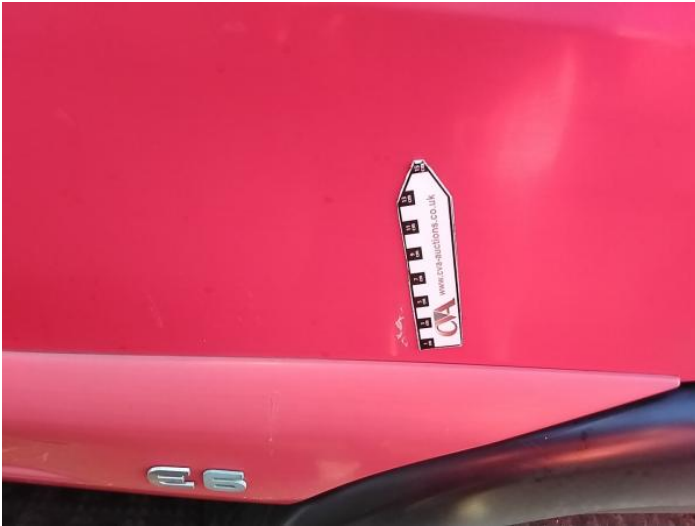
3: Door nsf
Scratched
Over 25mm Thru Paint

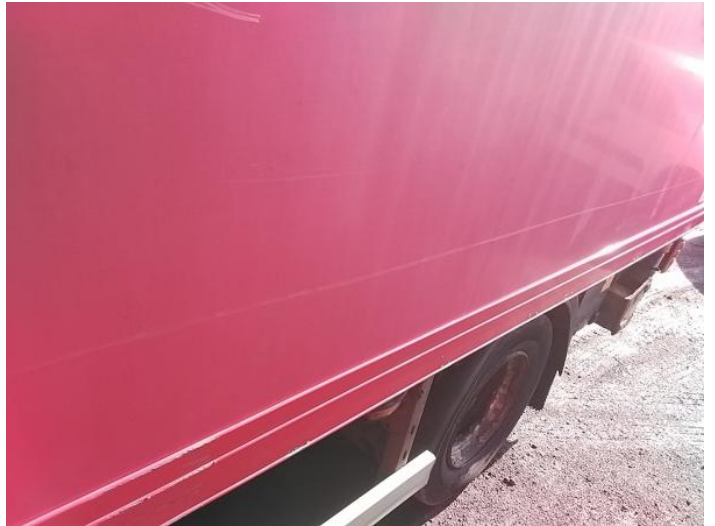
4: Qtr Panel nsr
Scratched
Over 25mm Thru Paint

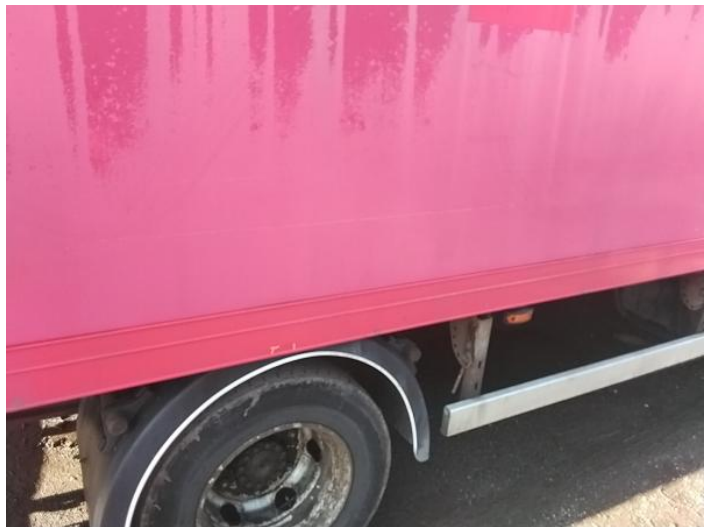
6: Qtr Panel osr
Scratched
Over 25mm Thru Paint

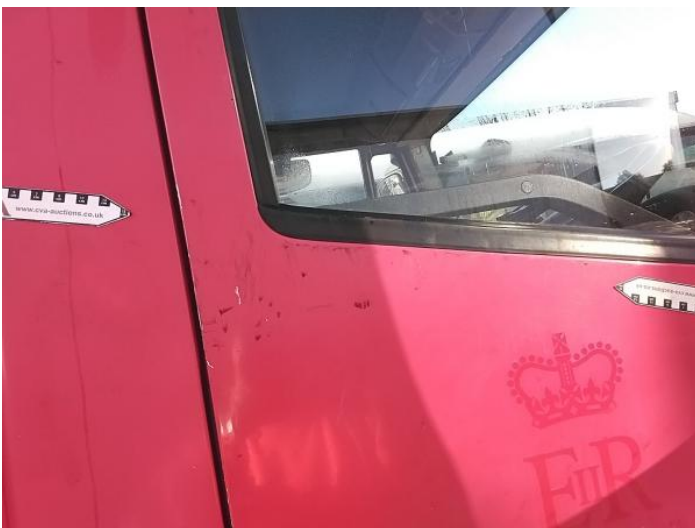
7: Door osf
Scratched
Over 25mm Thru Paint

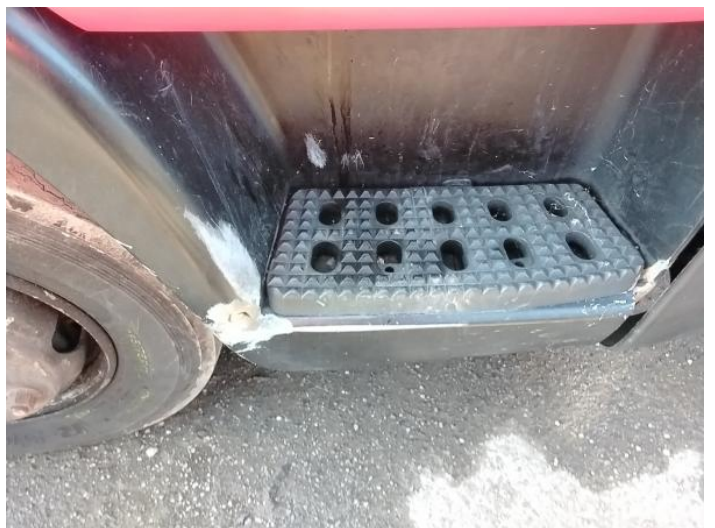
8: Wing osf
Cracked
Replace

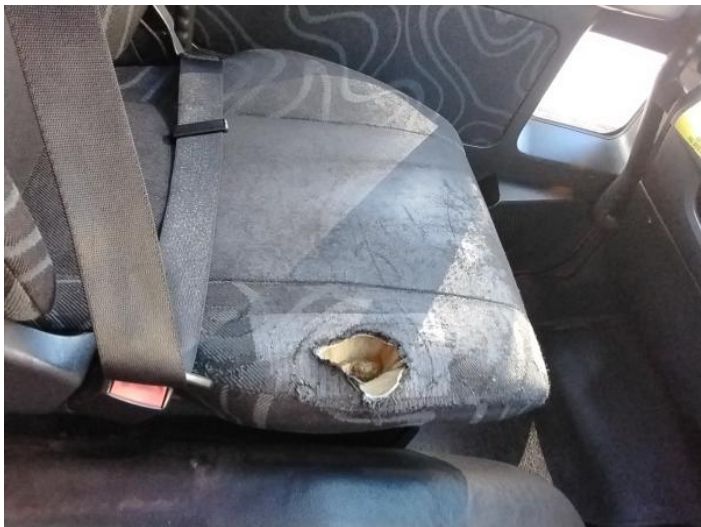
9: Seat Base Cover nsf
Holed
Over 3mm
