VEHICLE INSPECTION REPORT

WM67HDF

Mercedes-Benz Sprinter 314 CDI

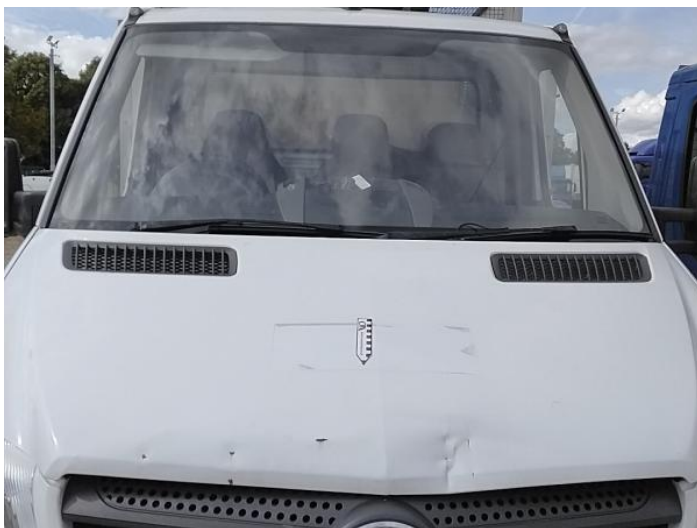
1: Bonnet
Dented
With Paint Damage

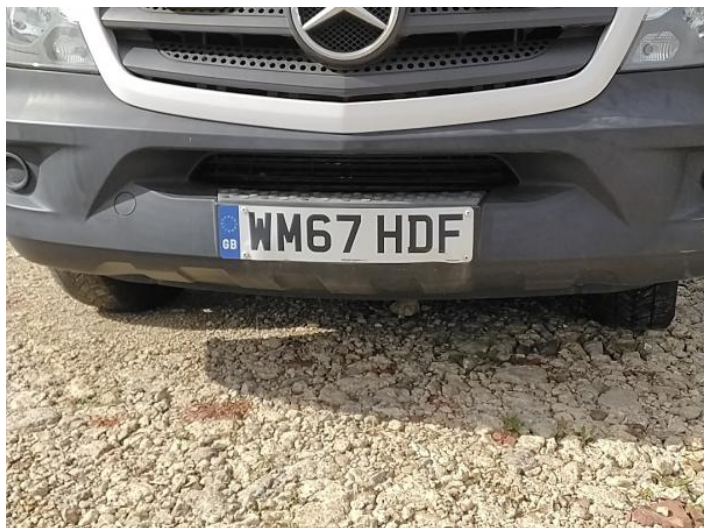
2: Number Plate Front
Broken
Replace

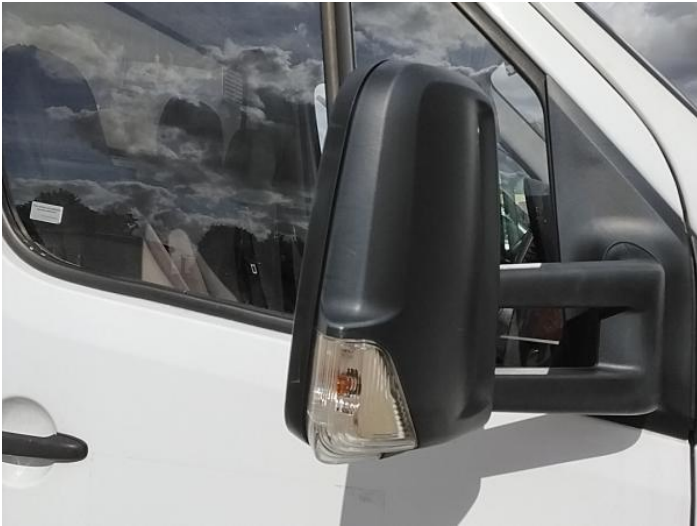
3: Door Mirror Assy osf
Scuffed (Unpainted)
UpTo 100mm
