VEHICLE INSPECTION REPORT

SJ17SUF

Mercedes-Benz Econic 2630

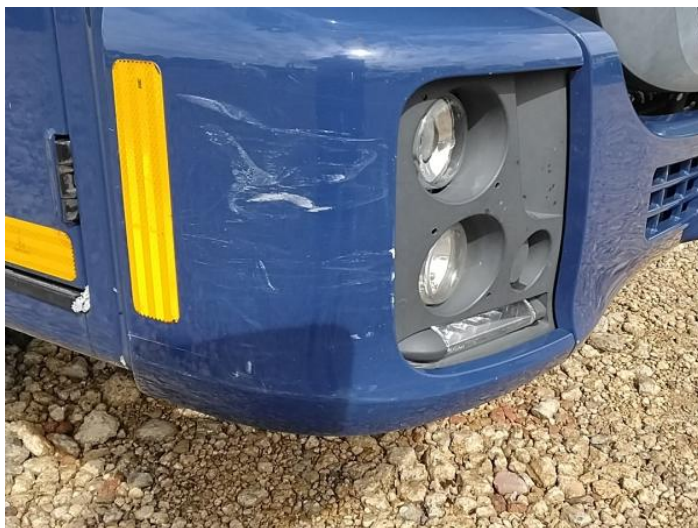
1: Fog Lamp Surround os
Scratched (Painted)
UpTo 25mm Thru Paint

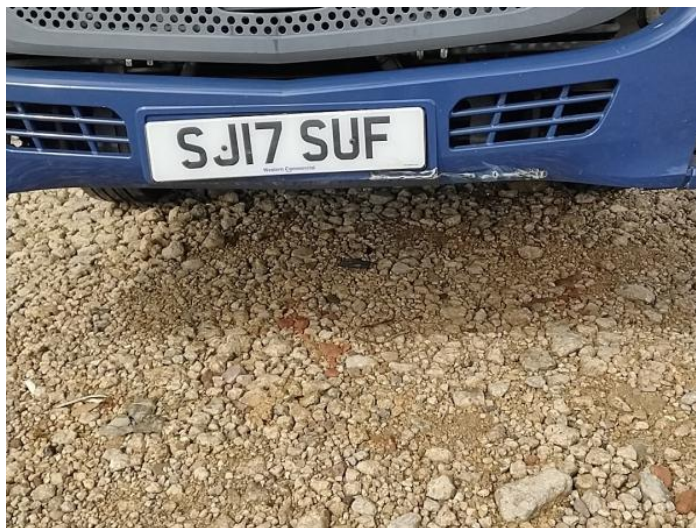
2: Bumper Front
Scratched
25 to 100mm Thru Paint

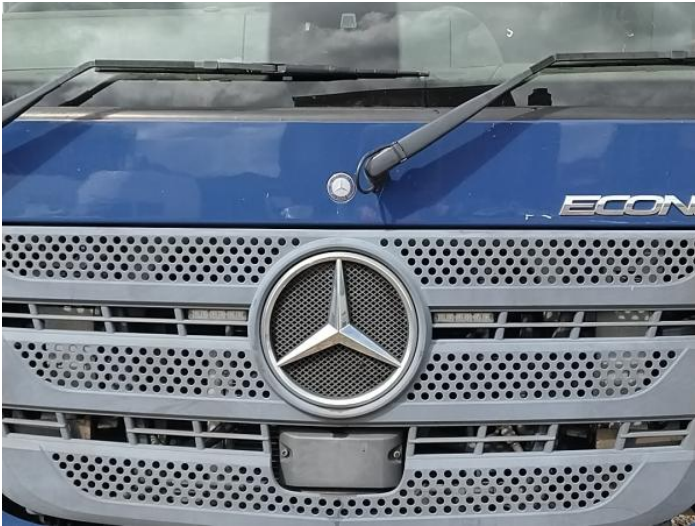
3: Panel Front
Scratched
UpTo 25mm Thru Paint

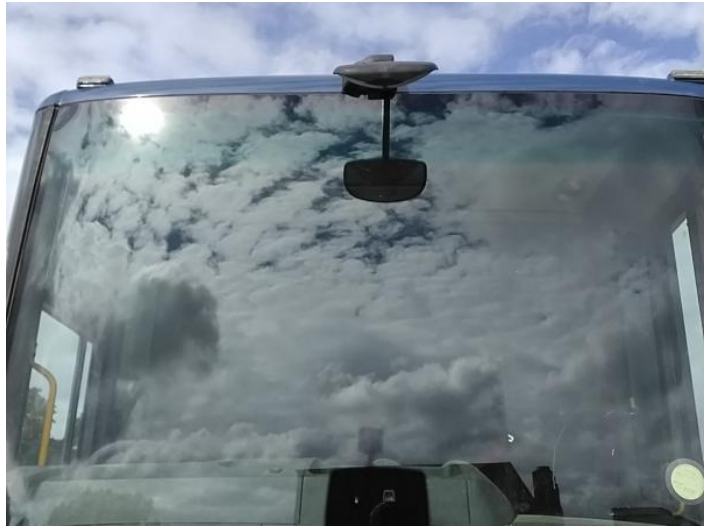
4: Screen Front
Chipped
UpTo 10mm

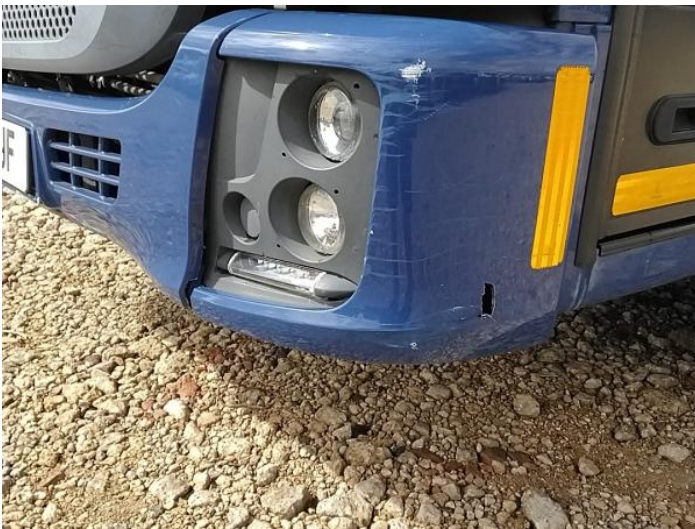
5: Fog Lamp Surround ns
Broken
Replace

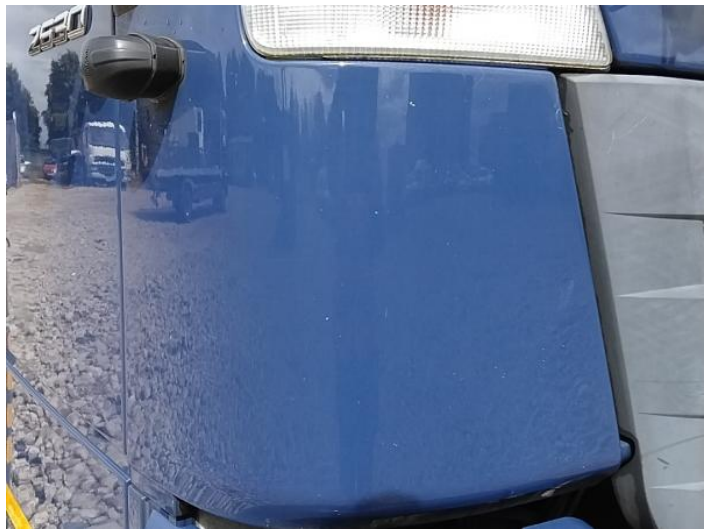
6: Wing osf
Chipped
Multiple Chips

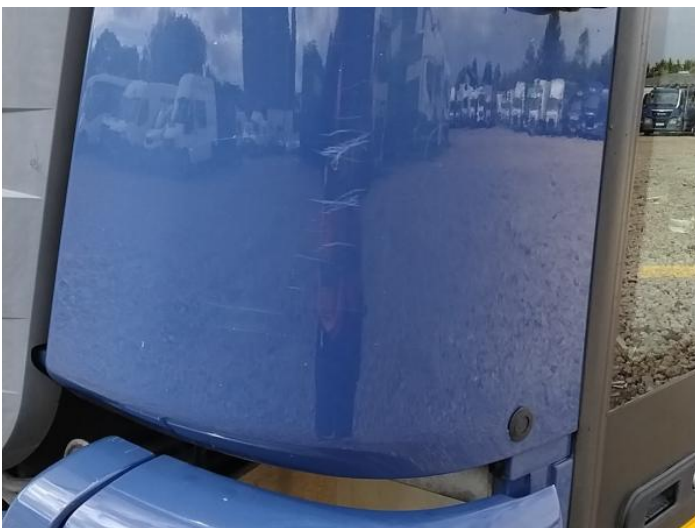
7: Wing nsf
Scratched
UpTo 25mm Not Thru Paint

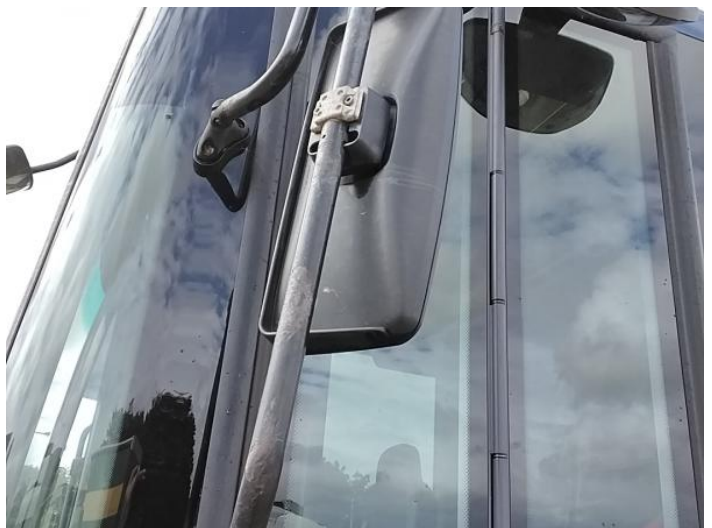
8: Door Mirror Assy nsf
Scuffed (Unpainted)
UpTo 100mm

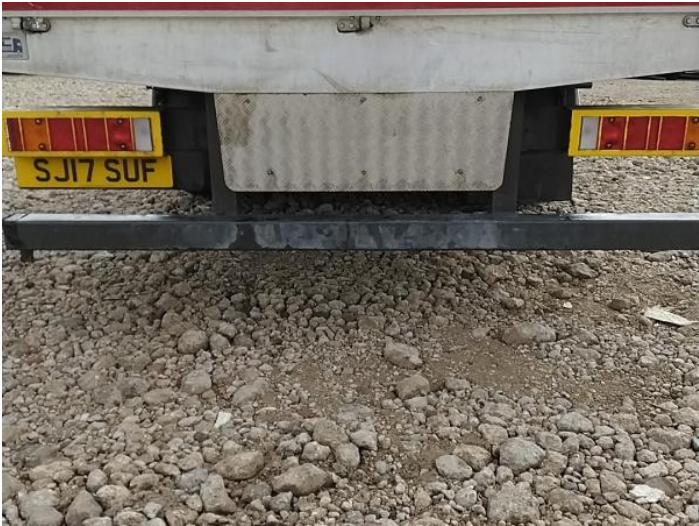
9: Bumper Rear
Rusted
Over 5mm

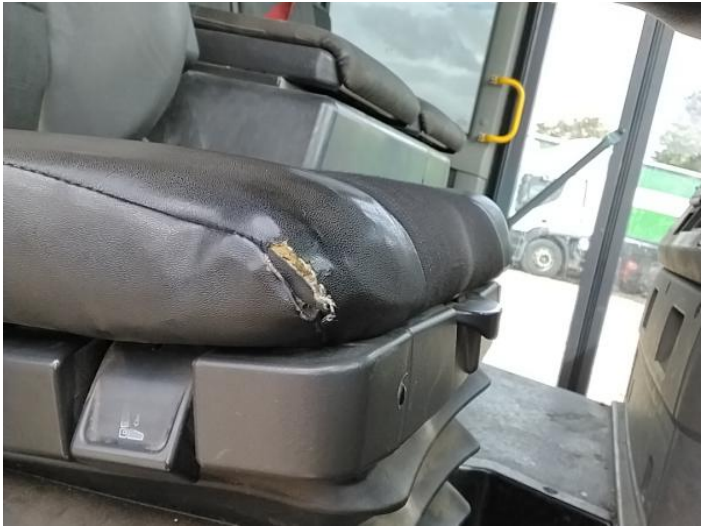
10: Seat Base Cover osf
Holed
Over 3mm
