VEHICLE INSPECTION REPORT

KU64SYJ

Fuso Canter 7C15

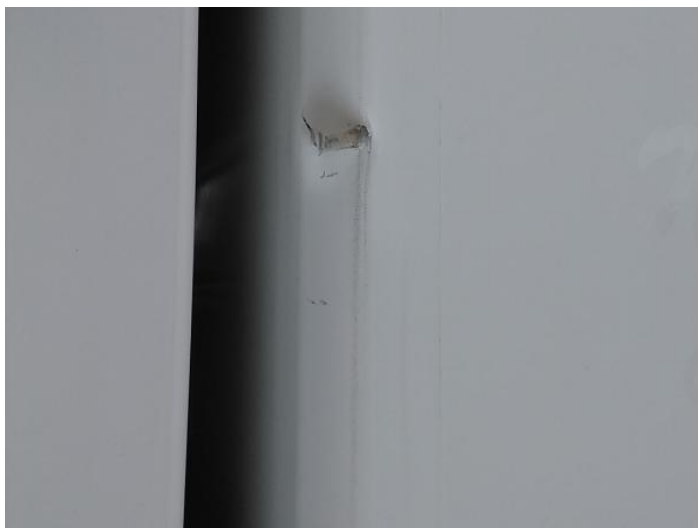
1: Qtr Panel osr
Dented
Over 30mm

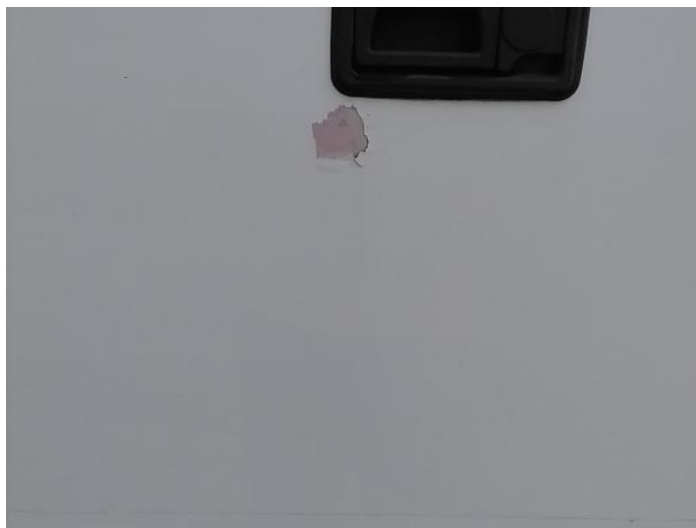
2: Door nsr
Rusted
Over 5mm

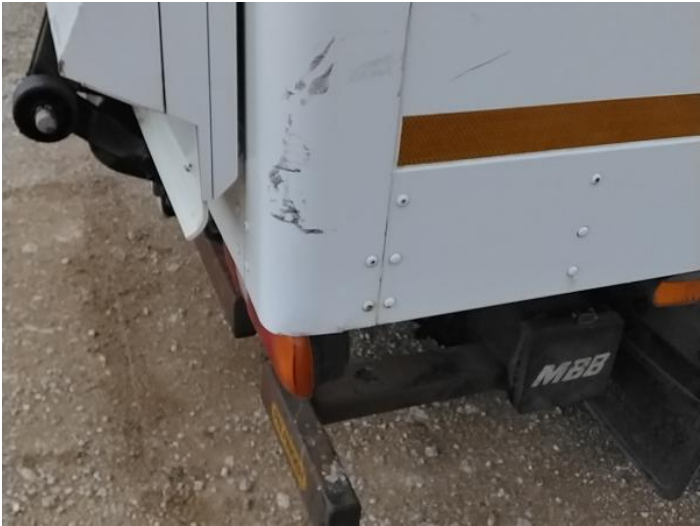
3: Panel Rear
Scratched
UpTo 25mm Not Thru Paint
