VEHICLE INSPECTION REPORT

LN64CFO

Mercedes-Benz Econic 2630

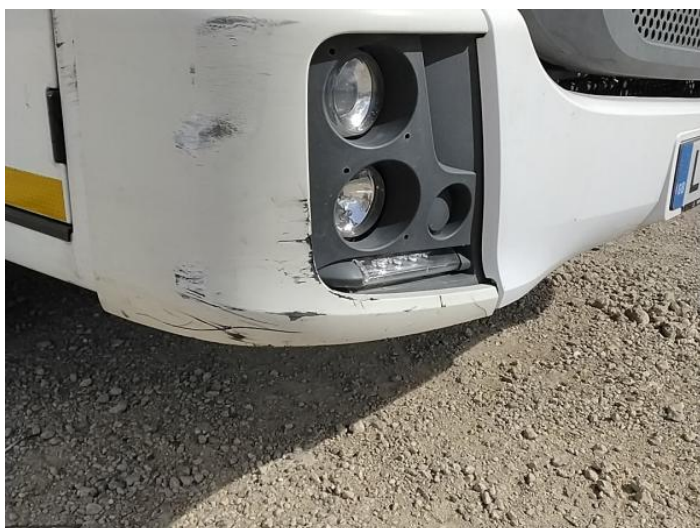
1: Fog Lamp Surround as
Scratched (Painted)
Over 25mm Thru Paint

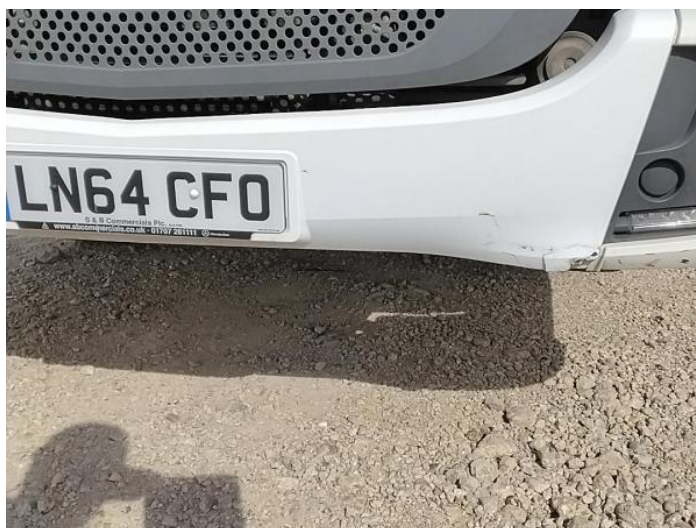
2: Bumper Front
Cracked
Up To 25mm

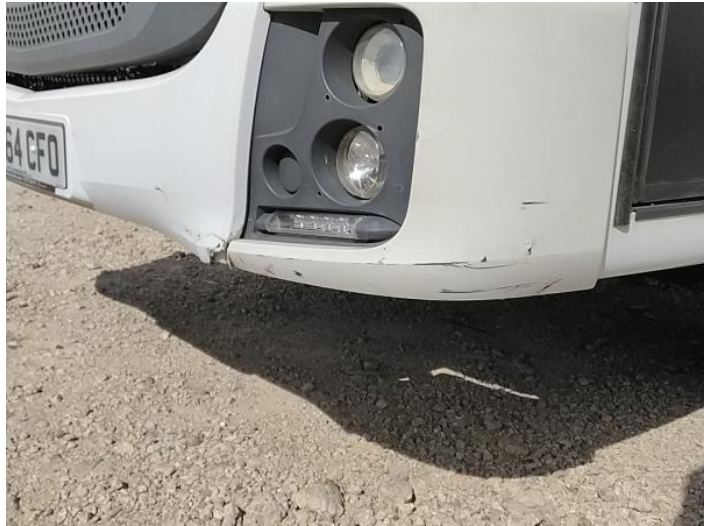
4: Fog Lamp Surround ns
Scratched (Painted)
Over 25mm Thru Paint

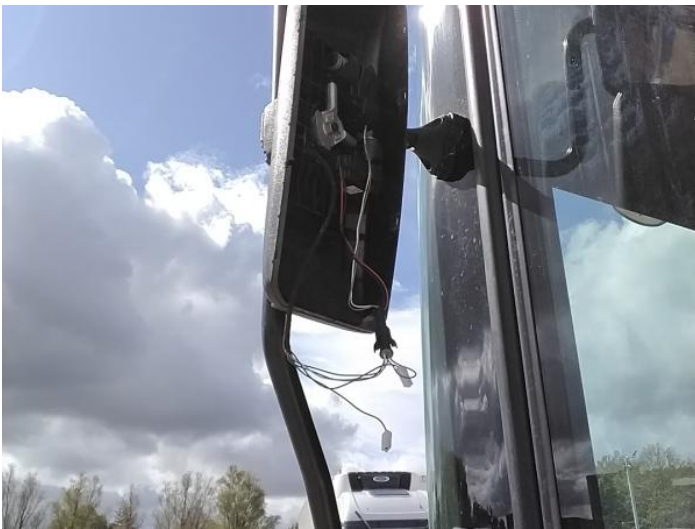
5: Door Mirror Glass ns
Missing
Replace

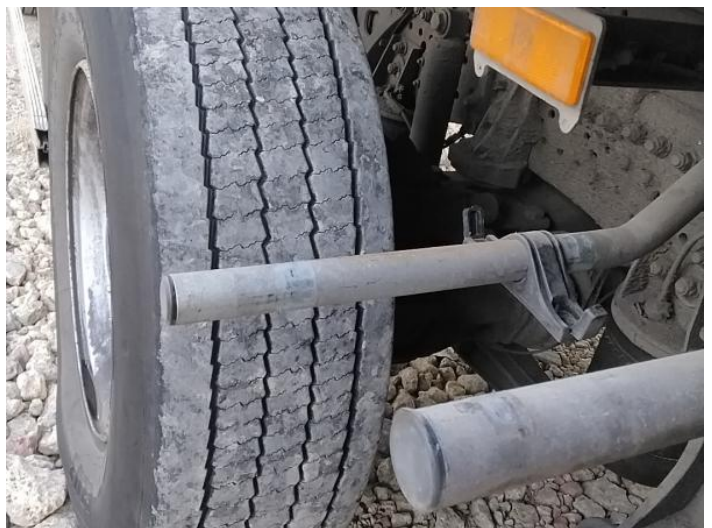
8: Wheel nsr
Missing
Replace

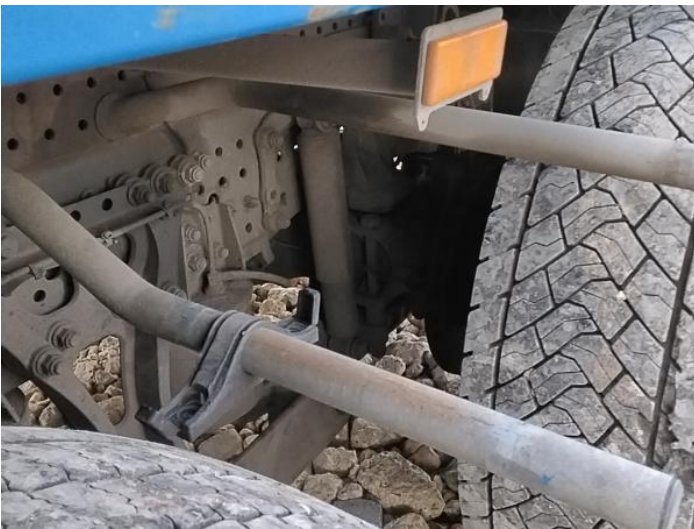
11: Wheel nsr
Missing
Replace

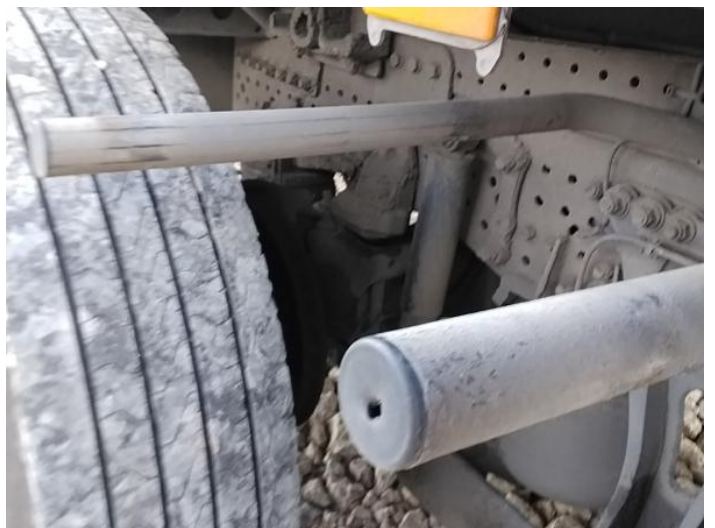
14: Wheel osr
Missing
Replace

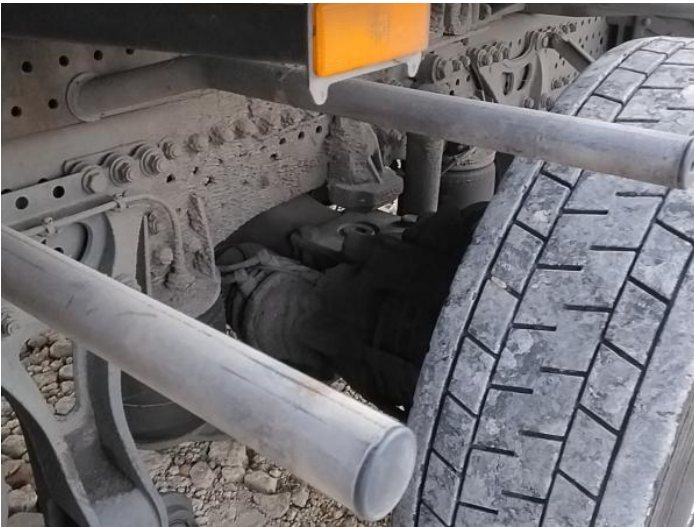
17: Wheel osr
Missing
Replace

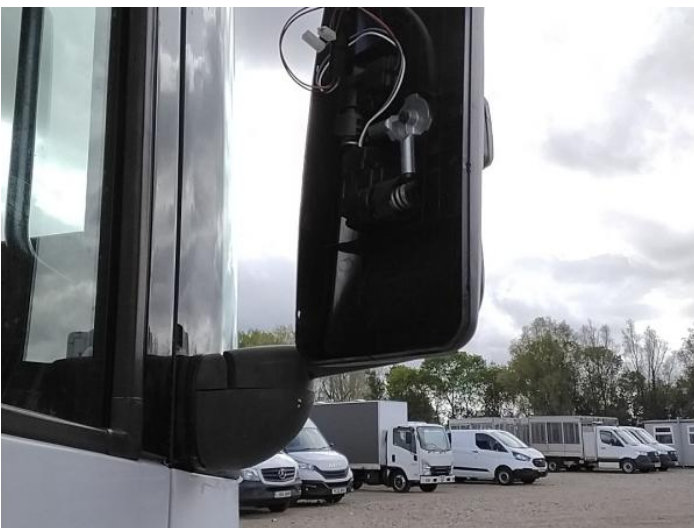
19: Door Mirror Glass os
Missing
Replace

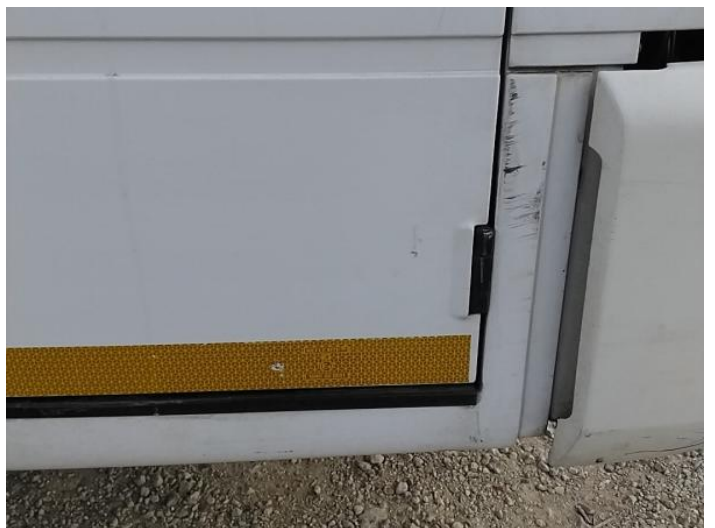
20: Door osf
Scratched
UpTo 25mm Thru Paint

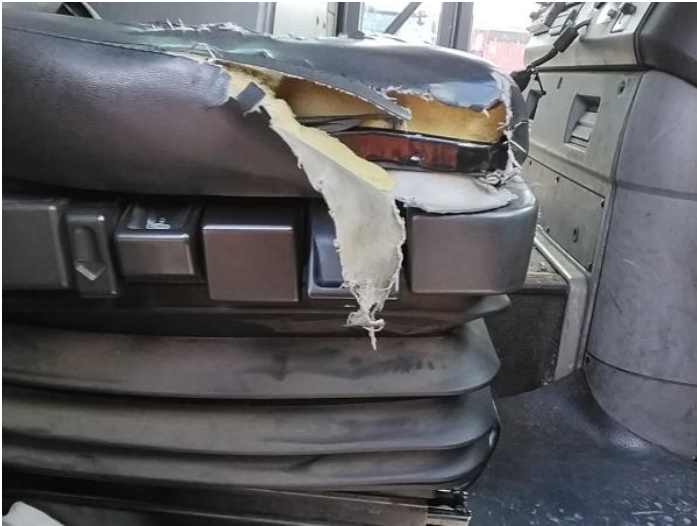
21: Seat Base Cover osf
Holed
Over 3mm
