# **VEHICLE INSPECTION REPORT**

**NL70CNO**

# Ford Transit Custom 2.0 EcoBlue 130ps Low Roof Trend Van

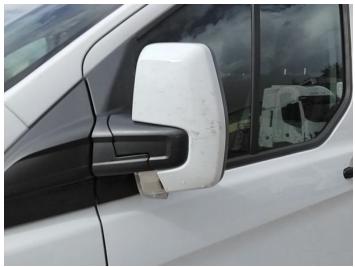
3: Door Mirror Assy nsf Scratched (Painted) Over 25mm Not Thru Paint

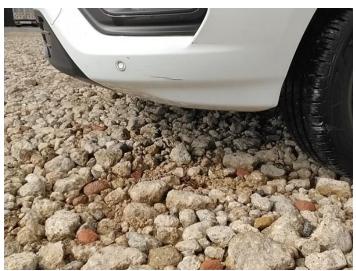
4: Bumper Front Scratched UpTo 25mm Thru Paint

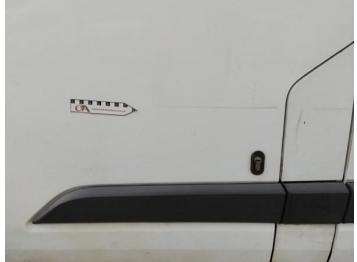
5: Door nsf Scratched Over 25mm Not Thru Paint

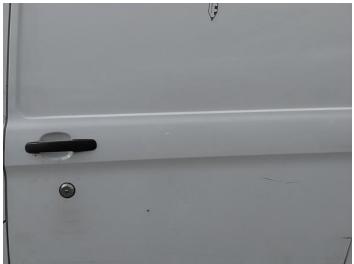
6: Door nsr Scratched Over 25mm Not Thru Paint

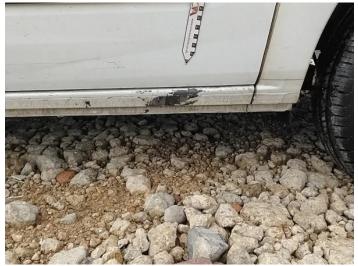
7: Sill ns Scratched Over 25mm Thru Paint

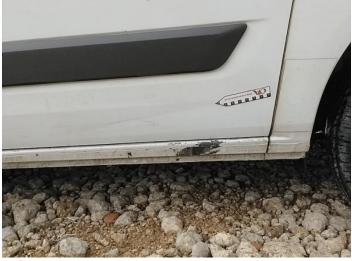
8: Door nsr Dented Between 10mm + 30mm

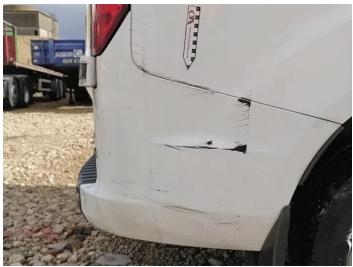
9: Bumper Rear Moulding Scratched (Painted) Over 25mm Thru Paint

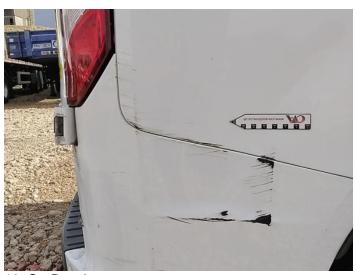
10: Qtr Panel osrScratchedOver 25mm Thru Paint

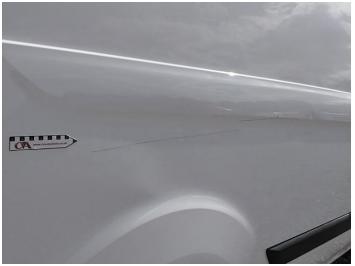
11: Qtr Panel osr Scratched Over 25mm Not Thru Paint

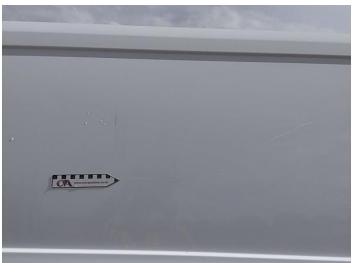
12: Qtr Panel osr Scratched Over 25mm Thru Paint

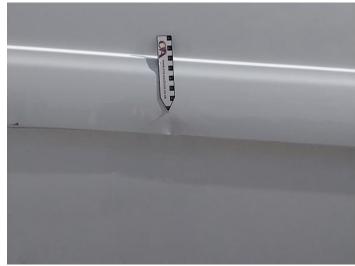
13: Qtr Panel osr Dented Between 10mm + 30mm

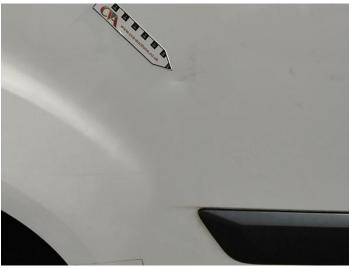
14: Qtr Panel osr Dented With Paint Damage

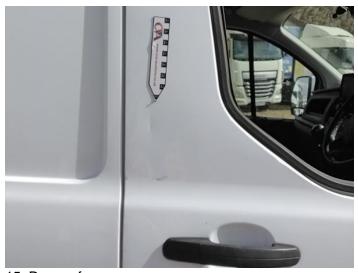
15: Door osf Dented Between 10mm + 30mm

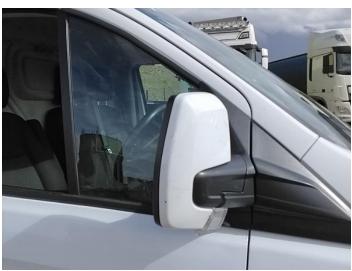
16: Door Mirror Assy osf Scratched (Painted) Over 25mm Thru Paint

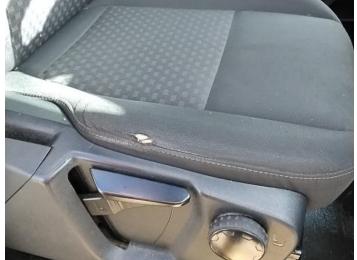
17: Seat Base Cover osf Holed Over 3mm
