# VEHICLE INSPECTION REPORT

**KX17SKJ**

## Mercedes-Benz Atego 1221

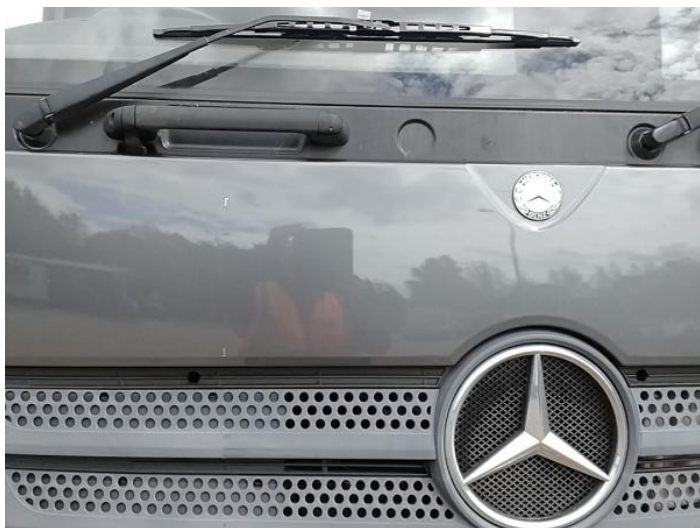
1: Bonnet  
Scratched  
UpTo 25mm Thru Paint

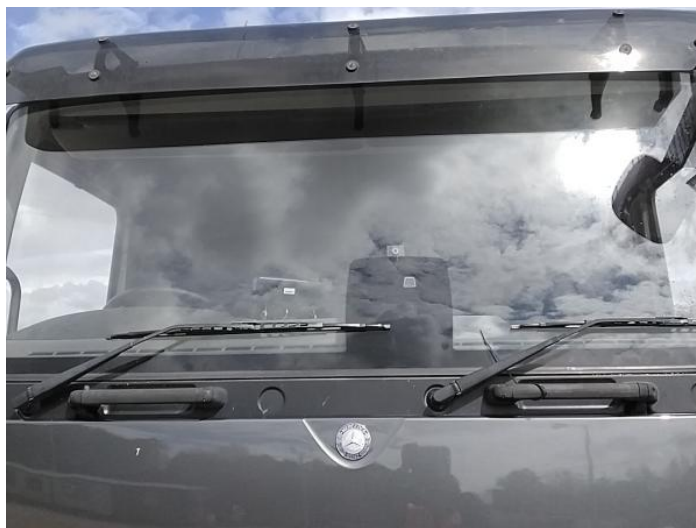
2: Screen Front  
Chipped  
UpTo 10mm

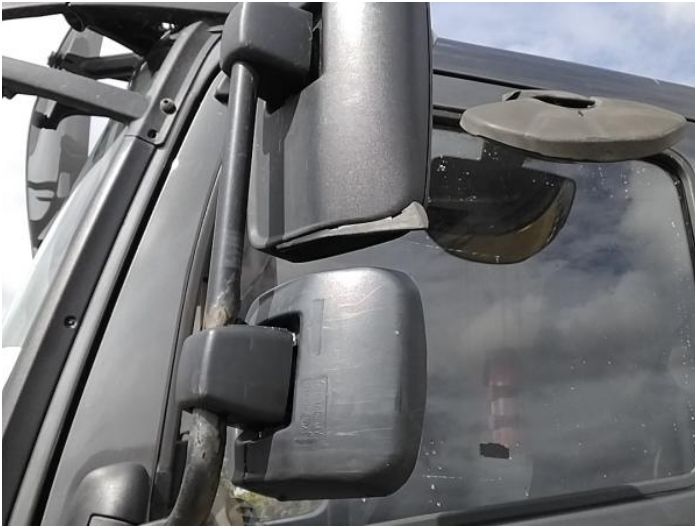
3: Door Mirror Assy nsf  
Scuffed (Unpainted)  
UpTo 100mm

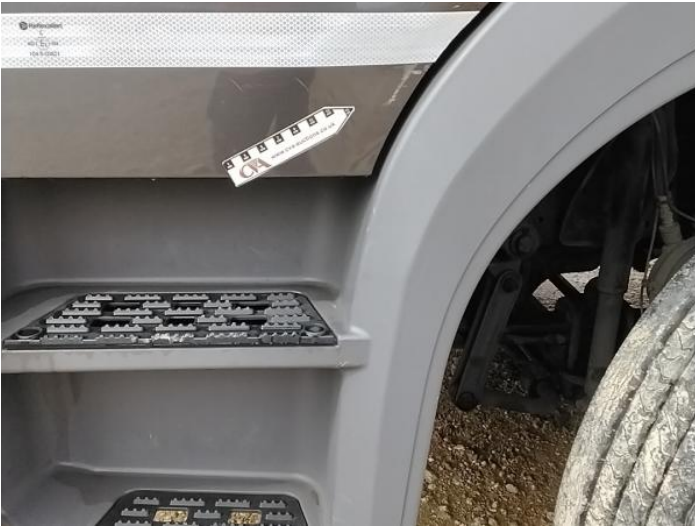
4: Door nsf  
Dented  
With Paint Damage

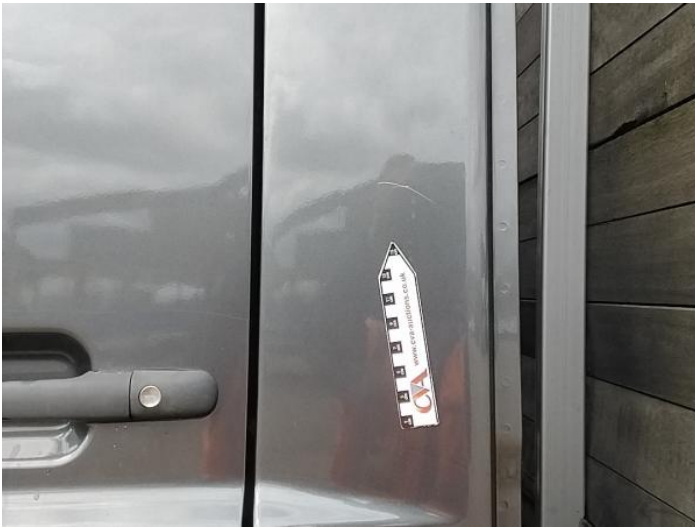
5: B Post ns  
Scratched  
UpTo 25mm Thru Paint
