VEHICLE INSPECTION REPORT

PE17HOH

Daf CF 440

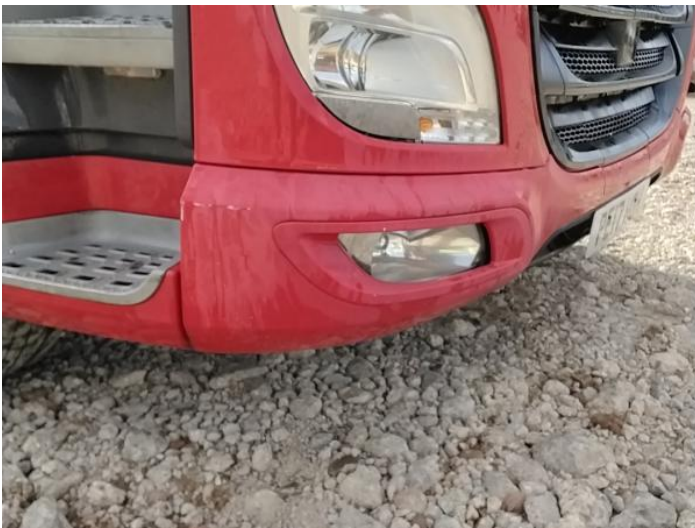
1: Bumper Front Moulding
Scratched (Painted)
Over 25mm Thru Paint

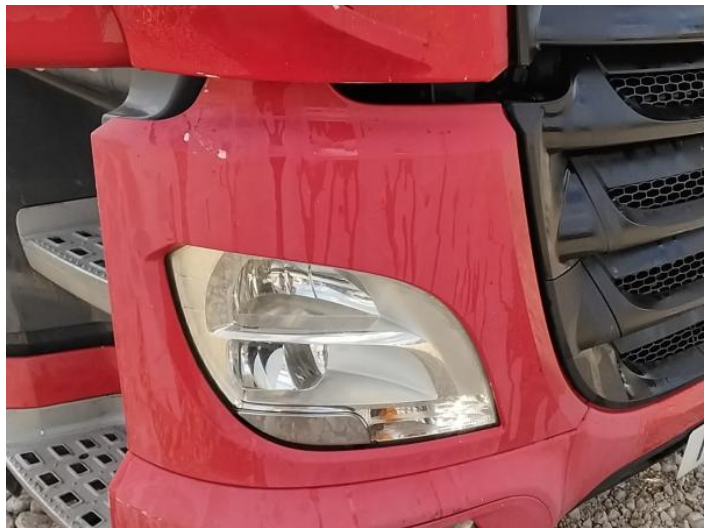
2: Fog Lamp Surround os
Scratched (Painted)
UpTo 25mm Thru Paint

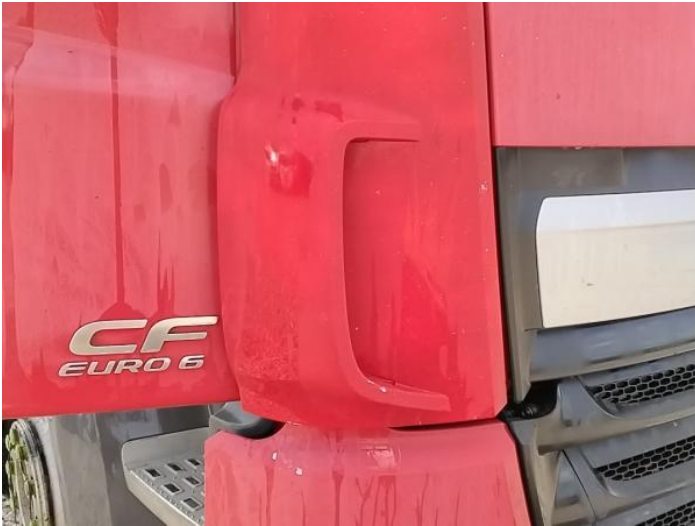
3: Wing osf
Scratched
Over 25mm Thru Paint

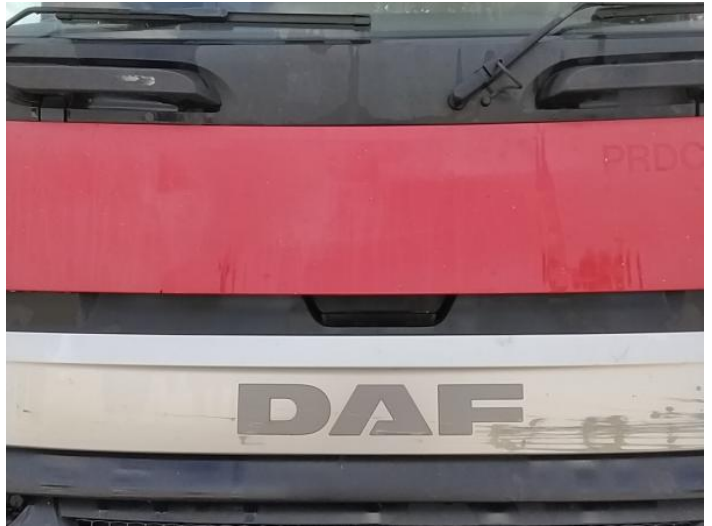
4: Bonnet
Chipped
Multiple Chips

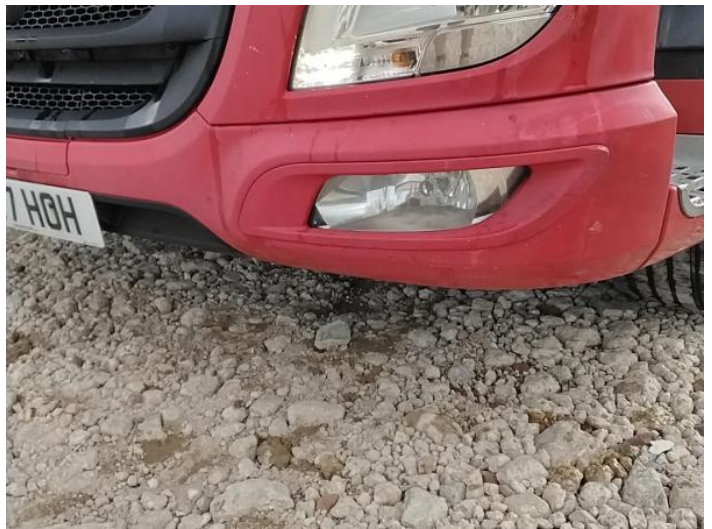
6: Bumper Front Moulding
Scratched (Painted)
UpTo 25mm Not Thru Paint

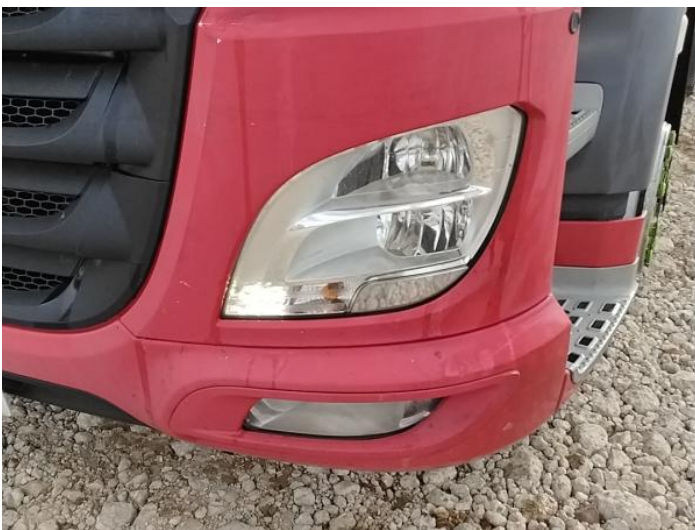
7: Fog Lamp Surround ns
Scratched (Painted)
UpTo 25mm Thru Paint

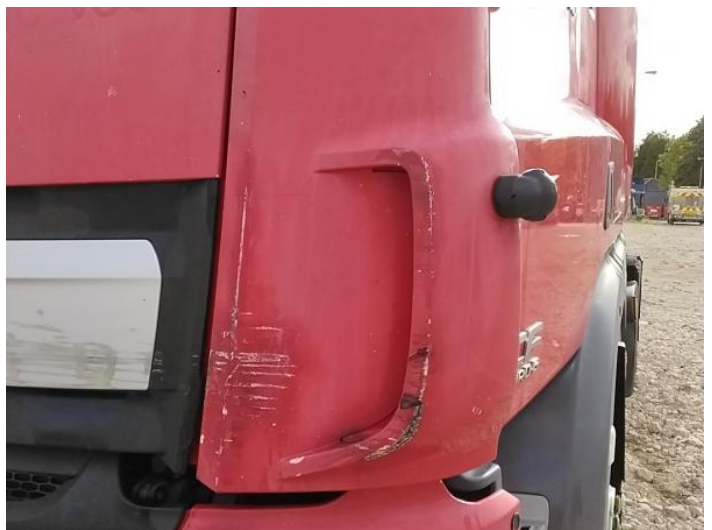
8: Wing nsf
Scratched
Over 25mm Thru Paint

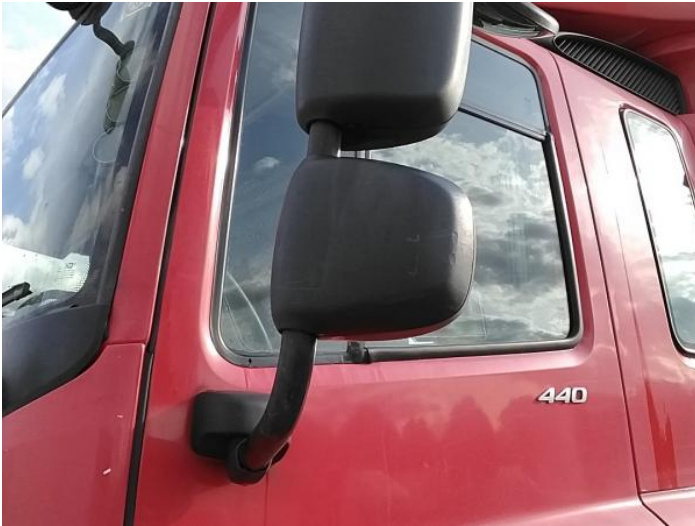
9: Door Mirror Assy nsf
Broken
Replace

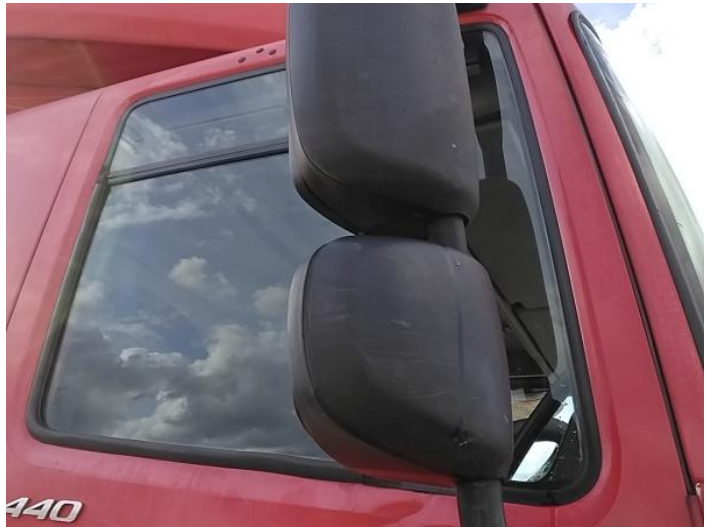
12: Door Mirror Assy osf
Scuffed (Unpainted)
UpTo 100mm
