VEHICLE INSPECTION REPORT

FP69HFX

Daf LF 180

Inspection

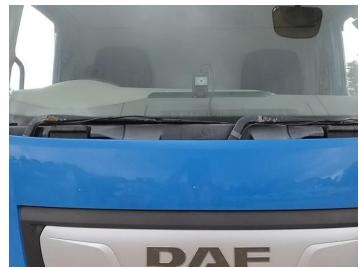
1: Bonnet Chipped Multiple Chips

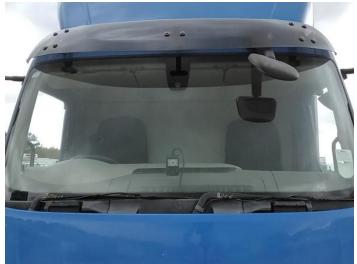
2: Screen Front Chipped UpTo 10mm

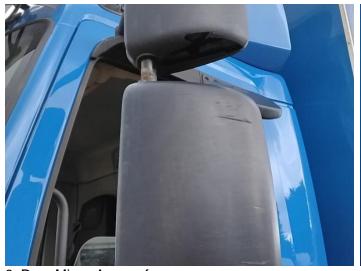
3: Door Mirror Assy nsf Broken Replace

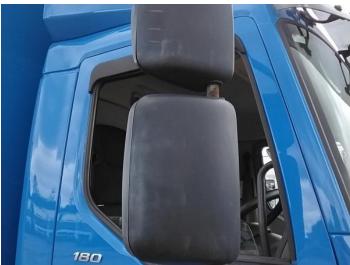
4: Door Mirror Assy osf Scuffed (Unpainted) UpTo 100mm

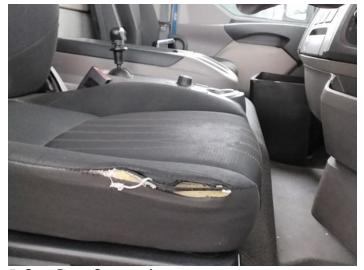
5: Seat Base Cover osf Torn Over 3mm
