# VEHICLE INSPECTION REPORT

**DK66KFJ**

## Man TGM 18.250

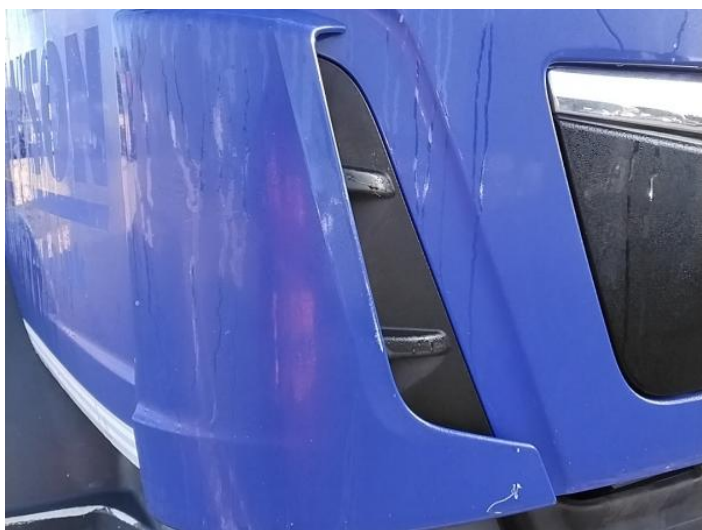
1: Wing of  
Scratched  
Up To 25mm Thru Paint

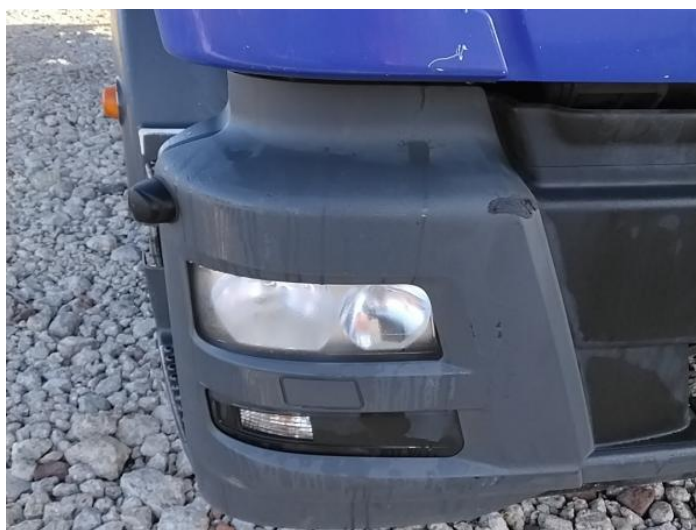
2: Fog Lamp Surround of  
Scuffed (Unpainted)  
Up To 100mm

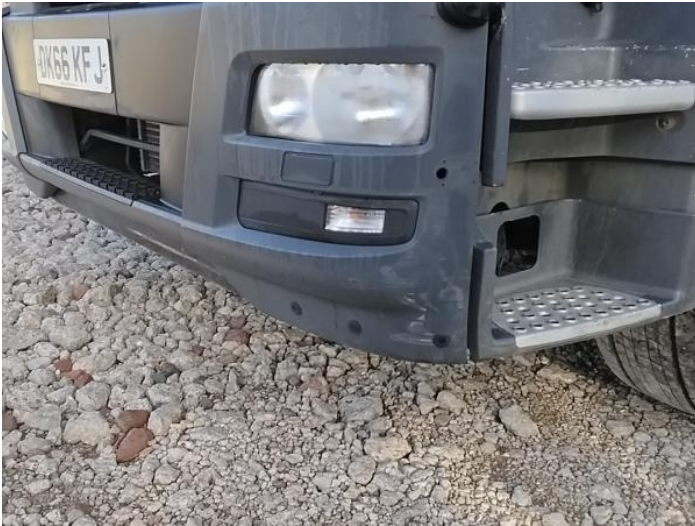
3: Fog Lamp Surround ns  
Scuffed (Unpainted)  
UpTo 100mm

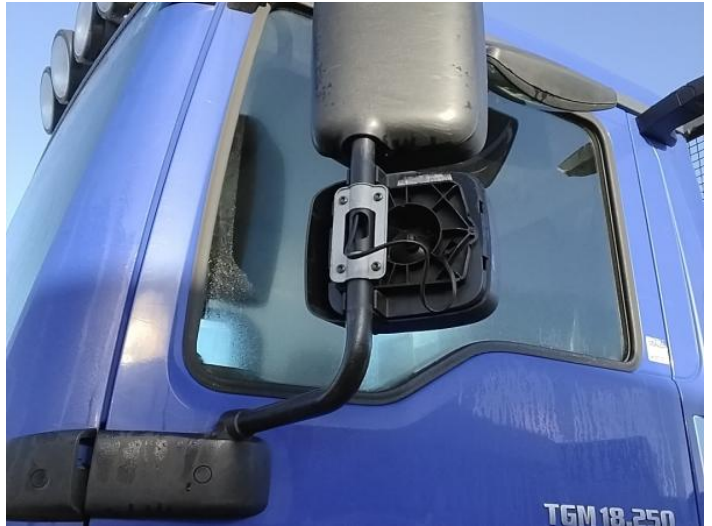
4: Door Mirror Assy nsf  
Missing  
Replace

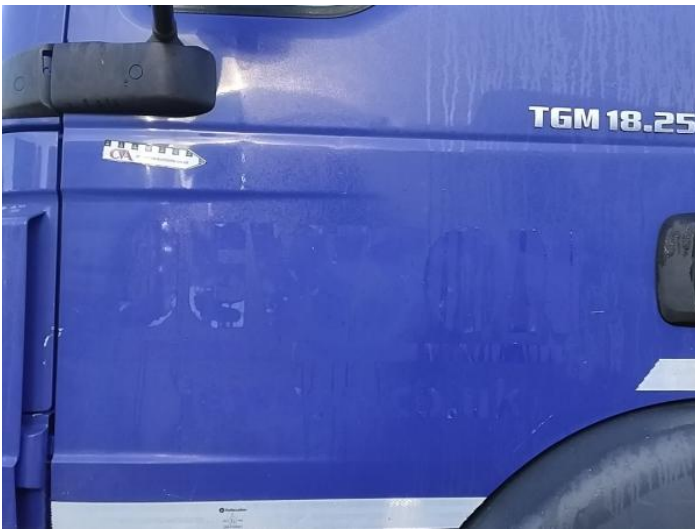
5: Door nsf  
Scratched  
Over 25mm Thru Paint

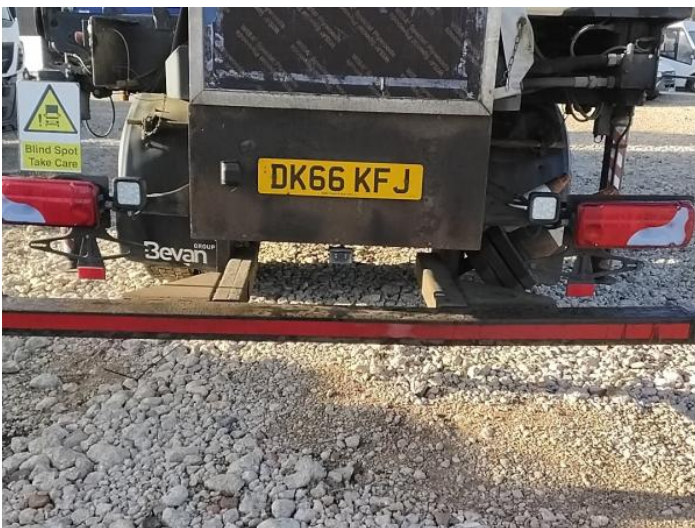
7: Bumper Rear  
Rusted  
Over 5mm

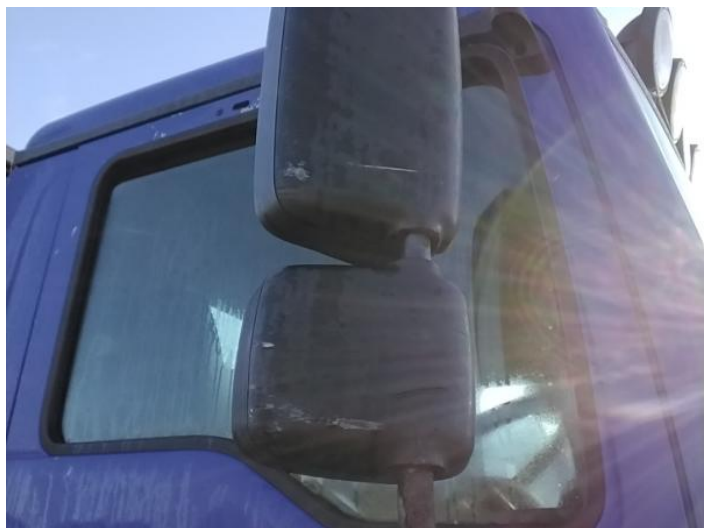
8: Door Mirror Assy osf  
Scuffed (Unpainted)  
UpTo 100mm

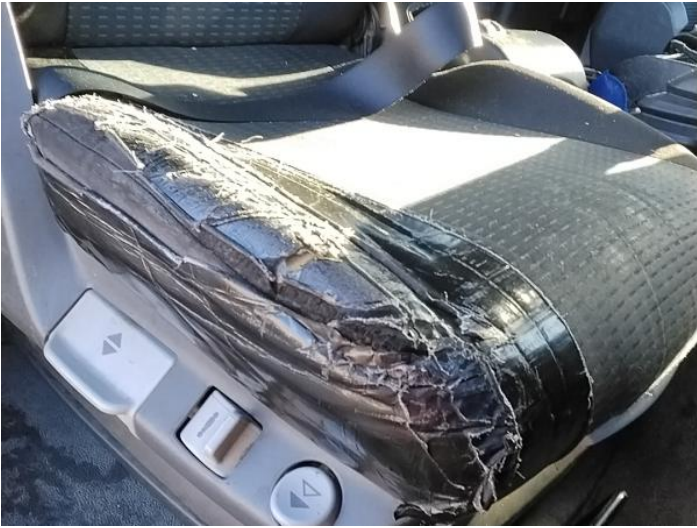
10: Seat Base Cover osf  
Torn  
Over 3mm

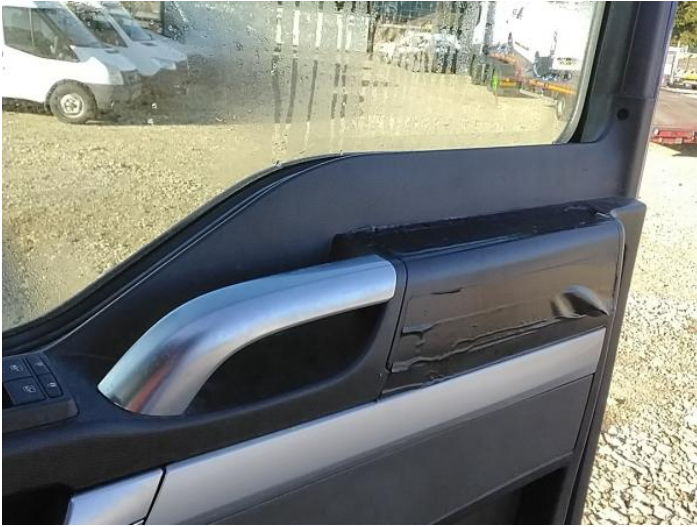
11: Door Pad osf  
Broken  
Replace
